*Excerpt from 2024 Sculpture Maintenance Overview- Presented by Pacific Coast Conservation*

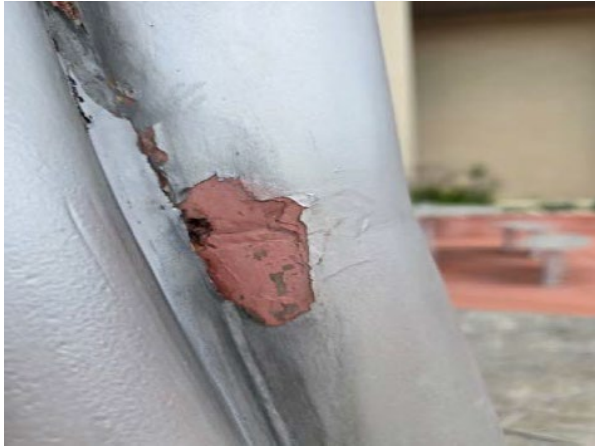
*Solar Tree (19)* has paint that is flaking and not adhered to the sculpture. Some stabilization and inpainting was done during this maintenance cycle. A full repainting is needed on the sculpture, a separate formal proposal will be submitted for full treatment of the sculpture.

*Detail: Area of failed paint pulled back to a stable point prior to painting*

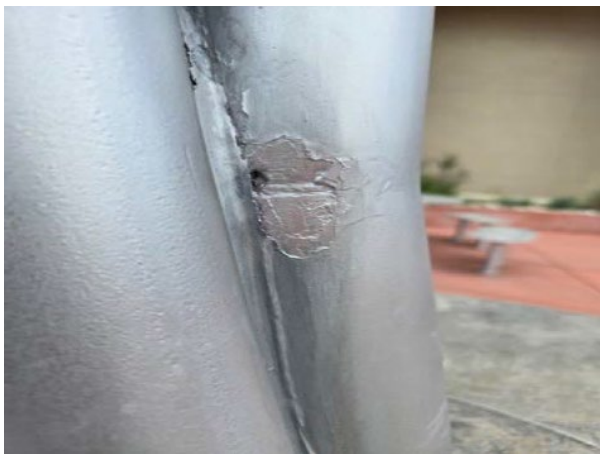
*Detail: Area of failed paint pulled back to a stable point and then painted.*
