## Mesa Public Library Noise Issues

## **Level 2 Meeting Rooms**

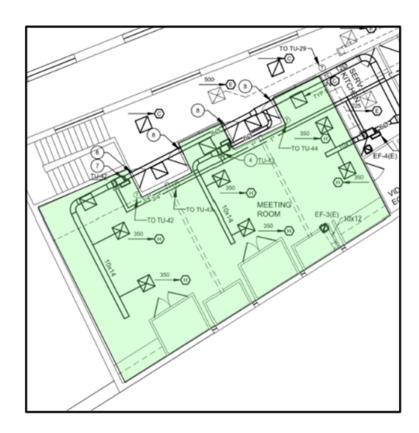
- Sound transmission between adjacent rooms when the operable partition are in use is poor.
- Speech intelligibility between meeting rooms relates to both the audibility of the intruding sound and the intelligibility of the speech itself.
- Eliminating the sound transfer entirely is not feasible with an operable wall.
- Over time the seals on the operable walls can become misaligned or degrade and no longer seal.

- It is recommended that the library contacts its local folding partition vendor (Modernfold is installed) to perform a maintenance inspection and to verify the integrity of the seals and wall panels.

- If this evaluation does not yield any noticable improvements the we recommend that the replacement of the existing partitions be considered.
- If replacement is the path forward, a newer option providing a higher level of sound isolation can be selected.

- We recommend that a partition with an STC-53 or better be selected.
  - This can be the Moderco Signature 800 or the Modernfold Encore
  - It should be noted that although operable partitions can be rated above an STC-50 they often perform 5-7 point lower than their STC rating once installed, due to various in-field conditions.

- The alternative is to replace the folding partitions with a fixed wall assembly.
   Although this would eliminate the flexibility of the space, the STC-55 assembly will achieve a superior level of acoustic noise reduction as compared to an operable wall.

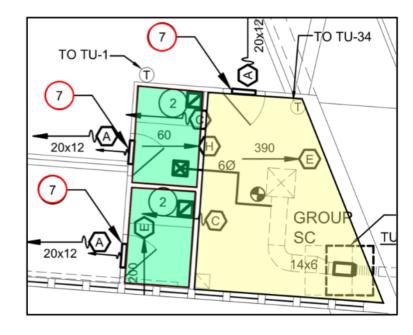
- Group SC Room: Elevated temperatures have occurred in this room prompting an increase in airflow to improve cooling. However, the added air volume is resulting in higher background noise levels in the room.

- Inter-room Noise Transfer: Sound is transferring between adjacent rooms. This occurs through 2 primary paths.
  - 1. Directly through the wall structure, which is dependent upon the performance of the assembly. (STC rating)

- 2. Indirectly thought the ceilings, where sound travel through the ceiling, over the top of the wall, and then enters the adjacent space through the ceiling of the neighboring room. (CAC rating)

- Noise Leakage to Public Areas: Sound from the enclosed rooms is also escaping into adjacent public spaces via the return air openings located in the walls. These openings are shown as red circled "7" in the layout. The return air openings are located within the walls or doors below the room's ceiling plane.

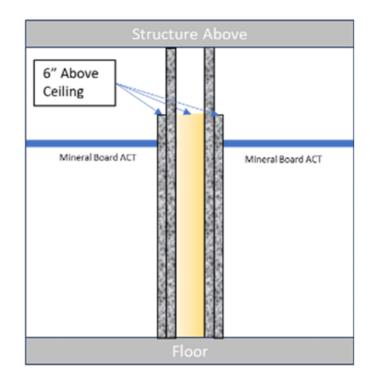
## Option 1: Improve Demising Walls & Extend Walls to Structure

- Existing walls in most rooms were determined to be constructed using 1 layer of sheetrock on each side of 3-5/8" metal studs with no insulation in the stud cavity. This wall performs around an STC-35 to STC-40.
- · Walls are partial height and stop above the ceiling.
- The ceilings appear to be a mineral board ceiling tile which performs around a CAC-30 to CAC-35.
- With the open return grilles in the ceiling located close to one another, the performance through the ceiling is expected to be reduced. Therefore, the combined architectural separation between rooms is expected to be around an STC-35.

- Add insulation to the existing wall cavity. This can be done by removing the sheetrock on one side of the wall to add fiberglass or rockwool batt between the studs, or by keeping the sheetrock in place and blowing in loose insulation.
- Add 1 layer of 5/8" GWB on each side of the existing wall, for a total of 2 layers per side.
- Extend one layer on each side of the wall to the underside of structure. This can either be done on top of the existing layers, or by taking the new outer layers full height.

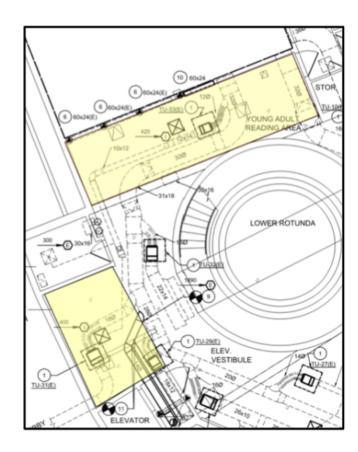
- Elevated background noise levels are present within the areas shown in yellow.
- This appears to be due to excessive airflow. When standing in these locations, one can feel a strong air current and observe nearby decoctions visibly moving, indicating high velocity air movement in the space.

- The background noise levels was measured to be 59 dBA (NC-52) which is substantially above the recommended background noise level of library reading zones of 35 dBA (NC-30).

- The Test & Balance Report dated February 25, 2019 was reviewed as part of this investigation and was assumed to be the final version.
- However, upon examination, several items listed on pages 8-10 remain unresolved.
   These include:

- Terminal units TU-33 and TU-31, located above the Reading Area per plans, are reported as balanced to maximum airflow rates of 1120 cfm and 2195 cfm respectively.

- But based on the pronounced airflow and movement of hanging elements in this
    area, it is likely that the actual airflow and associated airflow velocities in these
    zones are exceeding the reported values.

- It is also conceivable that the air reaching the Group SC Room on Level 1 is impacted by the amount of air being lost over the Youn Adult Reading Area, resulting in less air available to cool this room and possibly other rooms in the library.

- · Check the air balance of the HVAC System.
  - It is quite possible that if the system is out of balance, then correcting the airflow balance may just resolve the noise issues on the ground level and the airflow issues in other parts of the library.

- This would need to be completed by a mechanical contractor or balancing/controls engineer.
- If system balancing is completed and noise issues persist, or if balancing provides unfeasible, and the issues remain, then the following measures should be implemented:

- Replace the open ceiling in the reading area west of the rotunda with a sheetrock ceiling (yellow) which consists of 1 layer of 5/8" GWB with R-11 batts placed on top of the ceiling.

- The second reading area north of the rotunda has an acoustically transparent ceiling and large return air openings located above the ceiling which are connected to the mechanical room wall. Here the Terminal Unit TU-33 should be relocated to the ptionin inidicated by the red dot. From there, ti should be ducted either rabove or below the existing 32" round duct. The yellow area below the red dot should be replaced with a sheetrock ceiling. A minimum of 5-feet of lintnerlaly lined ductwork should be instaeed between the terminal unit and the first diffuser using 1" thick fiberglass ductliner to support acoustic attenuation.

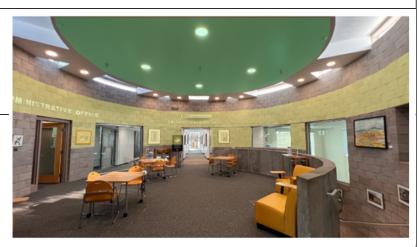
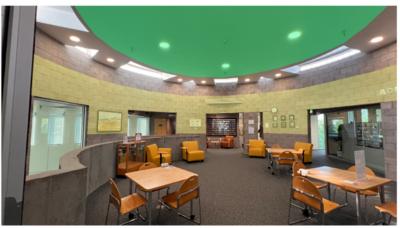
#### Level 2 - Gallery

- · Level 2 of the rotunda is a gallery area with seating.
- Sound is reflecting off the hard walls and ceilings and focusing towards the center of the rotunda, which can result in an acoustic phenomenon where a person can perceive an amplification of their own voice.

- To mitigate the lively acoustics and concentration of sound, sound absorptive
  materials should be installed on both the ceiling and walls of the gallery to reduce
  reverberation and diffuser focused sound reflections.

- Ceiling sound absorption (green areas) should be achieved using 1" thick acoustic material with a minimum NRC 0.70.
  - Wall treatments (yellow areas) should utilize 2" thick absorptive panels with a minimum NRC 0.95.

- Ceiling installations may be interrupted around fixtures such as lighting and sprinkler heads
- Wall panels should be applied continuously to maintain consistent acoustic coverage.
