# Mesa Public Library Noise Issues

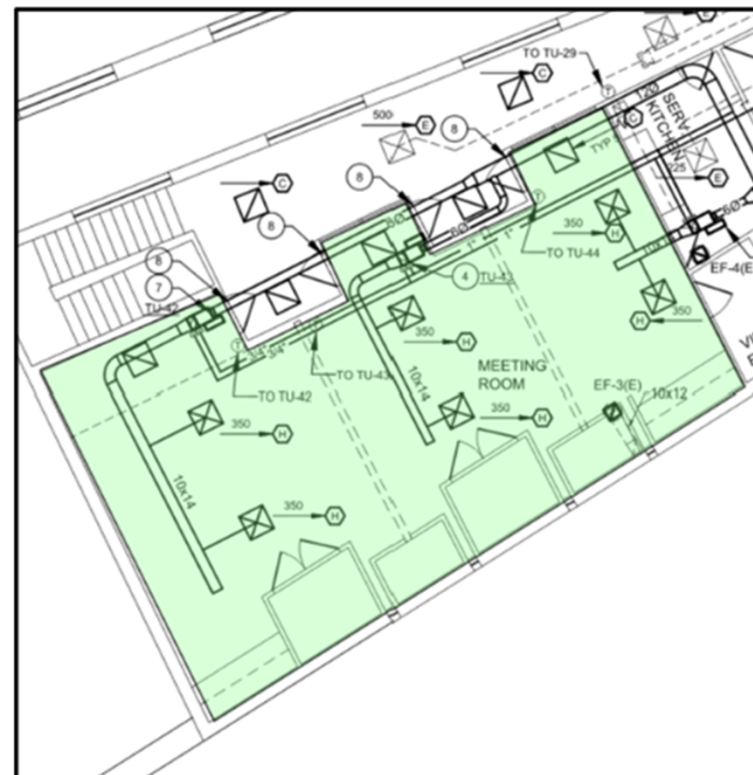
- Sound transmission between adjacent rooms when the operable partition are in use is poor.
- Speech intelligibility between meeting rooms relates to both the audibility of the intruding sound and the intelligibility of the speech itself.
- Eliminating the sound transfer entirely is not feasible with an operable wall.
- Over time the seals on the operable walls can become misaligned or degrade and no longer seal.

- It is recommended that the library contacts its local folding partition vendor (Modernfold is installed) to perform a maintenance inspection and to verify the integrity of the seals and wall panels.

- If this evaluation does not yield any noticeable improvements the we recommend that the replacement of the existing partitions be considered.
- If replacement is the path forward, a newer option providing a higher level of sound isolation can be selected.

- We recommend that a partition with an STC-53 or better be selected.
  - This can be the Moderco Signature 800 or the Modernfold Encore
  - It should be noted that although operable partitions can be rated above an STC-50 they often perform 5-7 point lower than their STC rating once installed, due to various in-field conditions.

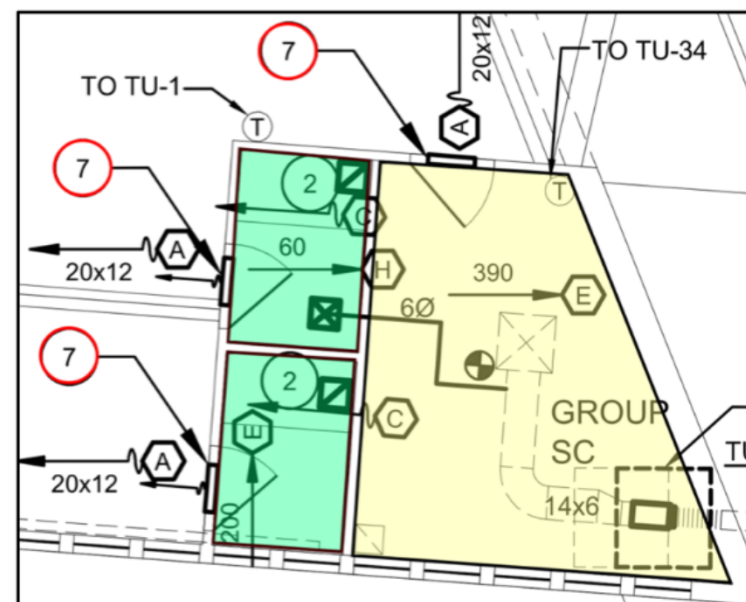
- **Group SC Room:** Elevated temperatures have occurred in this room prompting an increase in airflow to improve cooling. However, the added air volume is resulting in higher background noise levels in the room.

- **Inter-room Noise Transfer:** Sound is transferring between adjacent rooms. This occurs through 2 primary paths.
  1. Directly through the wall structure, which is dependent upon the performance of the assembly. (STC rating)

2. Indirectly through the ceilings, where sound travel through the ceiling, over the top of the wall, and then enters the adjacent space through the ceiling of the neighboring room. (CAC rating)

- **Noise Leakage to Public Areas:** Sound from the enclosed rooms is also escaping into adjacent public spaces via the return air openings located in the walls. These openings are shown as red circled “7” in the layout. The return air openings are located within the walls or doors below the room’s ceiling plane.

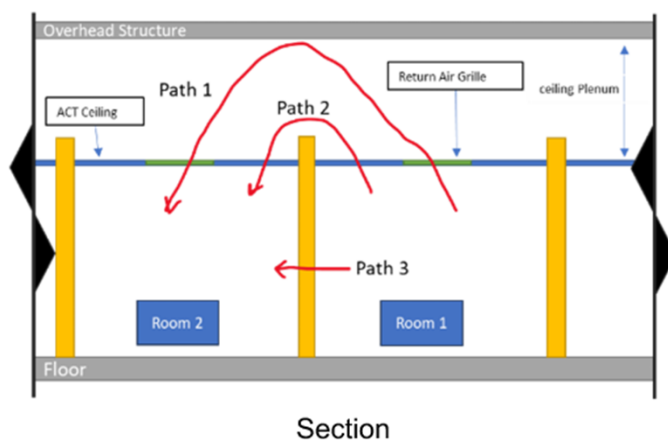
- Existing walls in most rooms were determined to be constructed using 1 layer of sheetrock on each side of 3-5/8" metal studs with no insulation in the stud cavity. This wall performs around an STC-35 to STC-40.
- Walls are partial height and stop above the ceiling.
- The ceilings appear to be a mineral board ceiling tile which performs around a CAC-30 to CAC-35.
- With the open return grilles in the ceiling located close to one another, the performance through the ceiling is expected to be reduced. Therefore, the combined architectural separation between rooms is expected to be around an STC-35.

- **Path1:** Through the return air opening into the ceiling plenum and back down through the return air opening into Room 2
- **Path2:** through the ACT tile into the ceiling plenum and back down through the ACT tile into Room 2
- **Path3:** through the body of the wall

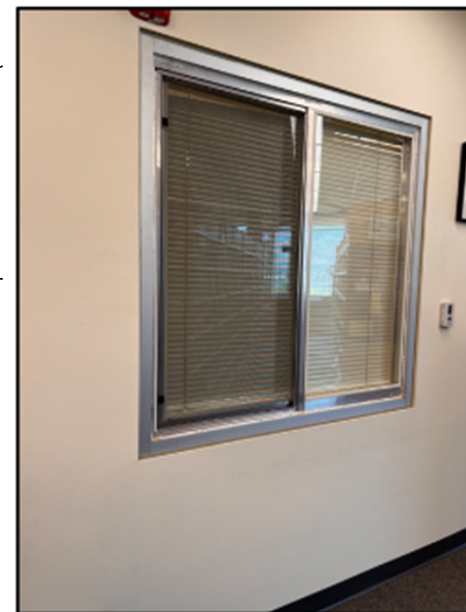
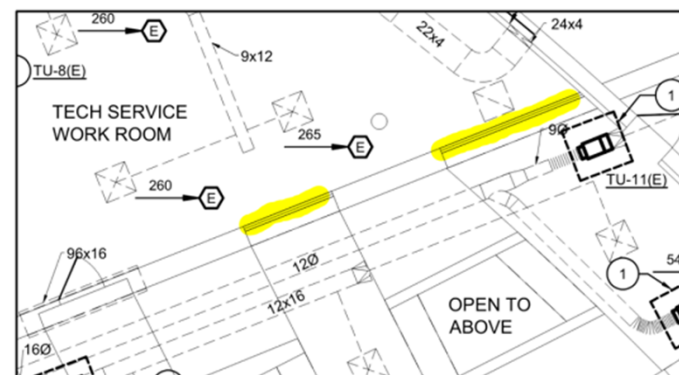
- Although this Level 1 office is currently vacant, the reported noise issues involves conversation within the space being audible in the adjacent public areas.
- Sound is easily passing through the single-pane wall mounted window.
- This window is now permanently sealed.
- Staff in the workroom can hear kids from the Children Collection Area through the single pane windows, highlighted in yellow.

- If the window is no longer needed, remove it and fill in the opening to match the wall's constructed assembly.
- If the window is still needed, replace it with a double pane window consisting of 1/4" glass\_1/2" airspace\_1/4" glass
  - This glazing assembly is expected to improve sound isolation by approximately 10 dB compared to the existing glass, effectively reducing the noise transmission by half.

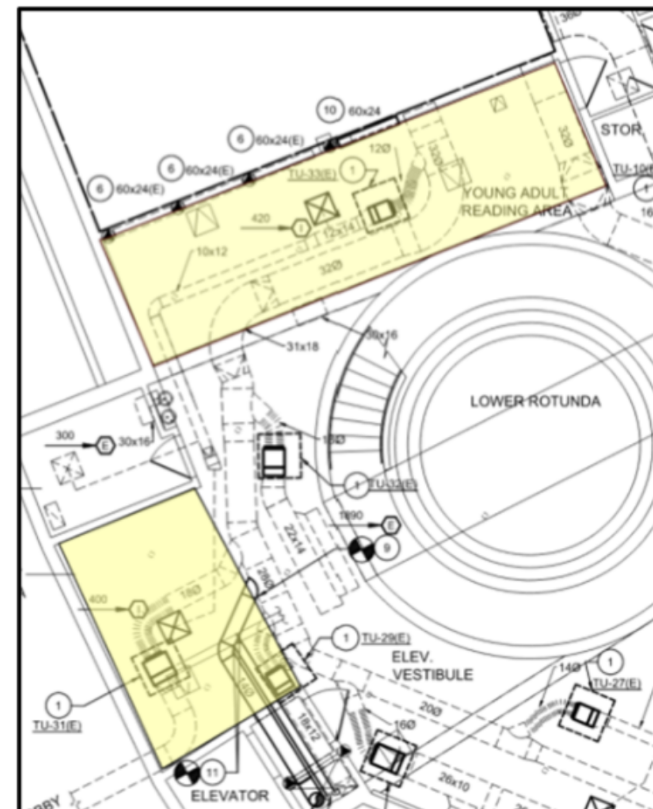
- Elevated background noise levels are present within the areas shown in yellow.
- This appears to be due to excessive airflow. When standing in these locations, one can feel a strong air current and observe nearby decoctions visibly moving, indicating high velocity air movement in the space.

- The background noise levels was measured to be 59 dBA (NC-52) which is substantially above the recommended background noise level of library reading zones of 35 dBA (NC-30).

- The Test & Balance Report dated February 25, 2019 was reviewed as part of this investigation and was assumed to be the final version.
- However, upon examination, several items listed on pages 8-10 remain unresolved. These include:

- Terminal units TU-33 and TU-31, located above the Reading Area per plans, are reported as balanced to maximum airflow rates of 1120 cfm and 2195 cfm respectively.

- But based on the pronounced airflow and movement of hanging elements in this area, it is likely that the actual airflow and associated airflow velocities in these zones are exceeding the reported values.

- It is also conceivable that the air reaching the Group SC Room on Level 1 is impacted by the amount of air being lost over the Youn Adult Reading Area, resulting in less air available to cool this room and possibly other rooms in the library.

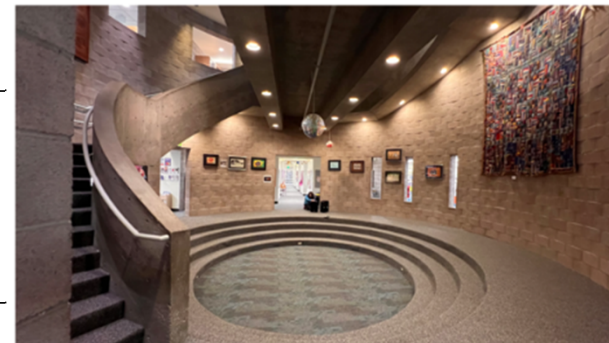
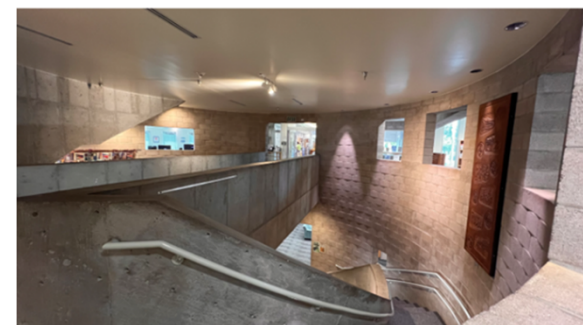
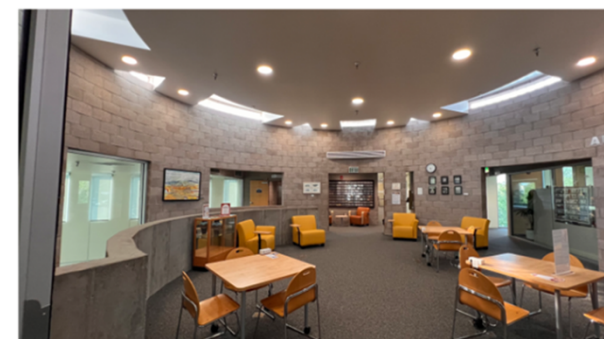
- The rotunda is a cylindrical architectural element that vertically connects all three levels of the library.
- The interior surfaces consist of primarily acoustically reflective materials, including concrete, concrete masonry unit (CMU) walls, and sheetrock ceilings.

- A stairway wraps around the perimeter of the rotunda, providing access between floors.
- The stair connecting Levels 1 and 2 includes a fire rated door, which remains open during business hours and would only close in the event of a fire.

- The rotunda walls feature open sections at each level, allowing sound that is generated within the rotunda to travel out into the nearby floors.
- The ground level of the rotunda is frequently used for children's programming, which often uses amplified music and speech.

- Level 2 of the rotunda is a gallery area with seating.
- Sound is reflecting off the hard walls and ceilings and focusing towards the center of the rotunda, which can result in an acoustic phenomenon where a person can perceive an amplification of their own voice.
