LOS ALAMOS COUNTY

Due Diligence Study

CB FOX DEPT. STORE

DUE DILIGENCE STUDY FOR 1735 CENTRAL AVE.

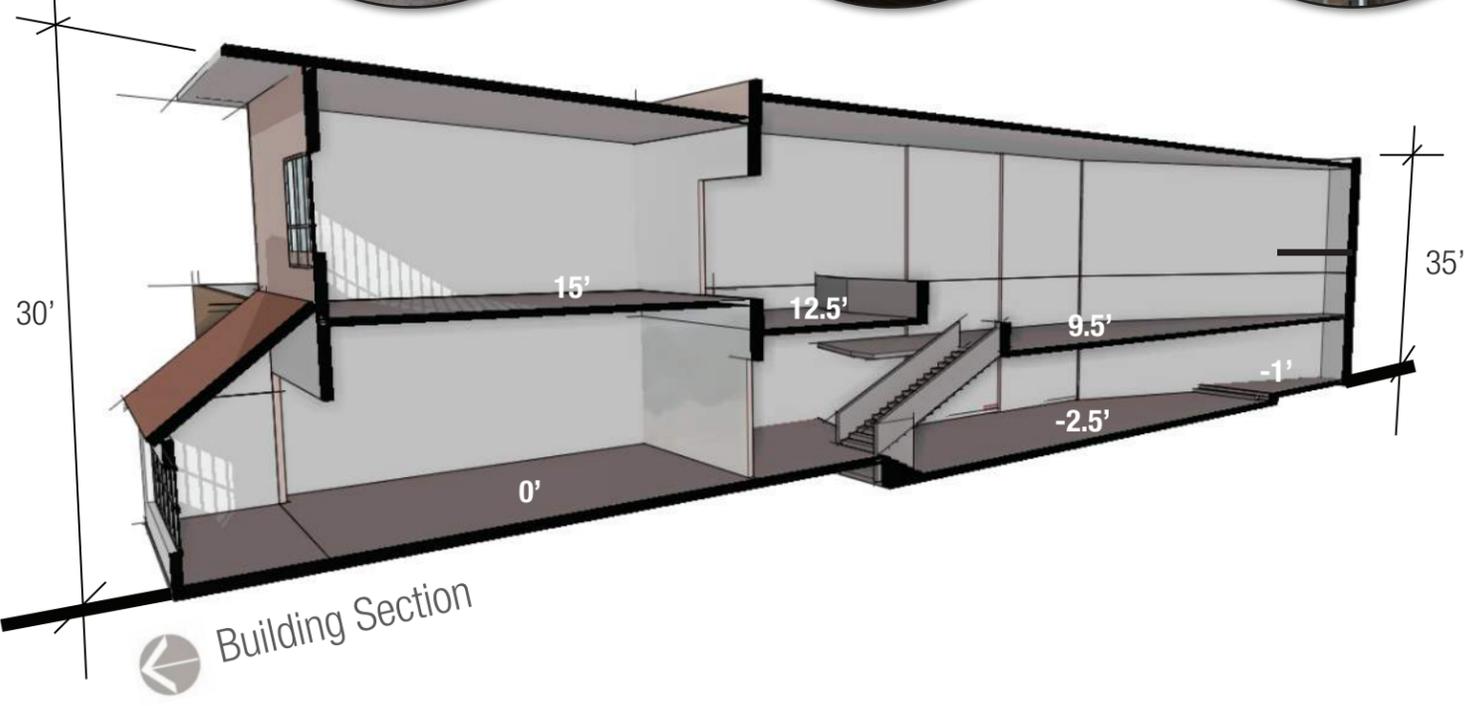
The existing building is constructed with multiple floor finish elevations as shown in the building section diagram. There are no ramps or elevators to comply with current ADA standards. Restrooms are also not adequately designed to meet these requirements.

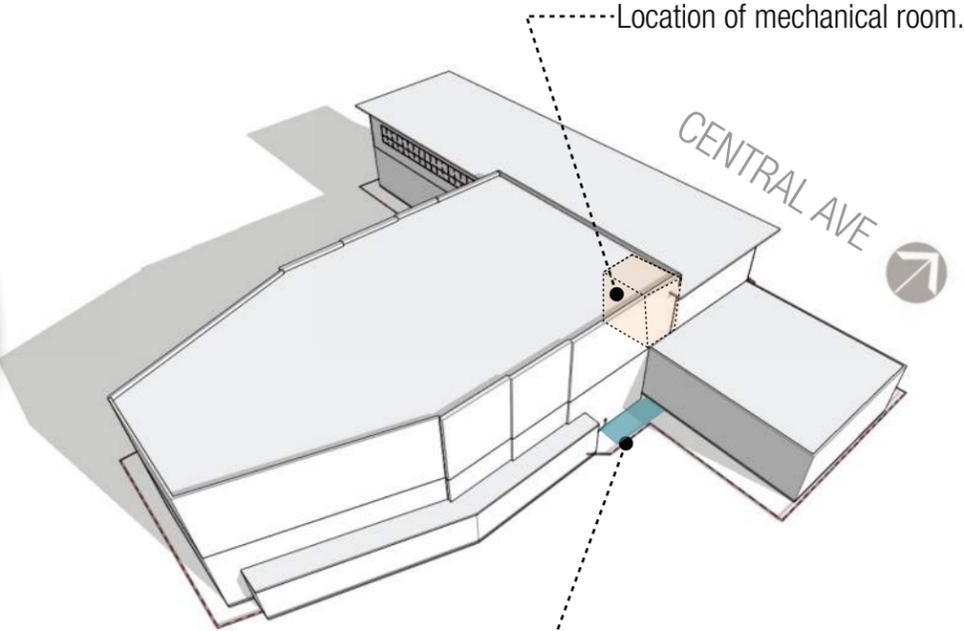
UTILITY ACCESS

Location of mechanical room.

Access to underground utility room which serves as a building service entry.

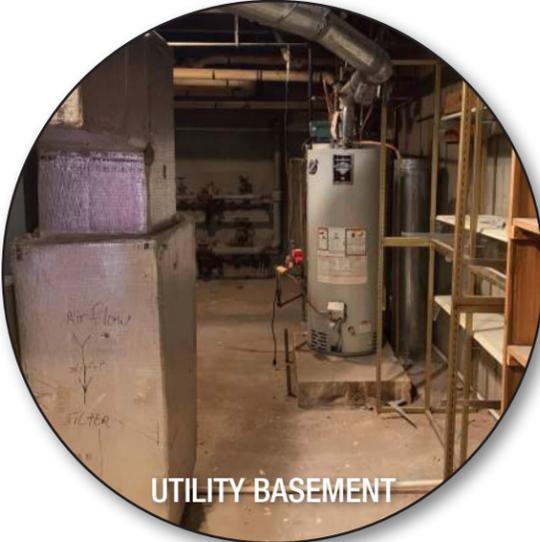
UTILITY BASEMENT

1. Underground Three-Phase primary distribution is derived from Trinity Dr./Deacon St.
2. A pad mounted transformer is located in the basement of the building.
3. A meters for the facility and it many stores are also located in the basement.

1. Existing secondary service to the Main Switchboard (MSB) located in basement. Existing electrical equipment is rated for 208Y/120V, 3 Phase, 4 wire, and MSB rated for 1200A. Existing MSB serves downstream panels for the various department stores.

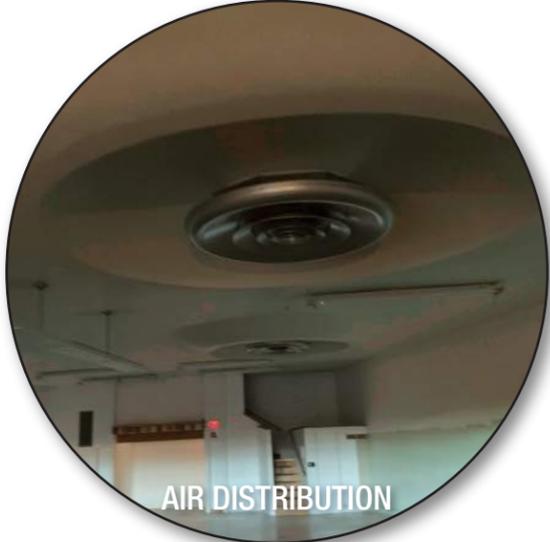
AIR DISTRIBUTION

Main HVAC system consists of an indoor central airhandler with split DX coil, gas fire heat exchanger. Indoor DX coil is connected through refrigerant piping to an outdoor air cooled condenser located on the nearby low roof. Most of the components of existing systems appear original to the building and are past their service life.

Air distribution from airhandler consists of ducted supply air diffuser (round) located on the second floor ceiling and ducted return air grilles.

General Recommendations
Recommend replacing systems in their entirety.

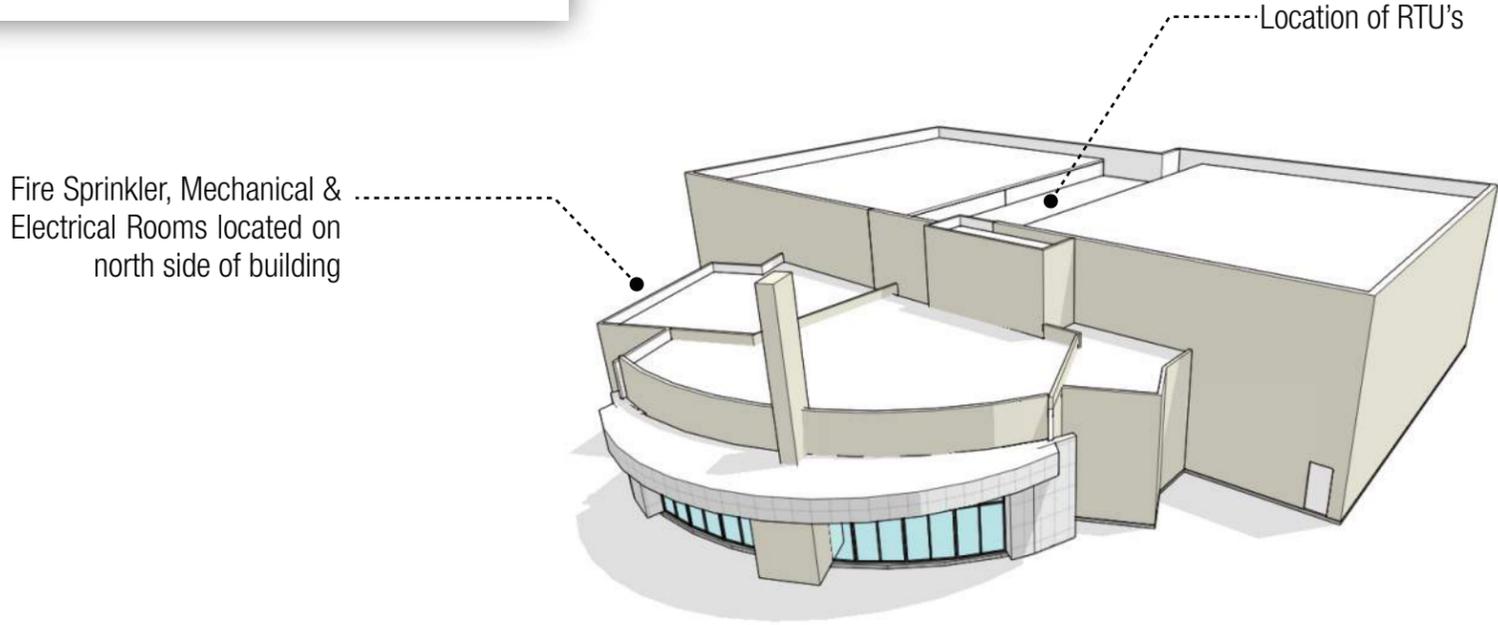
Cooling coil condensate drain is directly discharged on the roof which does not meet code and will result in possible roof damage over time.

Route cooling condensate drain line to indirect approved plumbing fixture as required by code.

Route cooling condensate drain pipe indirectly to approved plumbing fixture
