# Mesa Public Library Noise Issues

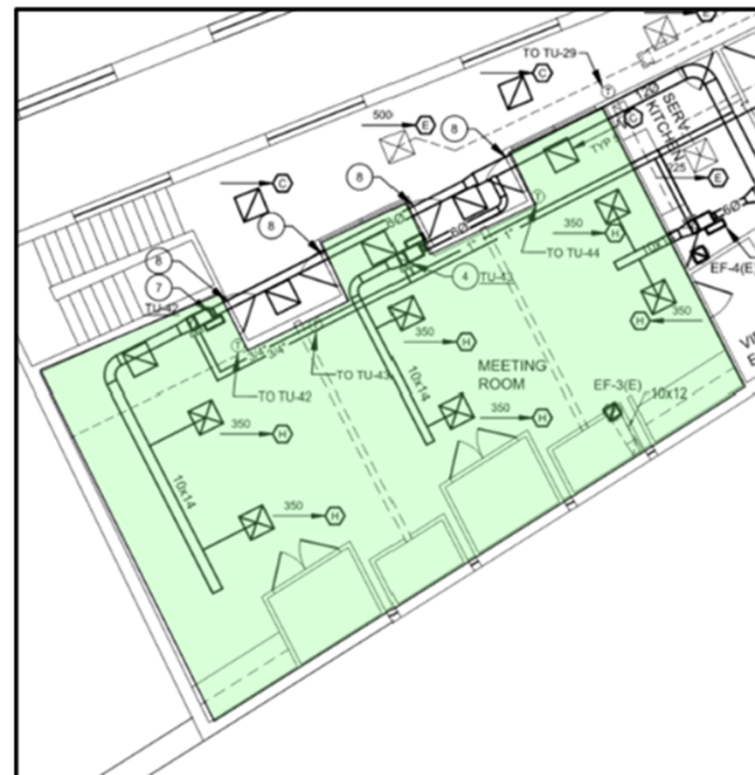
- Sound transmission between adjacent rooms when the operable partition are in use is poor.
- Speech intelligibility between meeting rooms relates to both the audibility of the intruding sound and the intelligibility of the speech itself.
- Eliminating the sound transfer entirely is not feasible with an operable wall.
- Over time the seals on the operable walls can become misaligned or degrade and no longer seal.

- It is recommended that the library contacts its local folding partition vendor (Modernfold is installed) to perform a maintenance inspection and to verify the integrity of the seals and wall panels.

- If this evaluation does not yield any noticeable improvements the we recommend that the replacement of the existing partitions be considered.
- If replacement is the path forward, a newer option providing a higher level of sound isolation can be selected.

- We recommend that a partition with an STC-53 or better be selected.
  - This can be the Moderco Signature 800 or the Modernfold Encore
  - It should be noted that although operable partitions can be rated above an STC-50 they often perform 5-7 point lower than their STC rating once installed, due to various in-field conditions.

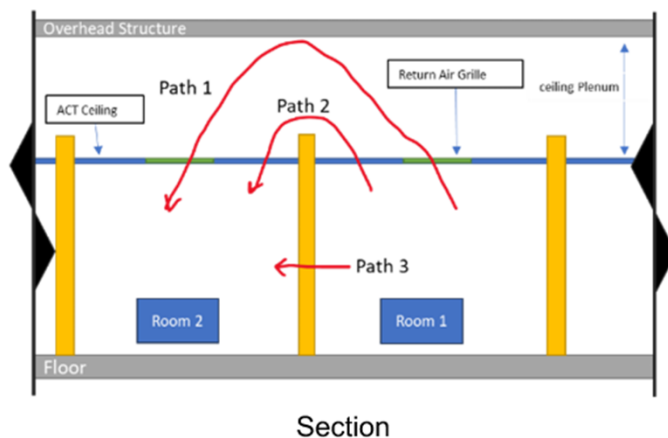
- Existing walls in most rooms were determined to be constructed using 1 layer of sheetrock on each side of 3-5/8" metal studs with no insulation in the stud cavity. This wall performs around an STC-35 to STC-40.
- Walls are partial height and stop above the ceiling.
- The ceilings appear to be a mineral board ceiling tile which performs around a CAC-30 to CAC-35.
- With the open return grilles in the ceiling located close to one another, the performance through the ceiling is expected to be reduced. Therefore, the combined architectural separation between rooms is expected to be around an STC-35.

- Path1:** Through the return air opening into the ceiling plenum and back down through the return air opening into Room 2
- Path2:** through the ACT tile into the ceiling plenum and back down through the ACT tile into Room 2
- Path3:** through the body of the wall

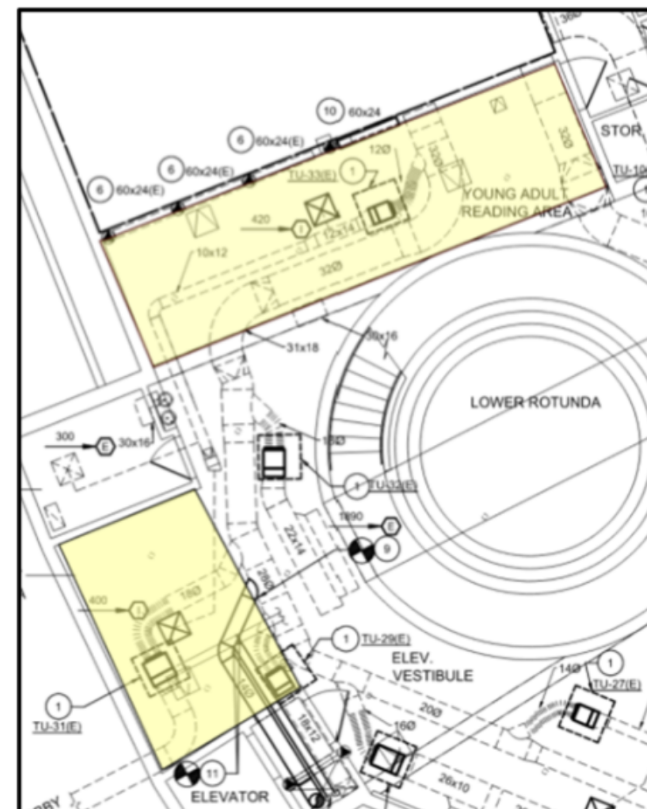
- Elevated background noise levels are present within the areas shown in yellow.
- This appears to be due to excessive airflow. When standing in these locations, one can feel a strong air current and observe nearby decoctions visibly moving, indicating high velocity air movement in the space.

- The background noise levels was measured to be 59 dBA (NC-52) which is substantially above the recommended background noise level of library reading zones of 35 dBA (NC-30).

- Terminal units TU-33 and TU-31, located above the Reading Area per plans, are reported as balanced to maximum airflow rates of 1120 cfm and 2195 cfm respectively.

- But based on the pronounced airflow and movement of hanging elements in this area, it is likely that the actual airflow and associated airflow velocities in these zones are exceeding the reported values.

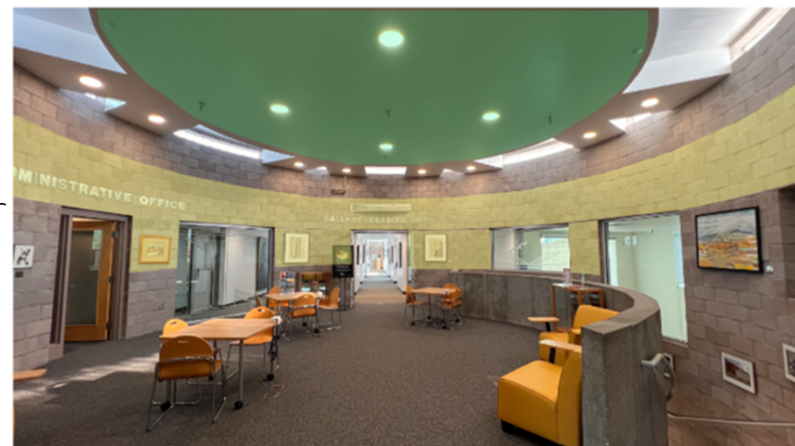
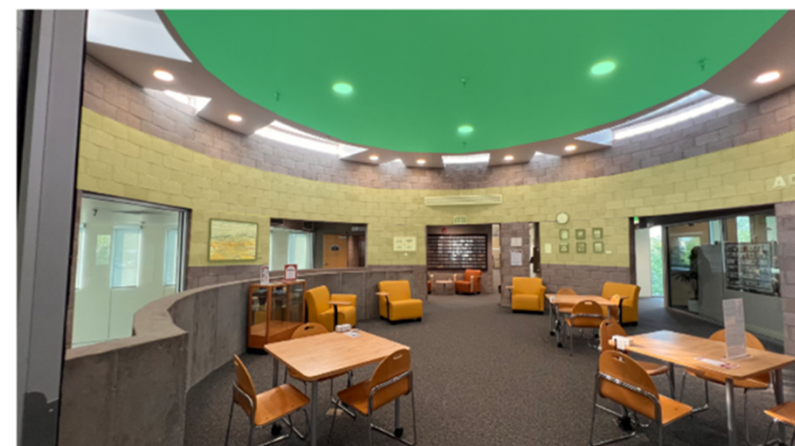
- To mitigate the lively acoustics and concentration of sound, sound absorptive materials should be installed on both the ceiling and walls of the gallery to reduce reverberation and diffuser focused sound reflections.

- Ceiling sound absorption (green areas) should be achieved using 1" thick acoustic material with a minimum NRC 0.70.
  - Wall treatments (yellow areas) should utilize 2" thick absorptive panels with a minimum NRC 0.95.

- Ceiling installations may be interrupted around fixtures such as lighting and sprinkler heads
- Wall panels should be applied continuously to maintain consistent acoustic coverage.

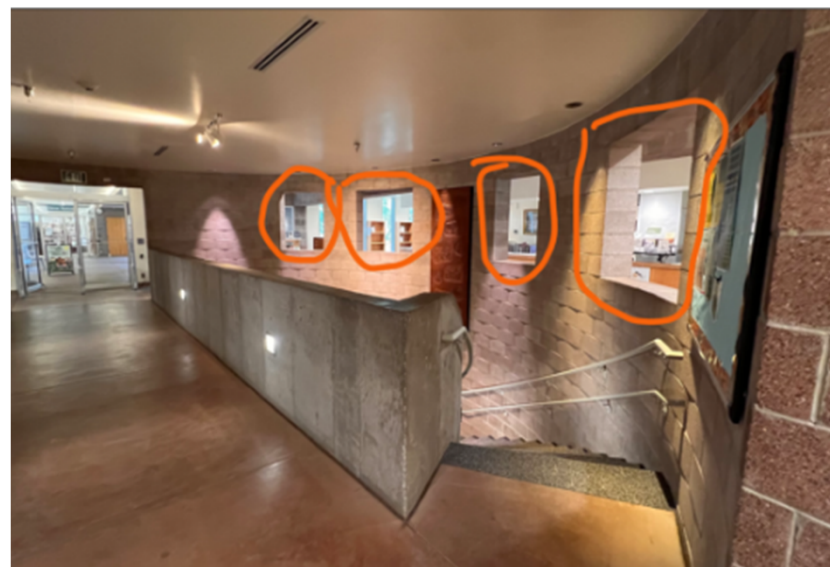
- Multiple openings in the circular walls of the rotunda permit sound to travel into adjacent areas of the library
- Blocking these opening with glass will substantially reduce noise transfer from the rotunda to surrounding spaces.
- The closure of these openings must be carefully coordinated with the building's HVAC airflow dynamics and fire/smoke evaluation requirements to ensure compliance with safety standards and to maintain proper ventilation.
- If closure of the openings is possible, the glass should be 3/8" thick.

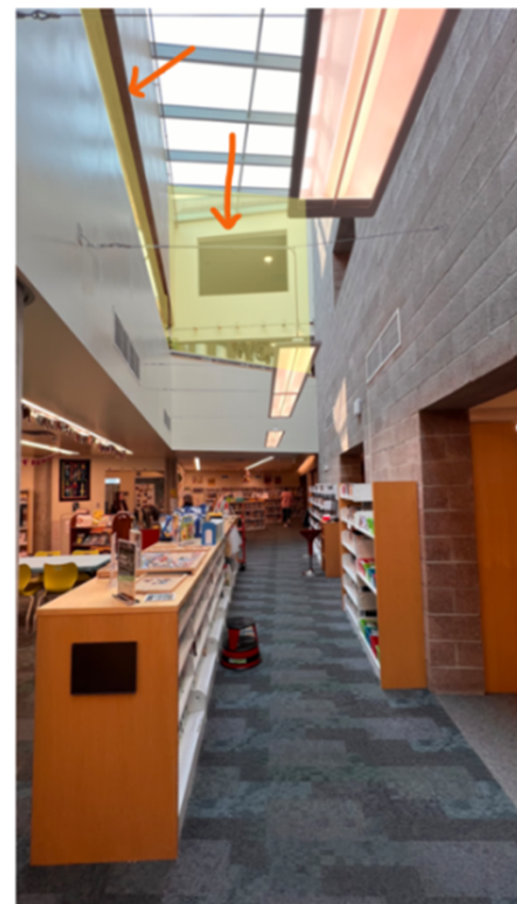
- Noise transmission between the ground level and the reference desk, as well as sound intrusion at the circulation desk is an ongoing issue that affects both staff and patrons.
- These areas are acoustically linked due to their architectural connectivity.
- To achieve meaningful noise reduction, a physical separation between these spaces would be needed.
  - One solution is to install glass walls at the Level 1 openings overlooking the ground floor.
  - Again, these closures must be carefully coordinated with the building's HVAC airflow dynamics and fire/smoke evaluation requirements to ensure compliance with safety standards and to maintain proper ventilation. There is also the possibility of it contributing to solar heat gain from the skylight above.
