# Mesa Public Library Noise Issues

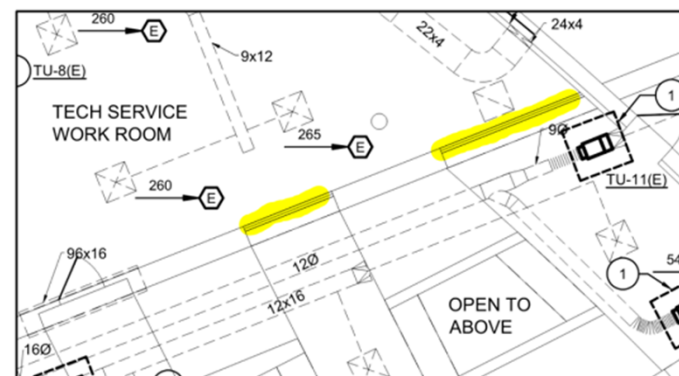
- Although this Level 1 office is currently vacant, the reported noise issues involves conversation within the space being audible in the adjacent public areas.
- Sound is easily passing through the single-pane wall mounted window.
- This window is now permanently sealed.
- Staff in the workroom can hear kids from the Children Collection Area through the single pane windows, highlighted in yellow.

- If the window is no longer needed, remove it and fill in the opening to match the wall's constructed assembly.
- If the window is still needed, replace it with a double pane window consisting of 1/4" glass\_1/2" airspace\_1/4" glass
  - This glazing assembly is expected to improve sound isolation by approximately 10 dB compared to the existing glass, effectively reducing the noise transmission by half.

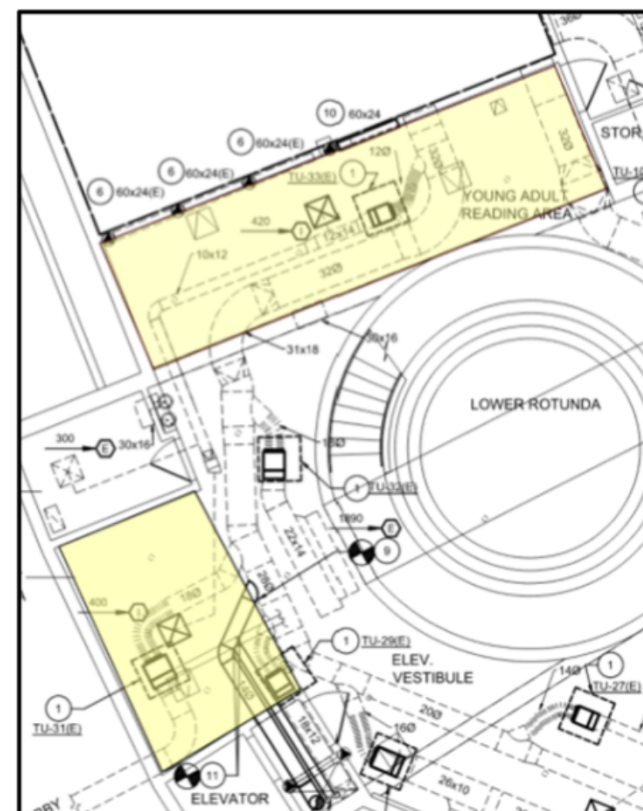
- Elevated background noise levels are present within the areas shown in yellow.
- This appears to be due to excessive airflow. When standing in these locations, one can feel a strong air current and observe nearby decoctions visibly moving, indicating high velocity air movement in the space.

- The background noise levels was measured to be 59 dBA (NC-52) which is substantially above the recommended background noise level of library reading zones of 35 dBA (NC-30).

- The Test & Balance Report dated February 25, 2019 was reviewed as part of this investigation and was assumed to be the final version.
- However, upon examination, several items listed on pages 8-10 remain unresolved. These include:

- Terminal units TU-33 and TU-31, located above the Reading Area per plans, are reported as balanced to maximum airflow rates of 1120 cfm and 2195 cfm respectively.

- But based on the pronounced airflow and movement of hanging elements in this area, it is likely that the actual airflow and associated airflow velocities in these zones are exceeding the reported values.

- It is also conceivable that the air reaching the Group SC Room on Level 1 is impacted by the amount of air being lost over the Youn Adult Reading Area, resulting in less air available to cool this room and possibly other rooms in the library.

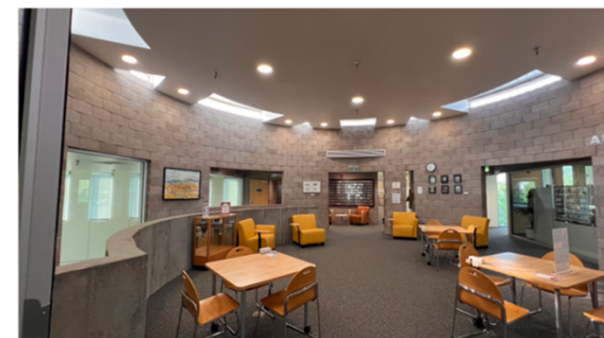
- The rotunda is a cylindrical architectural element that vertically connects all three levels of the library.
- The interior surfaces consist of primarily acoustically reflective materials, including concrete, concrete masonry unit (CMU) walls, and sheetrock ceilings.

- A stairway wraps around the perimeter of the rotunda, providing access between floors.
- The stair connecting Levels 1 and 2 includes a fire rated door, which remains open during business hours and would only close in the event of a fire.

- The rotunda walls feature open sections at each level, allowing sound that is generated within the rotunda to travel out into the nearby floors.
- The ground level of the rotunda is frequently used for children's programming, which often uses amplified music and speech.

- Level 2 of the rotunda is a gallery area with seating.
- Sound is reflecting off the hard walls and ceilings and focusing towards the center of the rotunda, which can result in an acoustic phenomenon where a person can perceive an amplification of their own voice.
