Los Alamos County
Department of Public Utilities

Electric Distribution
Reliability

November 20, 2024

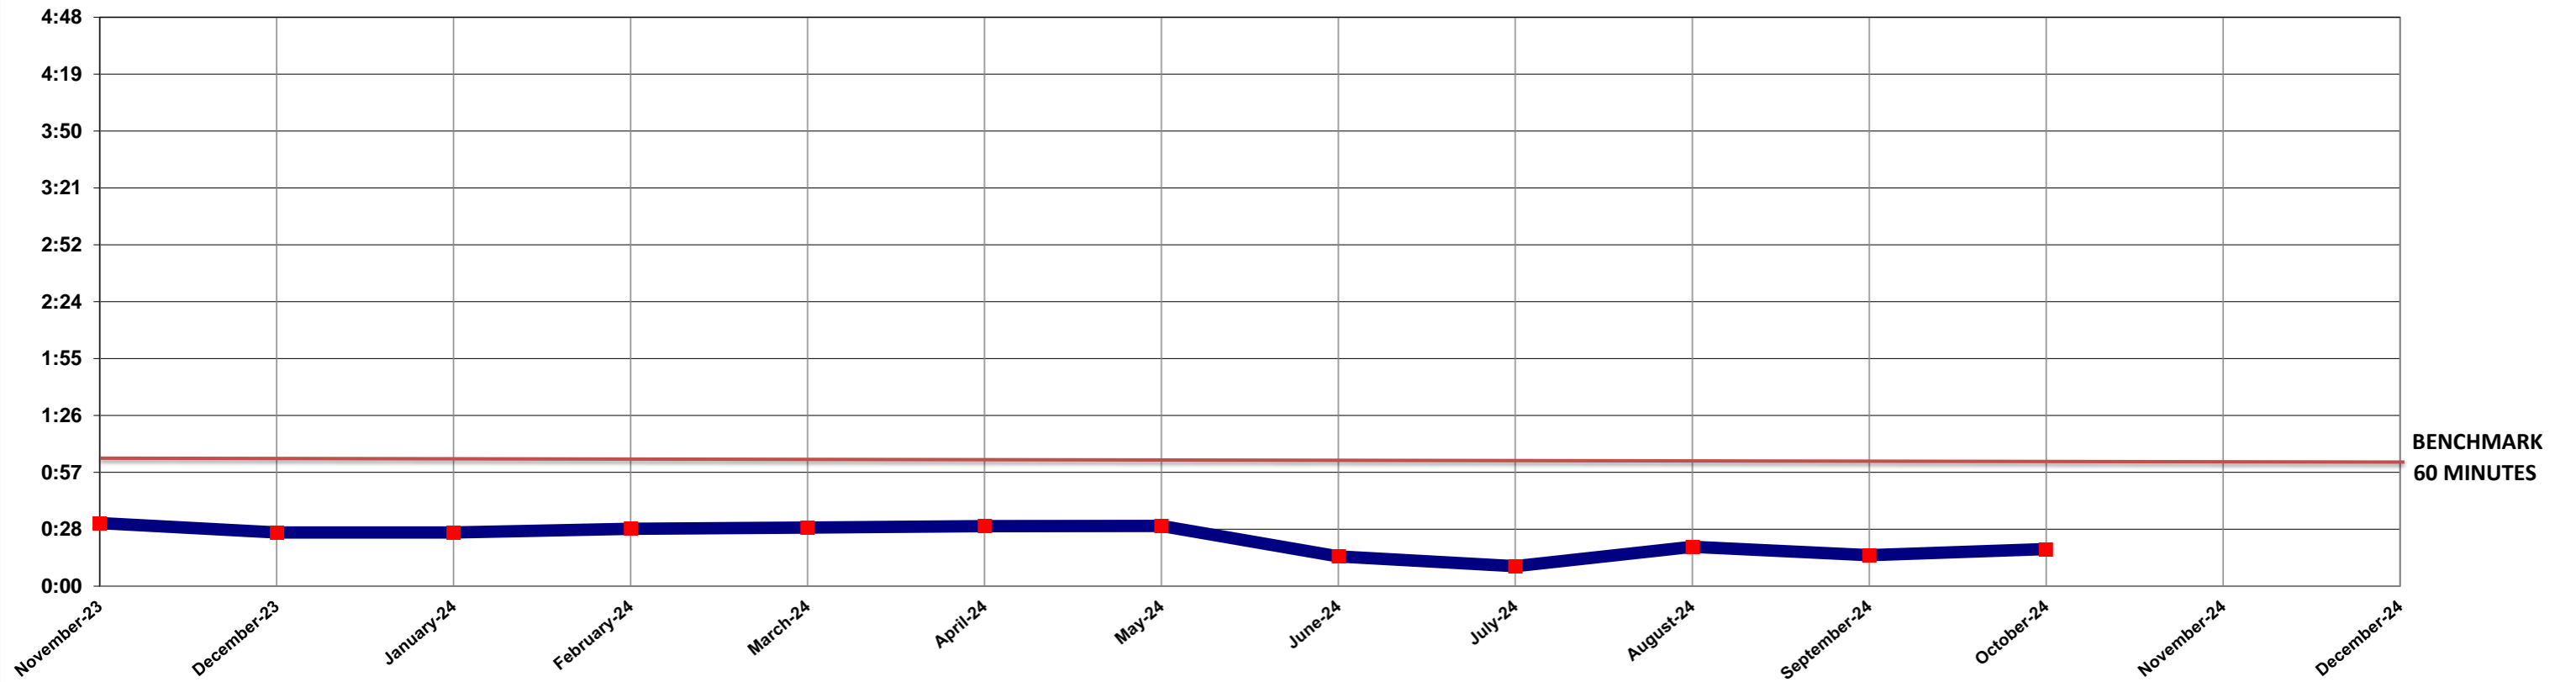
EACH POINT IS A MONTHLY SAIDI HISTORY
60 MINUTES = LACDPU SAIDI BENCHMARK

SAIDI NOW AT
18 MINUTES

BENCHMARK
60 MINUTES

SAIDI CALCULATED TO INCLUDE THIS OUTAGE:

Date	Circuit	Cause	Start Time	End Time	Duration	Number of Customers	Combined Customer Outage Durations	Total Outage H:M:S	Running SAIDI
OCT 20	WHITE ROCK	115KV PNM	21:25	1:40	4:15	2155	9158:45:00	11992:21:00	1:19:33
