# Annual Update on Water Systems (DW, WP & NP)

Clay Moseley, Deputy Utility Manager – Gas, Water, Sewer (GWS) Services

Board of Public Utilities Work Session – March 4, 2026

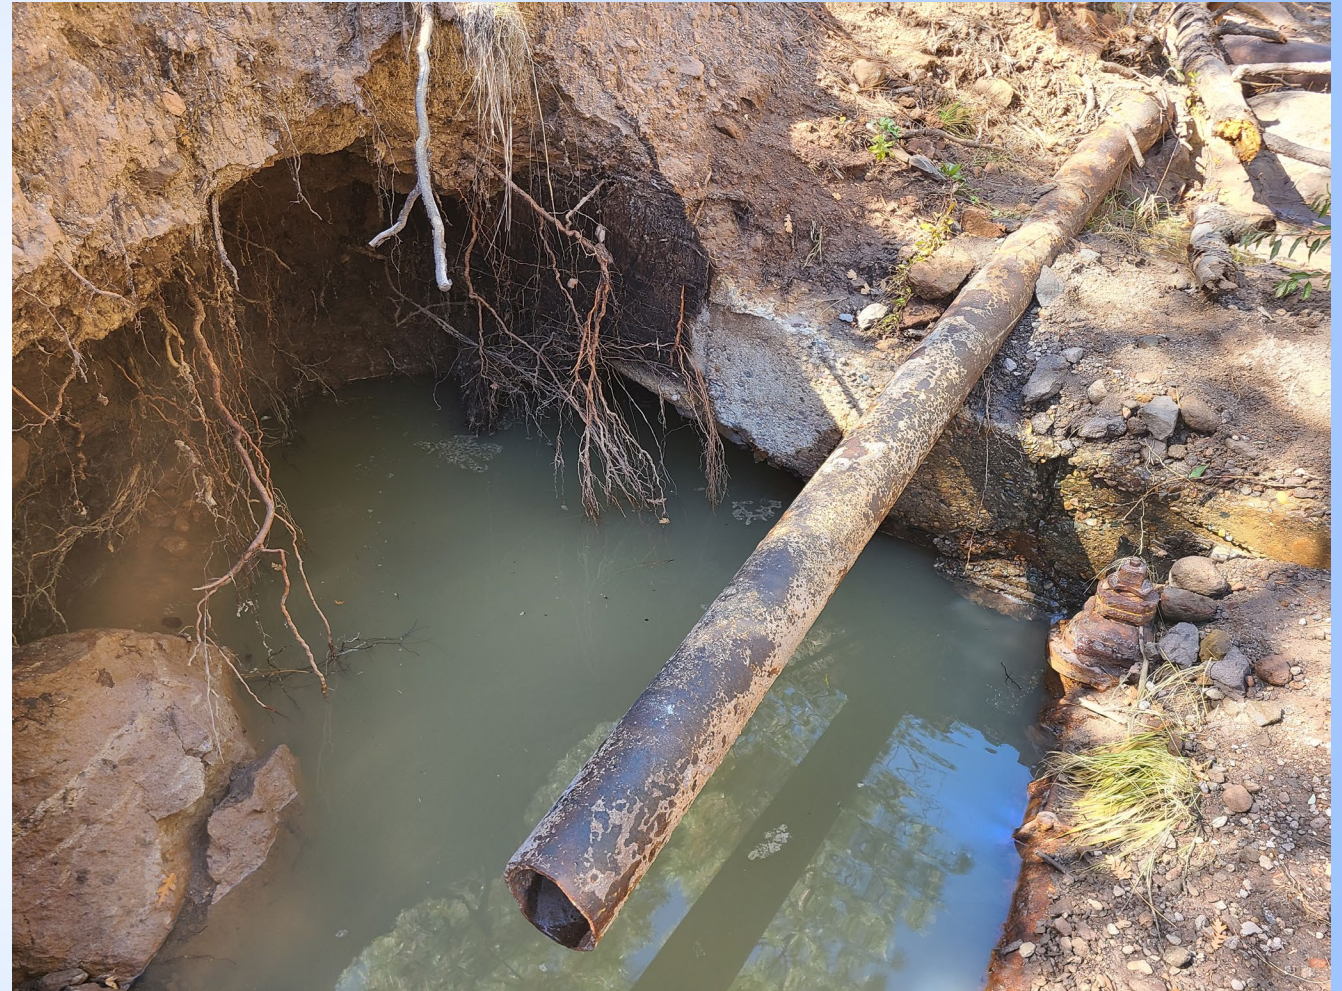
- **WP** – LANL transmission water lines are seeing age and condition issues, and there have been some breaks. WP staff can coordinate repairs quite well, but the break on the 18" concrete line traversing Two Mile Canyon was a difficult situation. WP staff was able to divert flows into an older 10" steel line that was not being used but still connected to the system. Repairs to the 18" line are pending, with assistance from WP staff.

# Water Production System – Installing Chlorine Injector Quill at PB-2 and the 18" CCP Rupture in Two-Mile Canyon
