# Annual Update on Water Systems (DW, WP & NP)

Clay Moseley, Deputy Utility Manager – Gas, Water, Sewer (GWS) Services

Board of Public Utilities Work Session – March 4, 2026

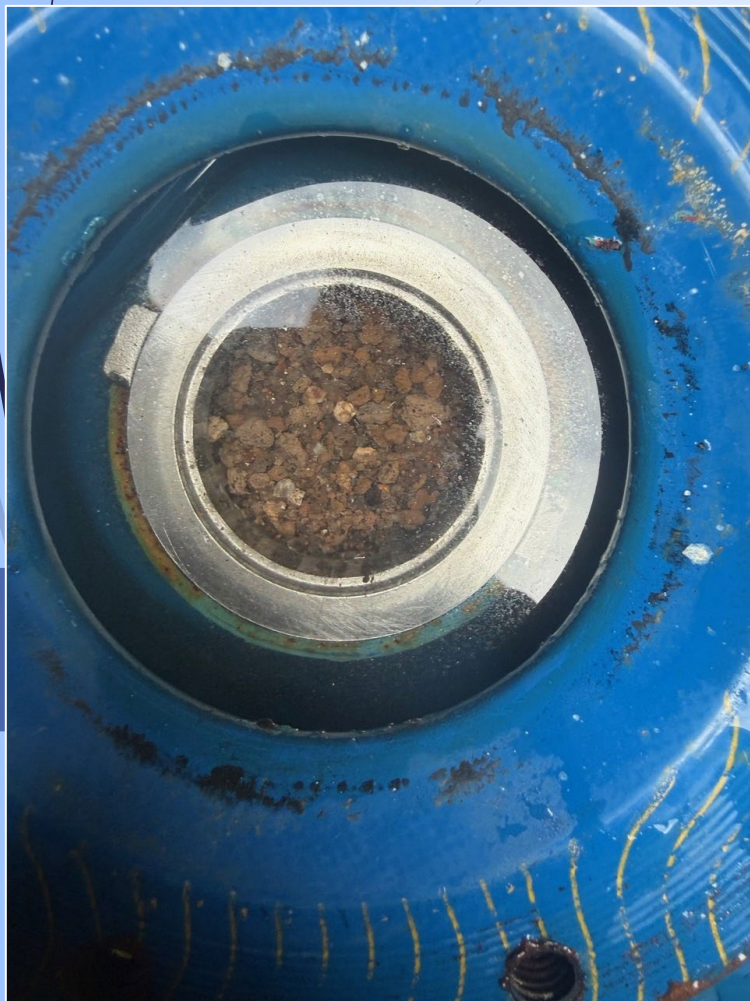
## Water Distribution PRV Rehabilitation Project

Continuing with the PRV rehabilitation project through the next 5-7 years. Shown here is a debris-clogged “low flow” PRV.

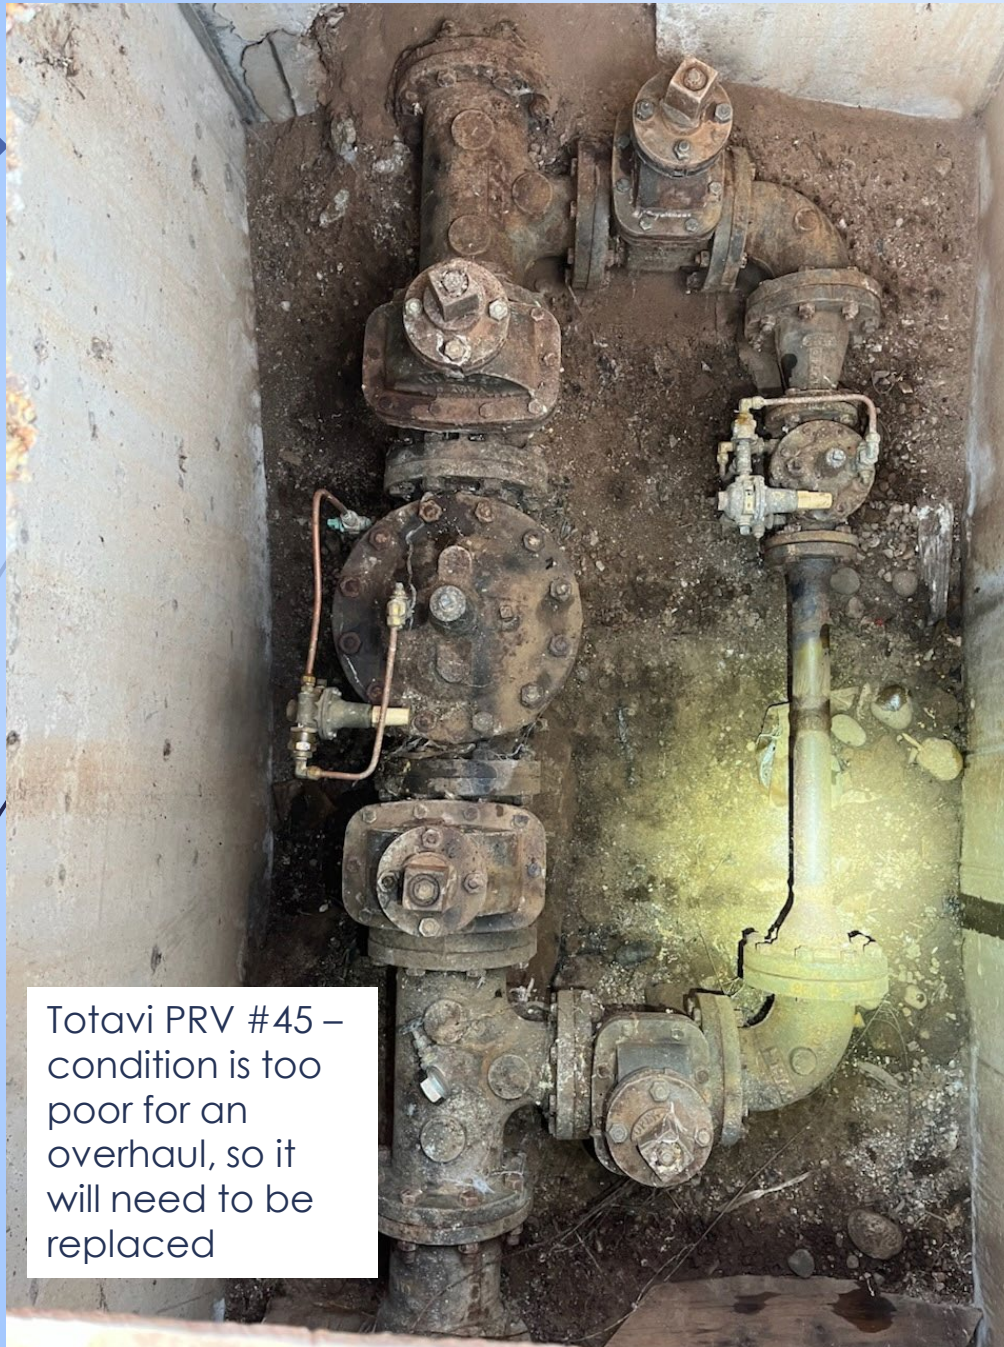
Totavi PRV #45 – condition is too poor for an overhaul, so it will need to be replaced

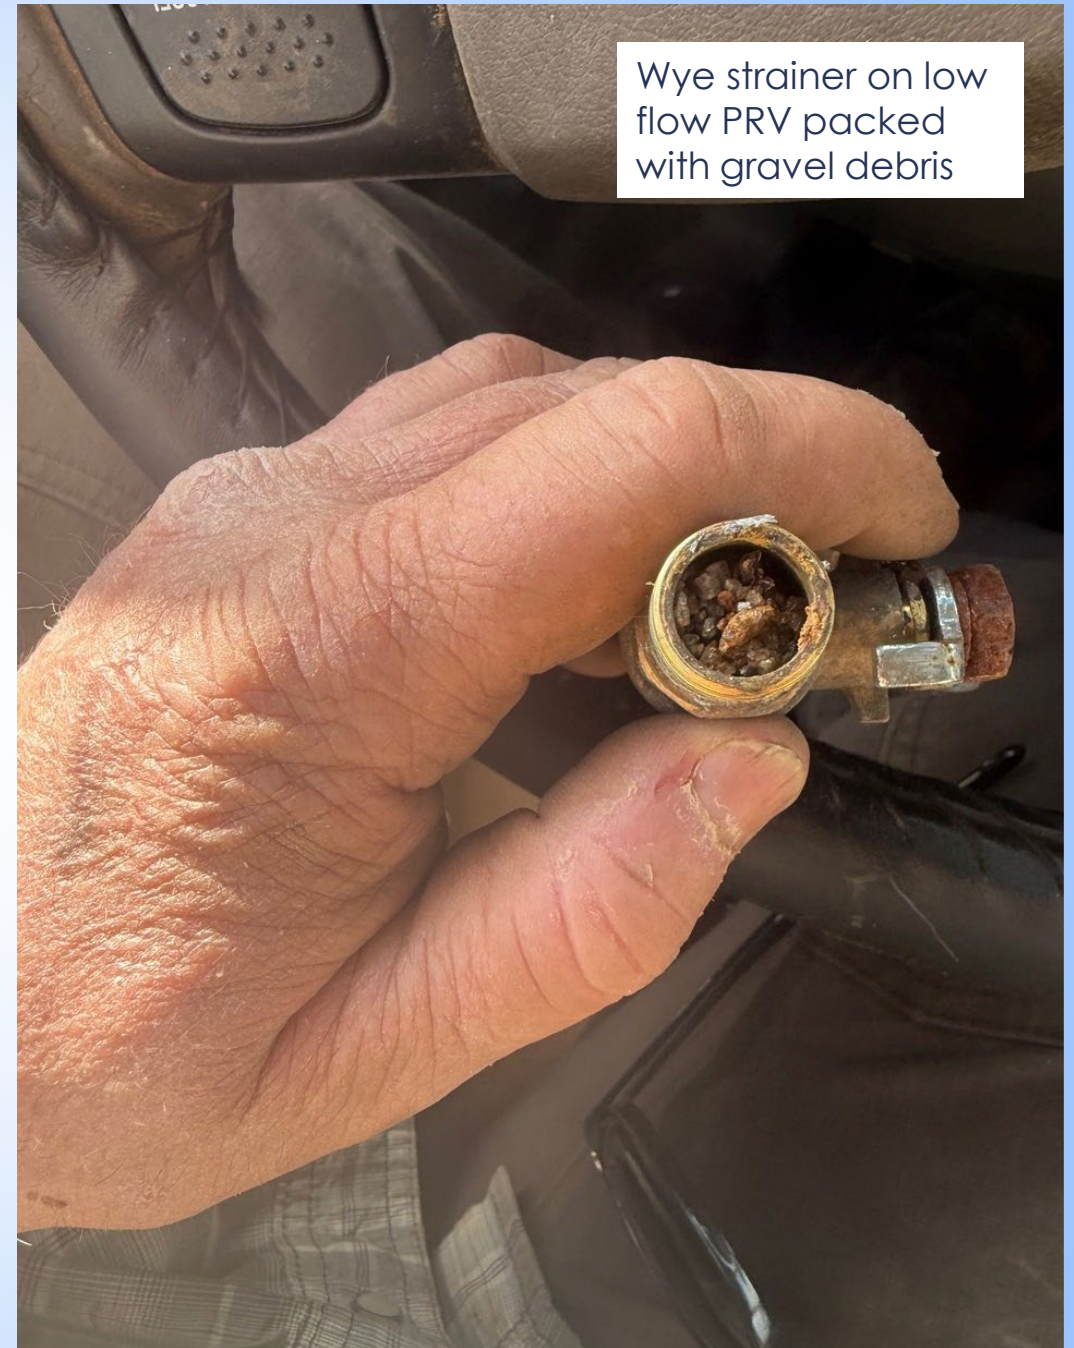
Wye strainer on low flow PRV packed with gravel debris

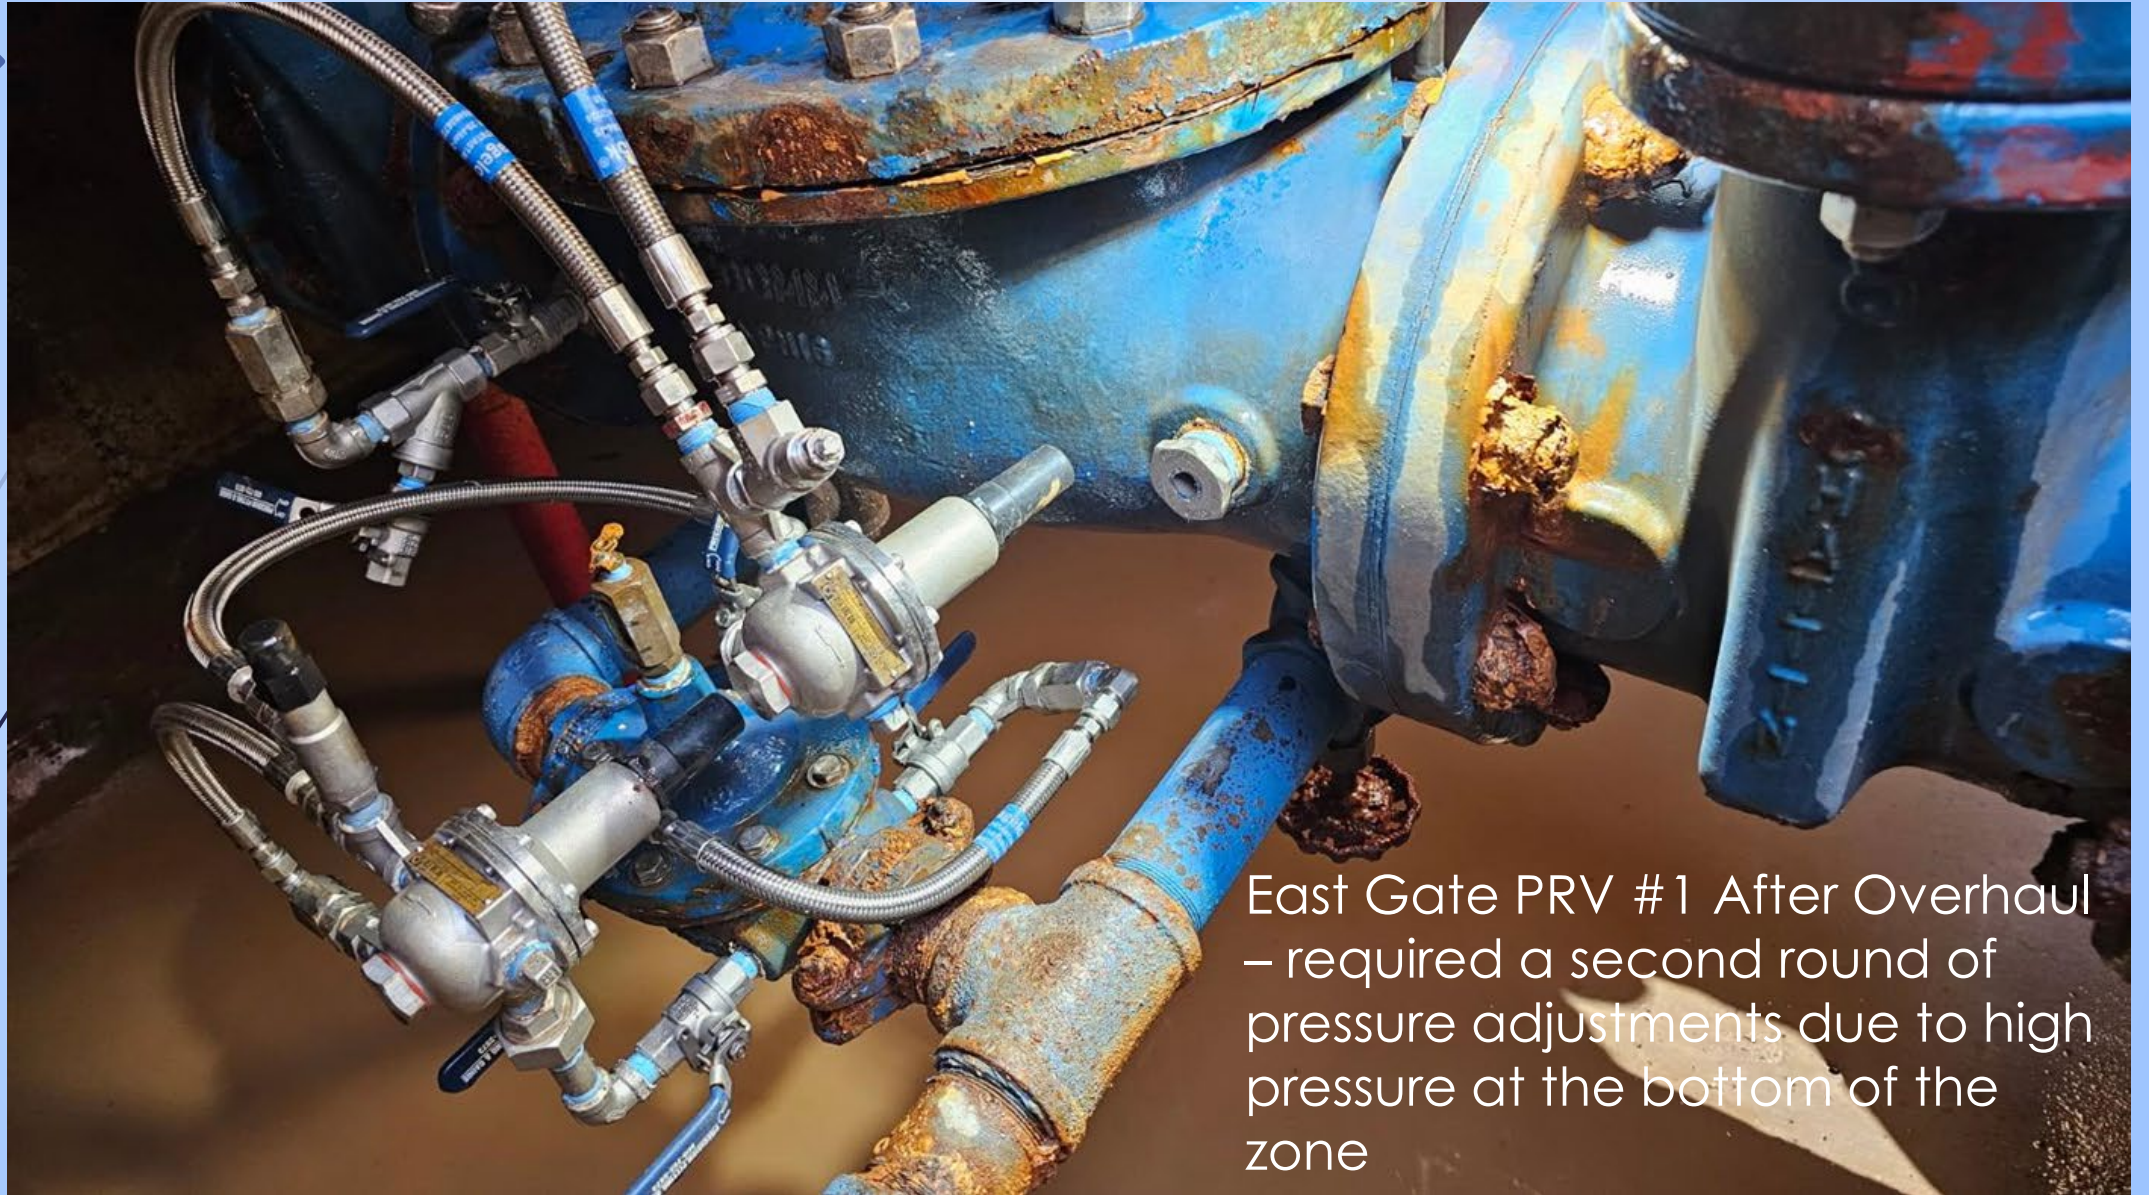
East Gate PRV #1 After Overhaul  
– required a second round of  
pressure adjustments due to high  
pressure at the bottom of the  
zone

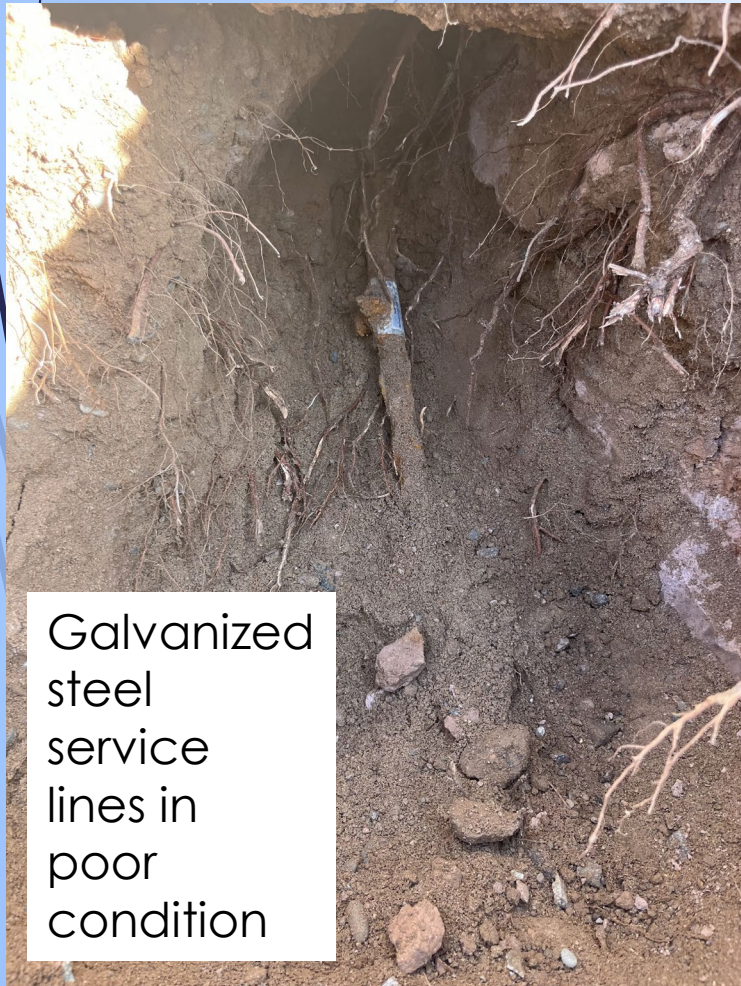
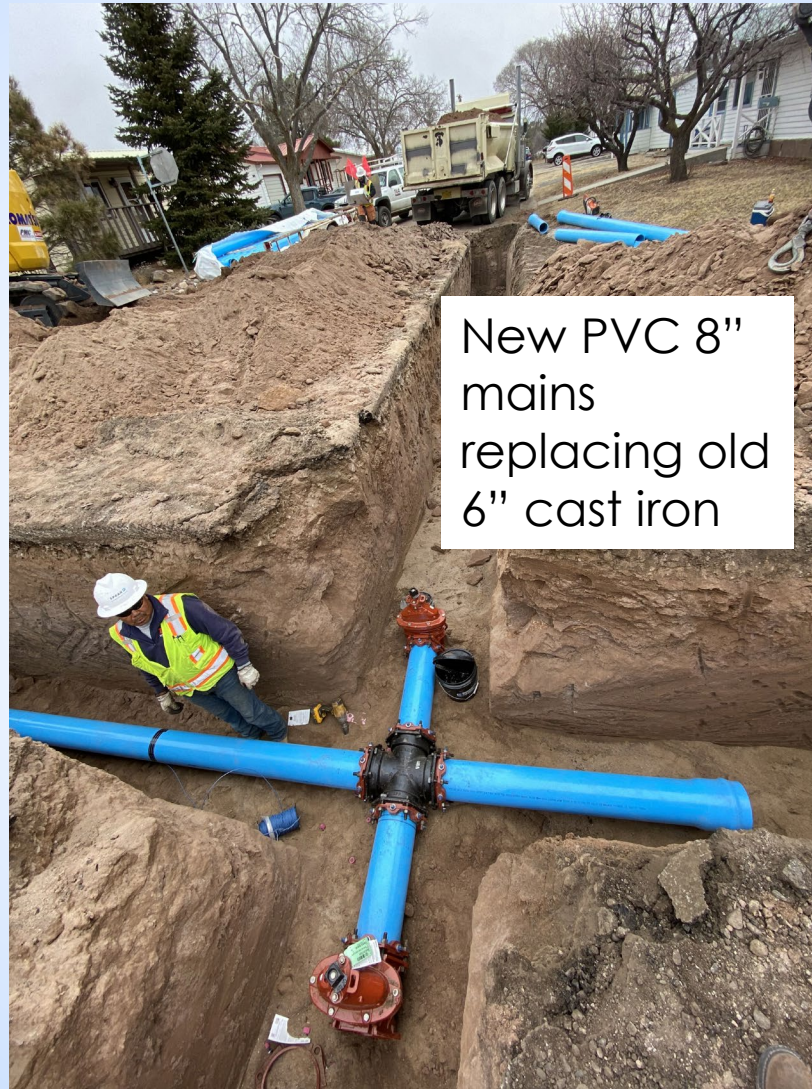
# Denver Steels Water Distribution Replacement

Virtually all  $\frac{3}{4}$ " service lines are corroded galvanized pipe; many with leaks and old repairs

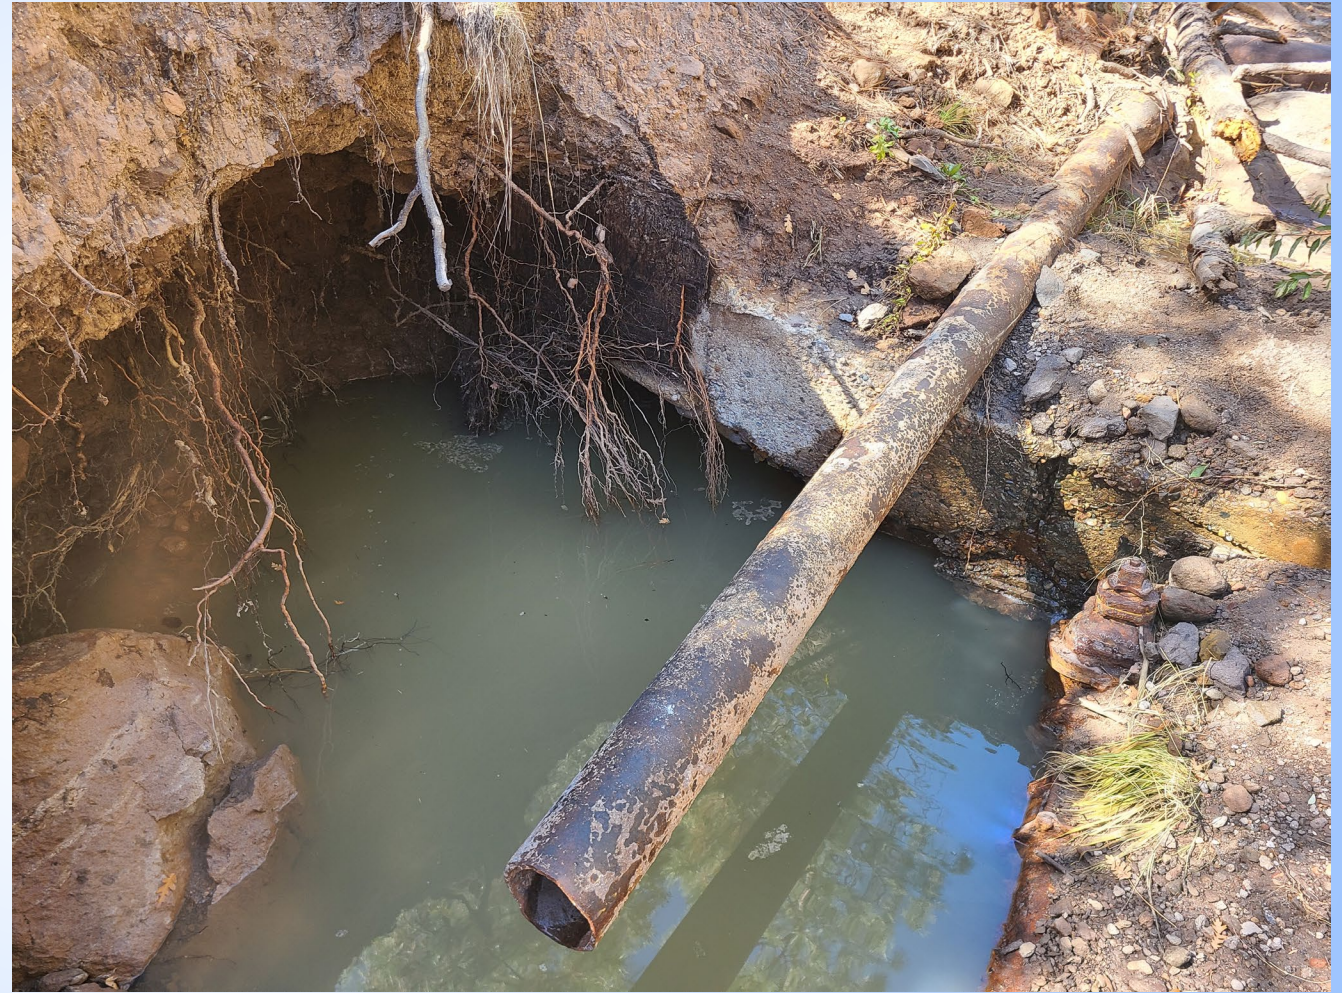
- **WP** – LANL transmission water lines are seeing age and condition issues, and there have been some breaks. WP staff can coordinate repairs quite well, but the break on the 18" concrete line traversing Two Mile Canyon was a difficult situation. WP staff was able to divert flows into an older 10" steel line that was not being used but still connected to the system. Repairs to the 18" line are pending, with assistance from WP staff.

# Water Production System – Installing Chlorine Injector Quill at PB-2 and the 18" CCP Rupture in Two-Mile Canyon
