Los Alamos County Mesa Public Library Siding Replacement and Crack Filling

Incorporated County of Los Alamos
Public Works Department
Capital Projects and Facilities

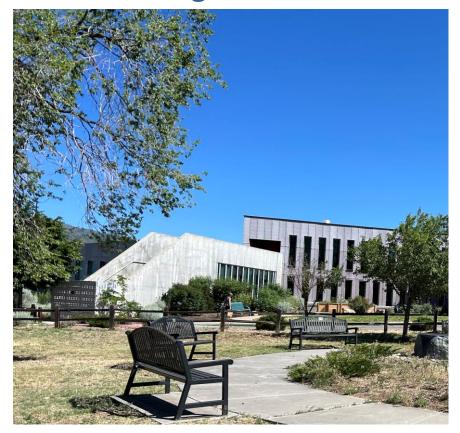
Current Siding Condition 2024

- Mesa Public Library constructed in 1994
- Original siding replaced in 2011
- Ultraviolet (UV) exposure has led to severe fading over time
- Replacement of the current siding is part of regular building maintenance and renewal
 - Necessary to maintain visual appeal
 - Replacement in accordance with the original architectural design
- Replacement product is crafted to withstand harsh weather conditions, including freezing temperatures, rain, and UV

Remove and replace siding on the Mesa Public Library to enhance the building's visual appeal

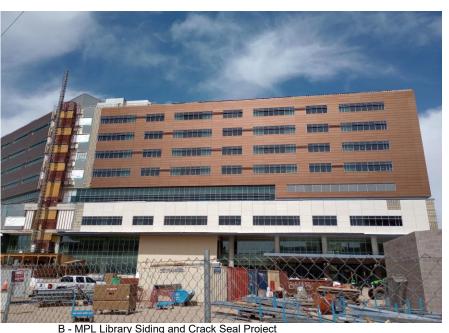
Selected Product

- KOL high-density, color impregnated, fiber cement façade panels
- Durable, long-lasting, fire resistant, not significantly affected by UV rays
- Waterproof sealer/protectant
- High pressure cleaning is not recommended
- UNM-H installing similar (photo left)

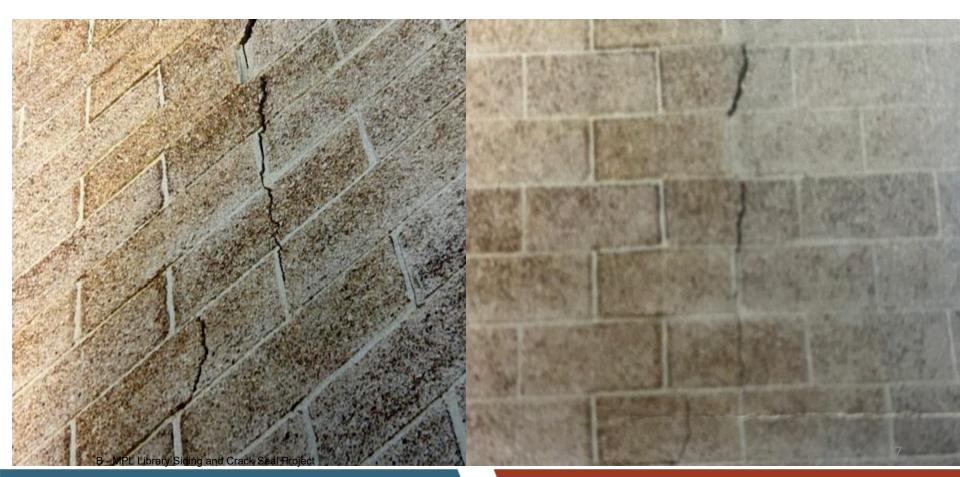
Sample of Cracks Observed

- Filling of cracks within the Concrete Masonry Unit (CMU) wall veneer
- The cracks are **NOT** indicative of any structural issues affecting the building's integrity
- Cracks in veneer need to be sealed to prevent water infiltration

-NOT Structural

Above the Entrance to MPL

East Wall

... While it is believed that none of the cracks are indicative of any structural problems that would affect the integrity of the building, it is still recommended that these cracks be maintained with caulking to ensure that water does not infiltrate the area.
