White Rock Substation Reliability Plan

Electric Distribution Division

Report to the Board of Public Utilities

September 3, 2025

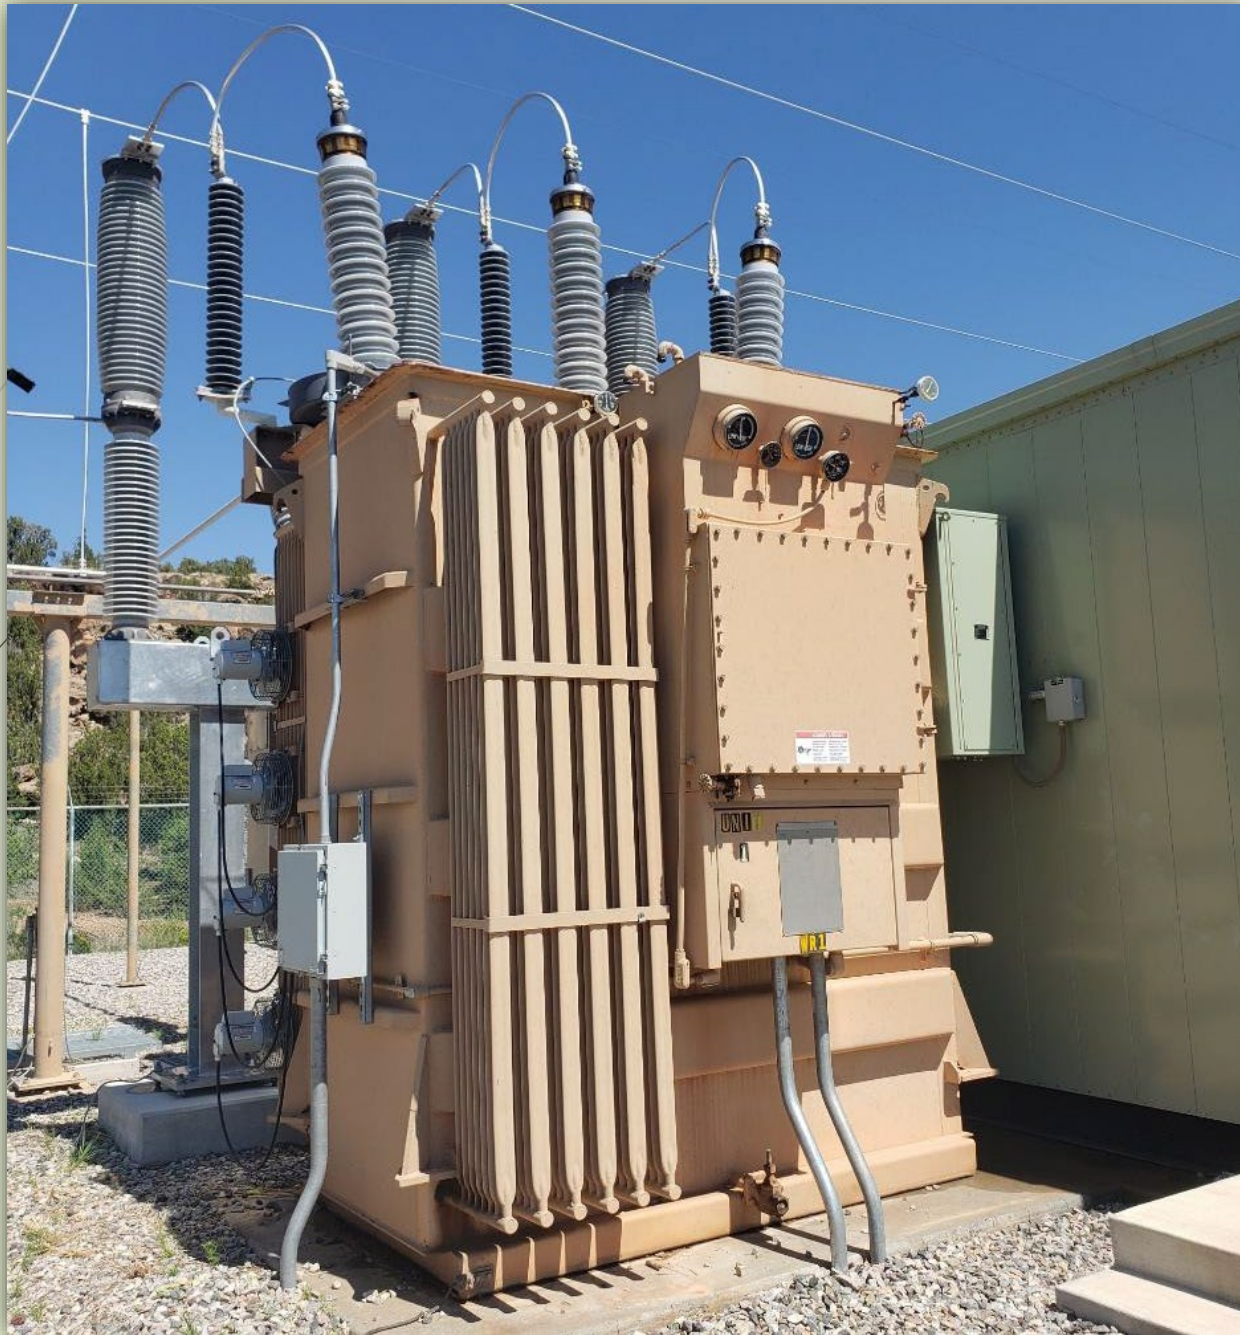
Unit 1
Transformer in
White Rock
(which failed)

Substation Transformer T1 Failure

- The primary transformer was due for maintenance on Monday, August 11.
- White Rock was transferred to the backup transformer on Thursday, August 7.
- The backup transformer failed at 3:20 am on Friday morning August 8th.
- Service was restored on the primary transformer at 6:00 am.
- The transformer tank was very hot when examined by personnel indicating internal failure.
- White Rock is an electrical island with no ties to LANL or Los Alamos.

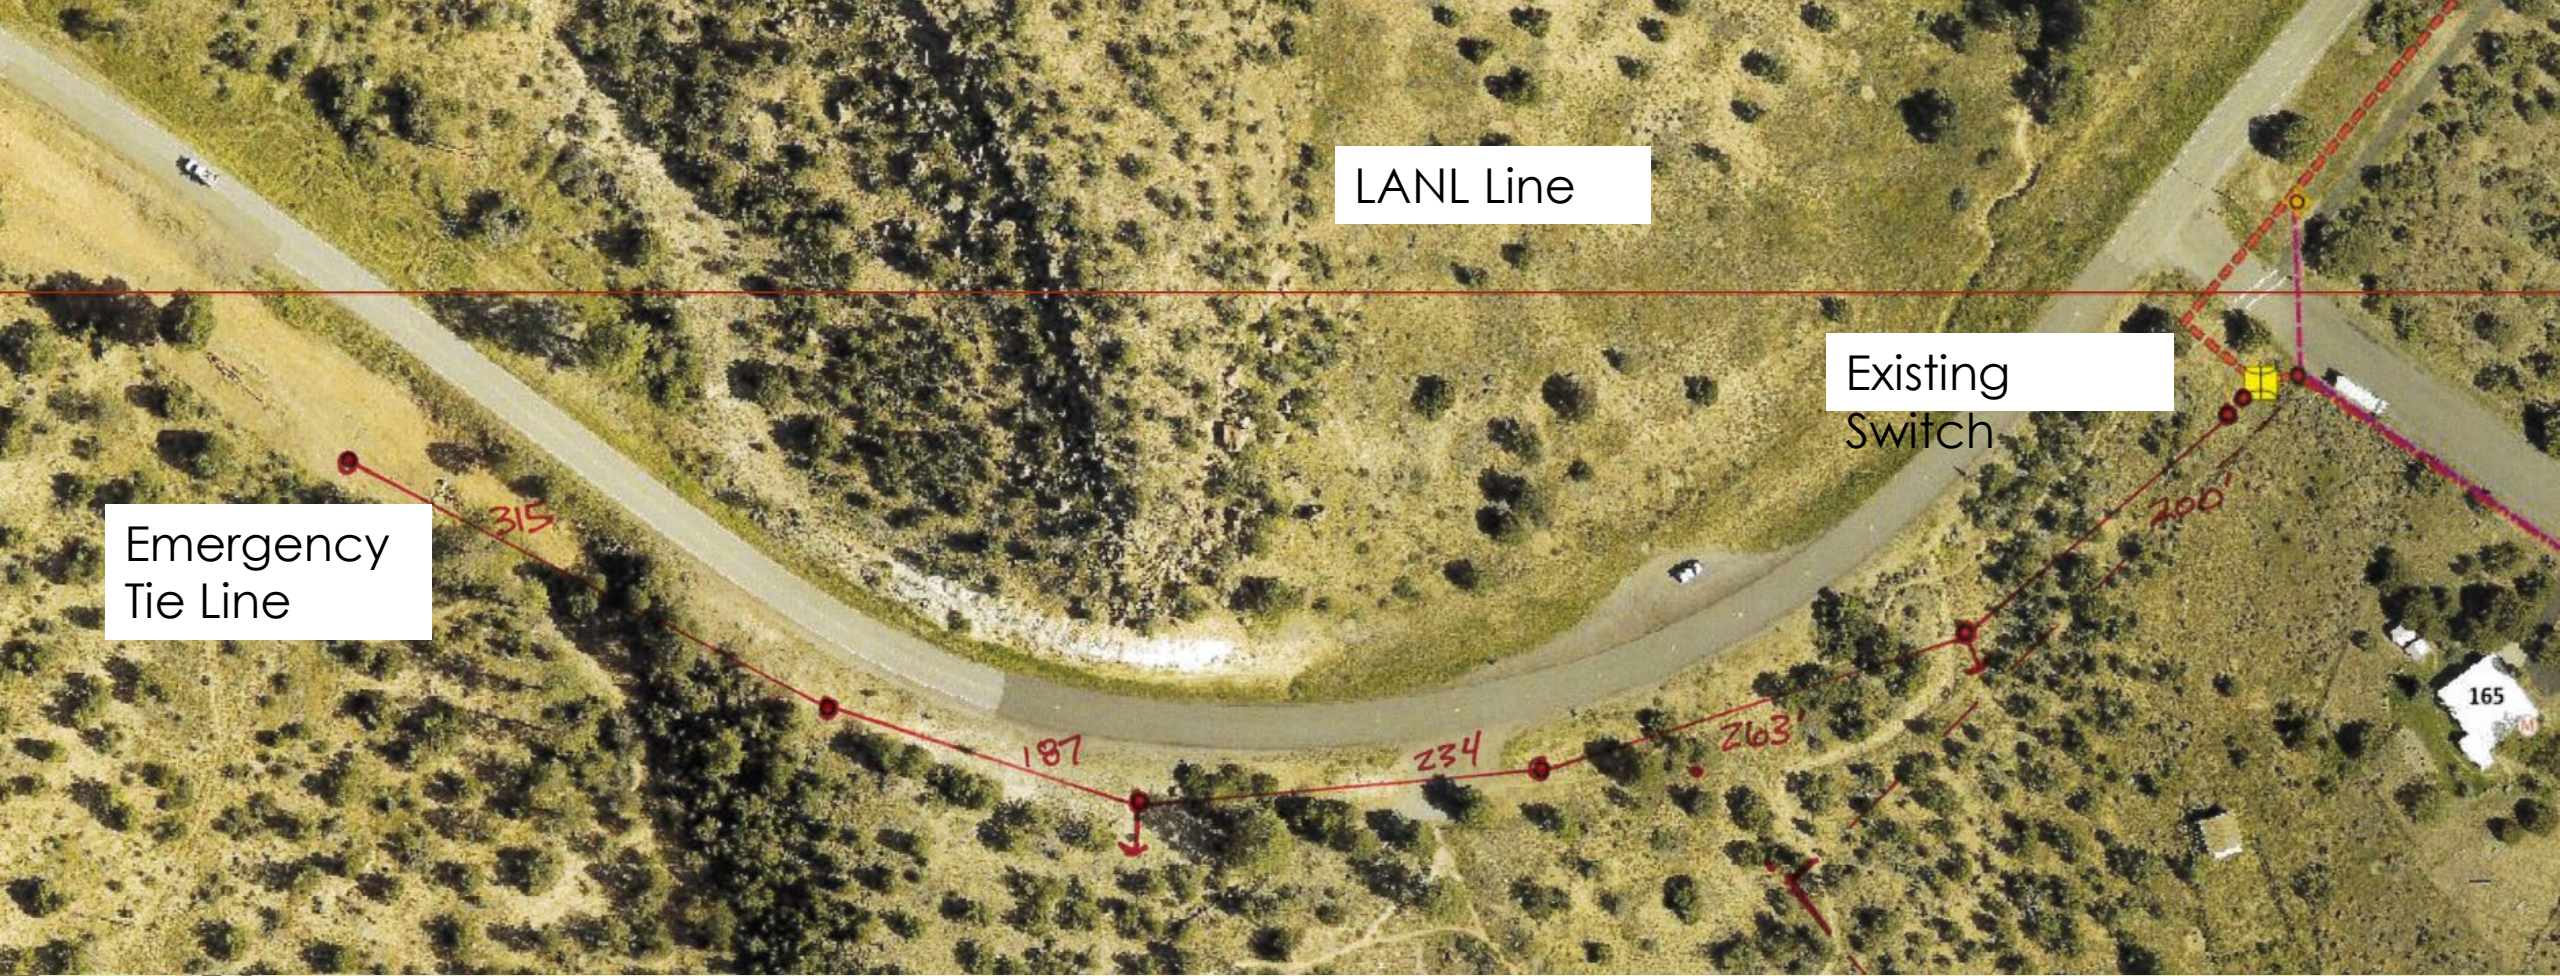
Emergency Option 1

- ▶ White Rock operates at 12,470/7,200 Volts while LANL operates at the same voltage as Los Alamos 13,200/7,620 Volts.
- ▶ LANL has a circuit through the edge of town from their substation South of White Rock.
- ▶ We evaluated several options to tap their line with the LANL utility department and selected SR4 at South Monte Rey as the best point.
- ▶ LANL will construct the line to the boundary point and DPU will construct the last span and a regulator station near the switch.
- ▶ This process is anticipated to take approximately 4 weeks.

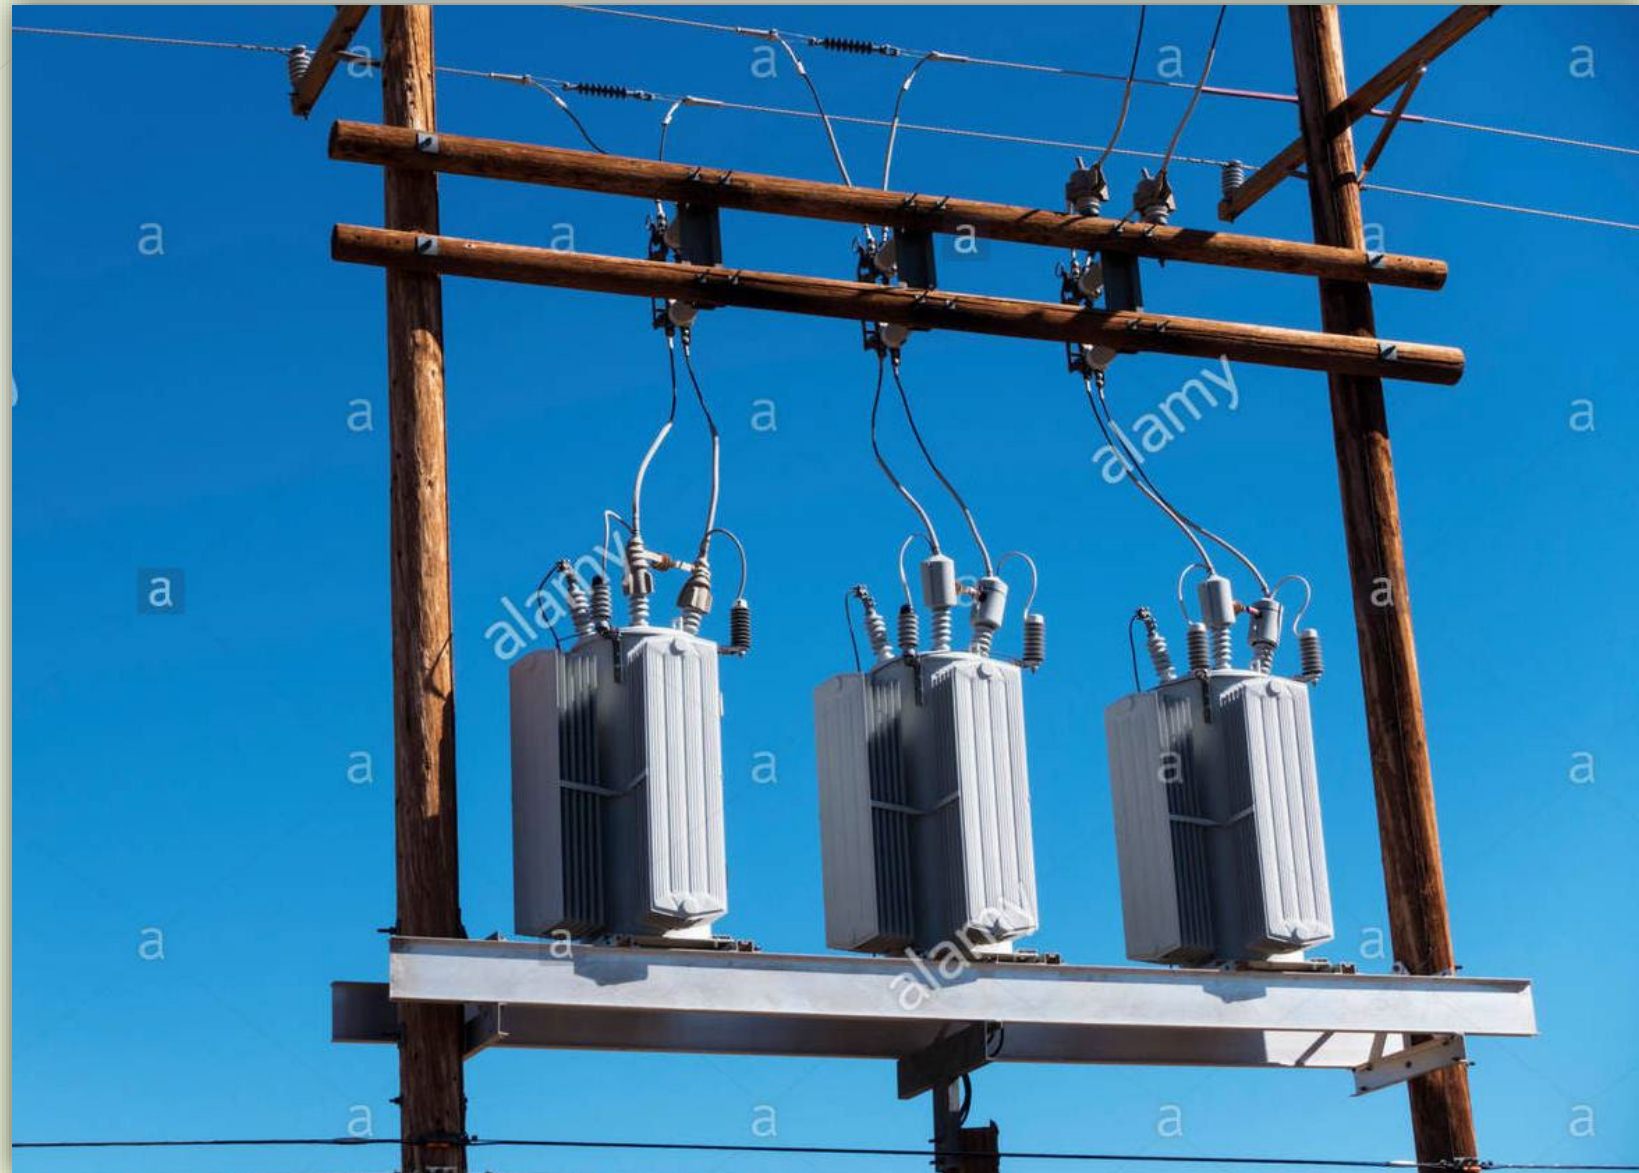
Typical Voltage Regulator Station

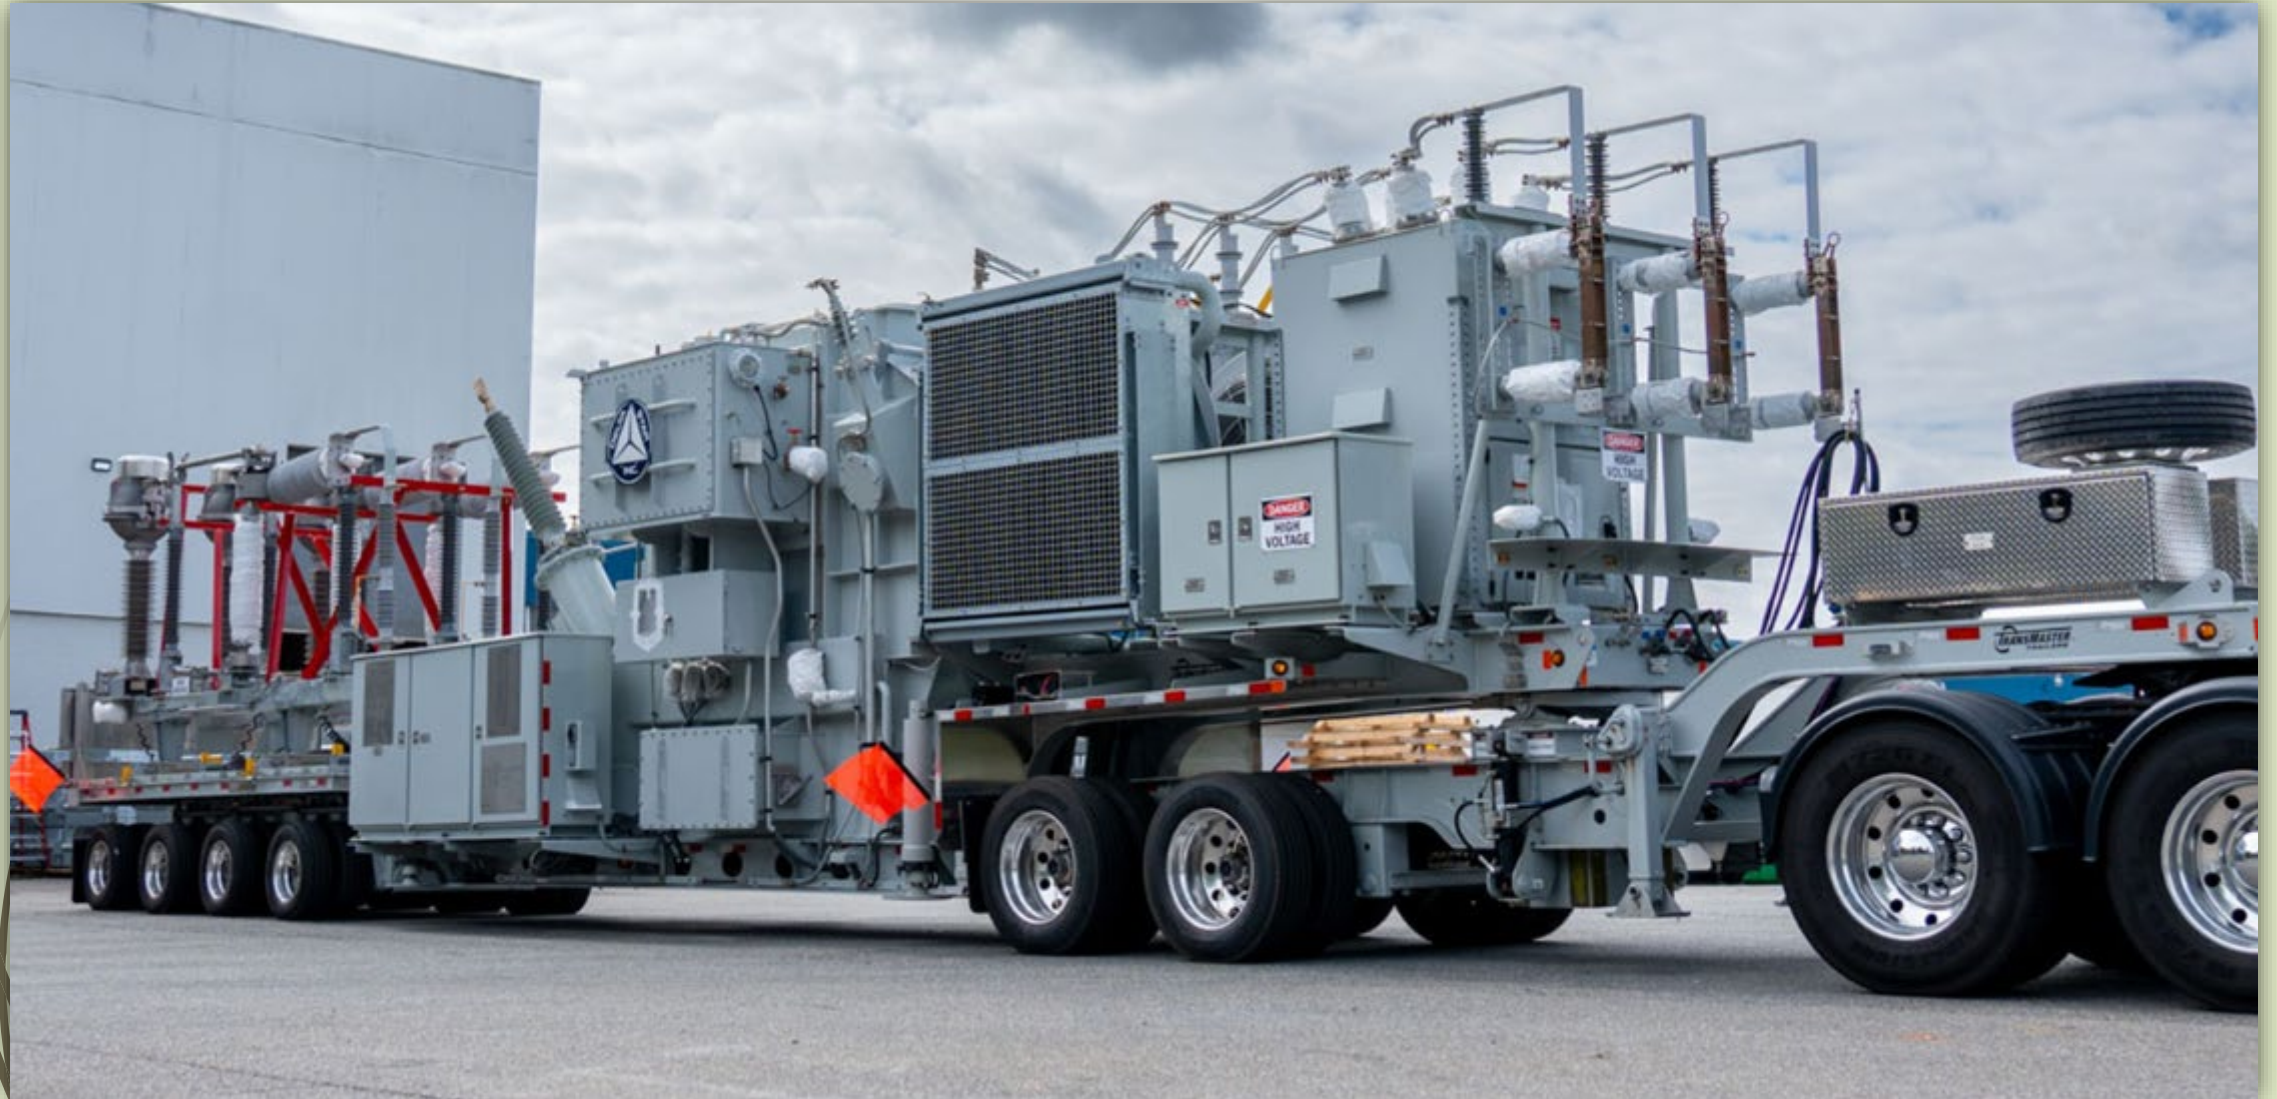
Emergency Option 2

- A second and logical option is to utilize a mobile substation to serve load.
- This could take a full day to move and set up if one were available and agreements are in place.
- The entrance into the substation from the adjacent property would make moving one into the actual substation difficult and likely not possible.
- We will evaluate nearby locations where one could be parked, connected and secured.
- DPU requested to enter into mutual aid type agreement with PNM who owns a mobile substation.
