# Mesa Public Library Noise Issues

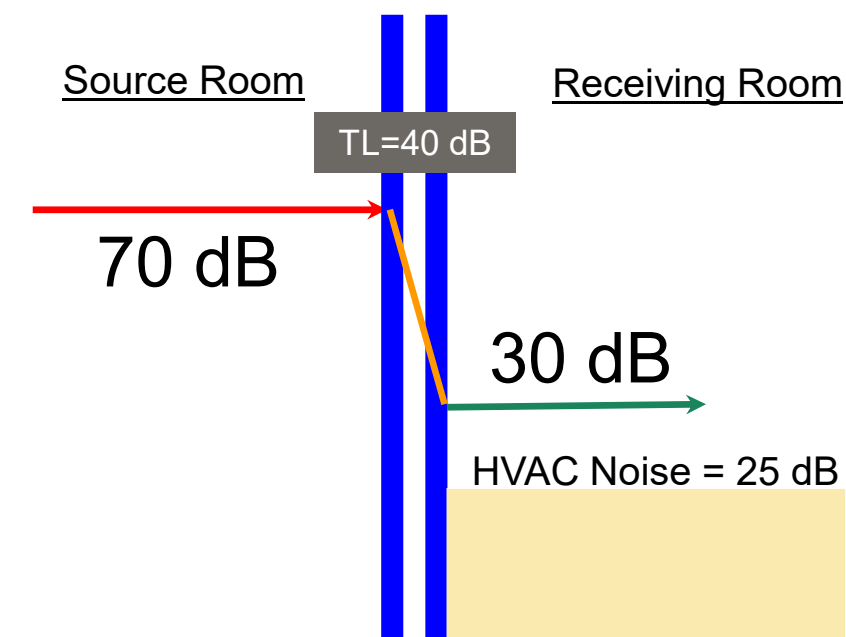
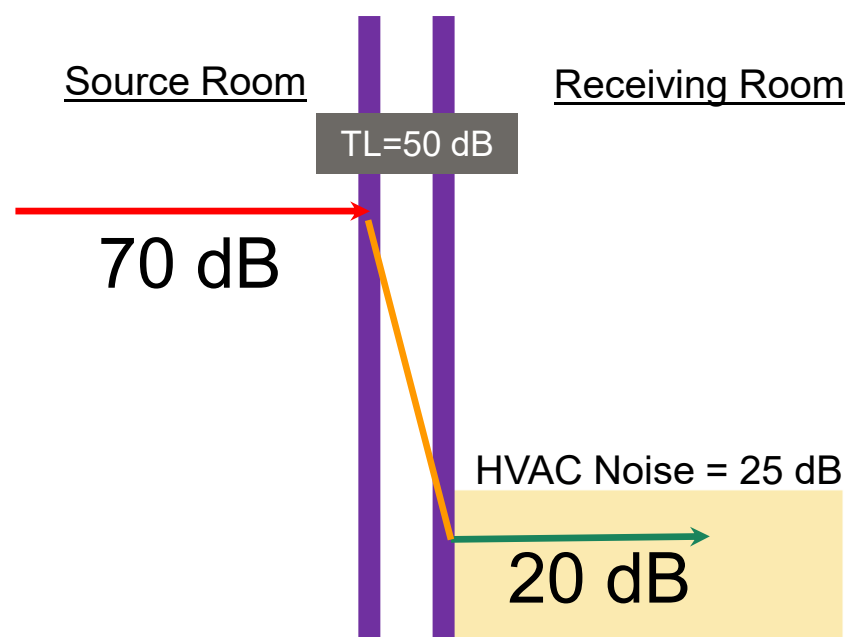
# Noise Reduction

- Sound transmission between adjacent rooms when the operable partition are in use is poor.
- Speech intelligibility between meeting rooms relates to both the audibility of the intruding sound and the intelligibility of the speech itself.
- Eliminating the sound transfer entirely is not feasible with an operable wall.
- Over time the seals on the operable walls can become misaligned or degrade and no longer seal.

- It is recommended that the library contacts its local folding partition vendor (Modernfold is installed) to perform a maintenance inspection and to verify the integrity of the seals and wall panels.

- If this evaluation does not yield any noticeable improvements the we recommend that the replacement of the existing partitions be considered.
- If replacement is the path forward, a newer option providing a higher level of sound isolation can be selected.

- We recommend that a partition with an STC-53 or better be selected.
  - This can be the Moderco Signature 800 or the Modernfold Encore
  - It should be noted that although operable partitions can be rated above an STC-50 they often perform 5-7 point lower than their STC rating once installed, due to various in-field conditions.

- The alternative is to replace the folding partitions with a fixed wall assembly. Although this would eliminate the flexibility of the space, the STC-55 assembly will achieve a superior level of acoustic noise reduction as compared to an operable wall.

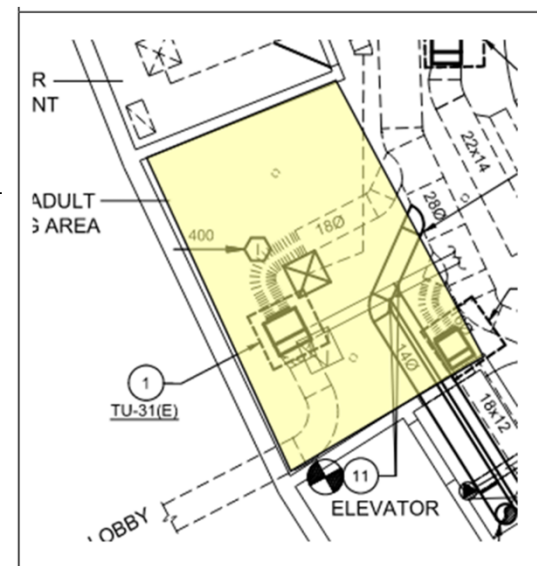
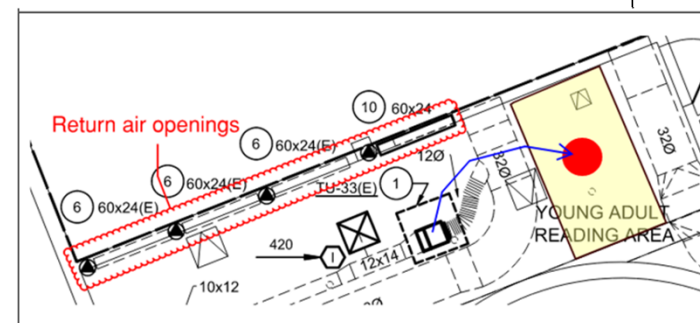
- The background noise levels was measured to be 59 dBA (NC-52) which is substantially above the recommended background noise level of library reading zones of 35 dBA (NC-30).

- Replace the open ceiling in the reading area west of the rotunda with a sheetrock ceiling (yellow) which consists of 1 layer of 5/8" GWB with R-11 batts placed on top of the ceiling.

- The second reading area north of the rotunda has an acoustically transparent ceiling and large return air openings located above the ceiling which are connected to the mechanical room wall. Here the Terminal Unit TU-33 should be relocated to the position indicated by the red dot. From there, it should be ducted either above or below the existing 32" round duct. The yellow area below the red dot should be replaced with a sheetrock ceiling. A minimum of 5-feet of internally lined ductwork should be installed between the terminal unit and the first diffuser using 1" thick fiberglass ductliner to support acoustic attenuation.
