LOS ALAMOS COUNTY

Due Diligence Study

CB FOX DEPT. STORE

DUE DILIGENCE STUDY FOR 1735 CENTRAL AVE.

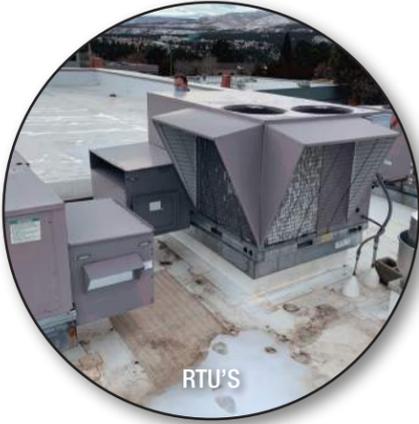
RTU'S

Main HVAC system consists of six (6) single zone, constant volume rooftop DX cooling and gas fired heating. The rooftop units which are manufactured by Carrier in year 2003. The units are controlled by standalone thermostats (one per unit) with sensors located in the space. No Building Automation System (BAS) was observed.

Cooling coil condensate drain is directly discharged on the roof which does not meet code and will result in possible roof damage over time.

Replace existing units with new. Typical service life of rooftop unit is about 15 years per ASHRAE recommendations.

Route cooling condensate drain line to indirect approved plumbing fixture as required by code.

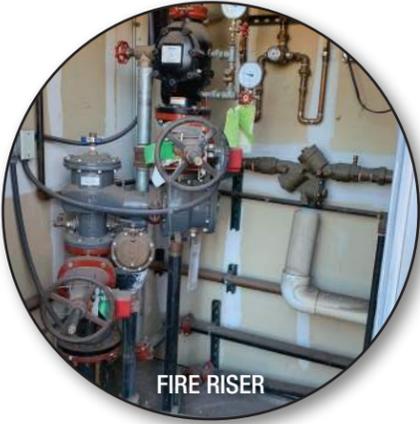
FIRE RISER

The building is equipped with water-based fire sprinkler systems serving the facility.

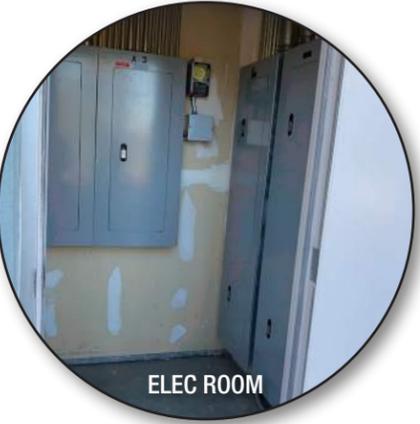
ELEC ROOM

1. Existing secondary service to the Main Switchboard (MSB) located on the exterior building on the north side. Existing electrical equipment is rated for 208Y/120V, 3Ph, 4W, and MSB rated for 800A. Existing MSB serves downstream panels for building general power and Mechanical equipment panels in the projector room, and panel for the electric heating system around the building.
