# Annual Update on Water Systems (DW, WP & NP)

Clay Moseley, Deputy Utility Manager – Gas, Water, Sewer (GWS) Services

Board of Public Utilities Work Session – March 4, 2026

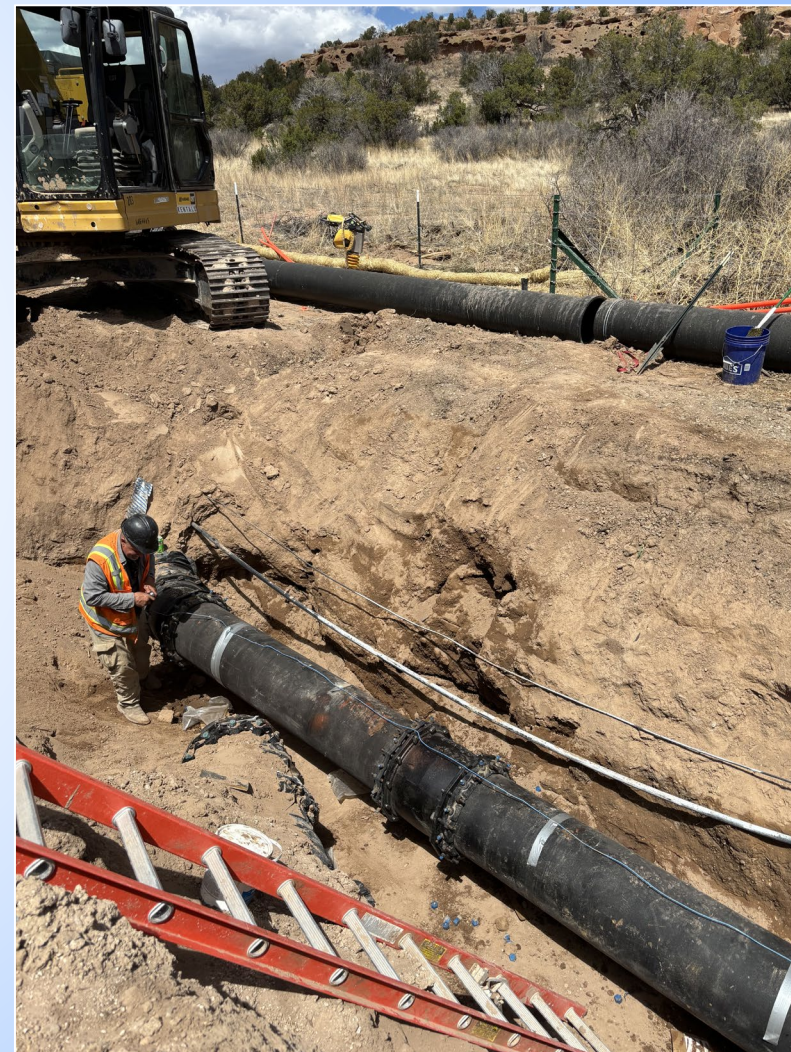
## Water Production NM-4 Transmission Line Replacement

Very difficult project that vastly improves system reliability and resiliency.

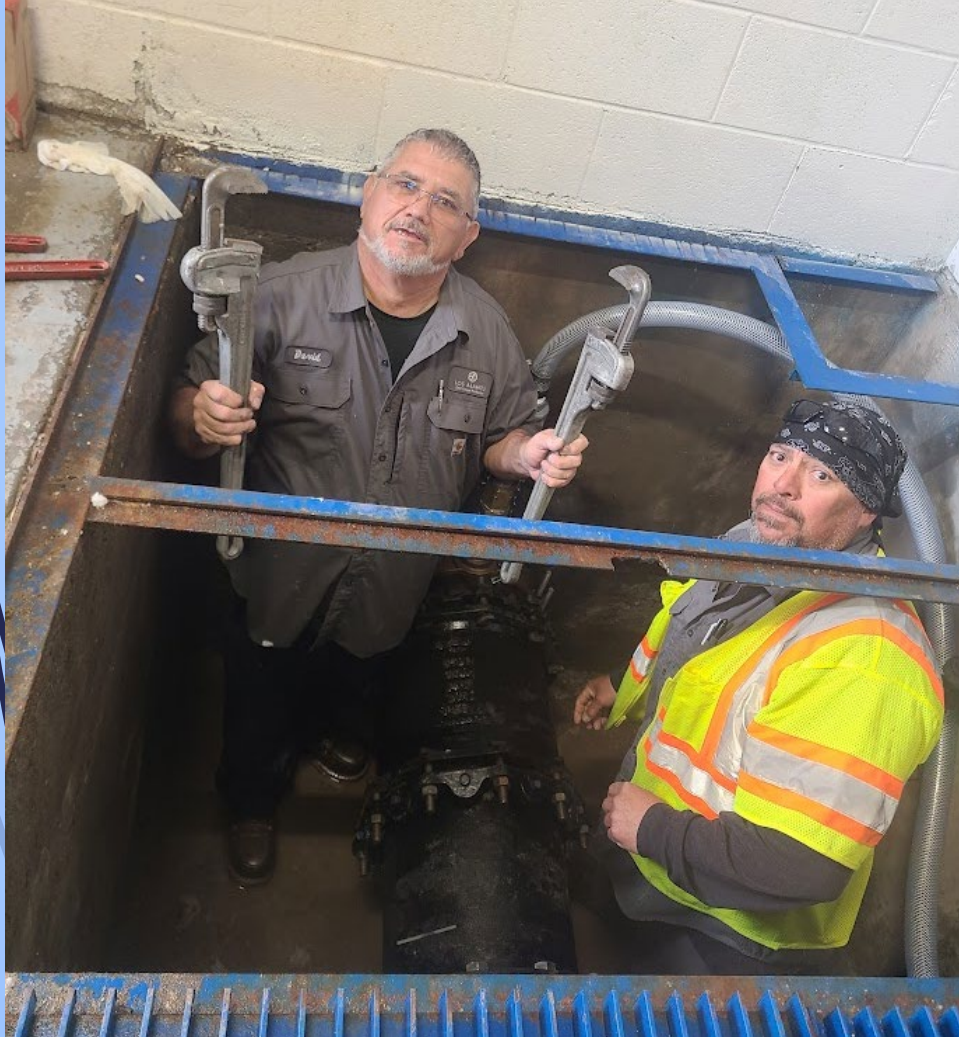
# Water Production System – Installing Chlorine Injector Quill at PB-2 and the 18" CCP Rupture in Two-Mile Canyon

- **WP** – LANL transmission water lines are seeing age and condition issues, and there have been some breaks. WP staff can coordinate repairs quite well, but the break on the 18" concrete line traversing Two Mile Canyon was a difficult situation. WP staff was able to divert flows into an older 10" steel line that was not being used but still connected to the system. Repairs to the 18" line are pending, with assistance from WP staff.
