LOS ALAMOS COUNTY DEPARTMENT OF PUBLIC UTILITIES

2021 ELECTRIC RELIABILITY PLAN

Stephen Marez, PE, PMP
Electrical Engineering Manager
Electric Distribution

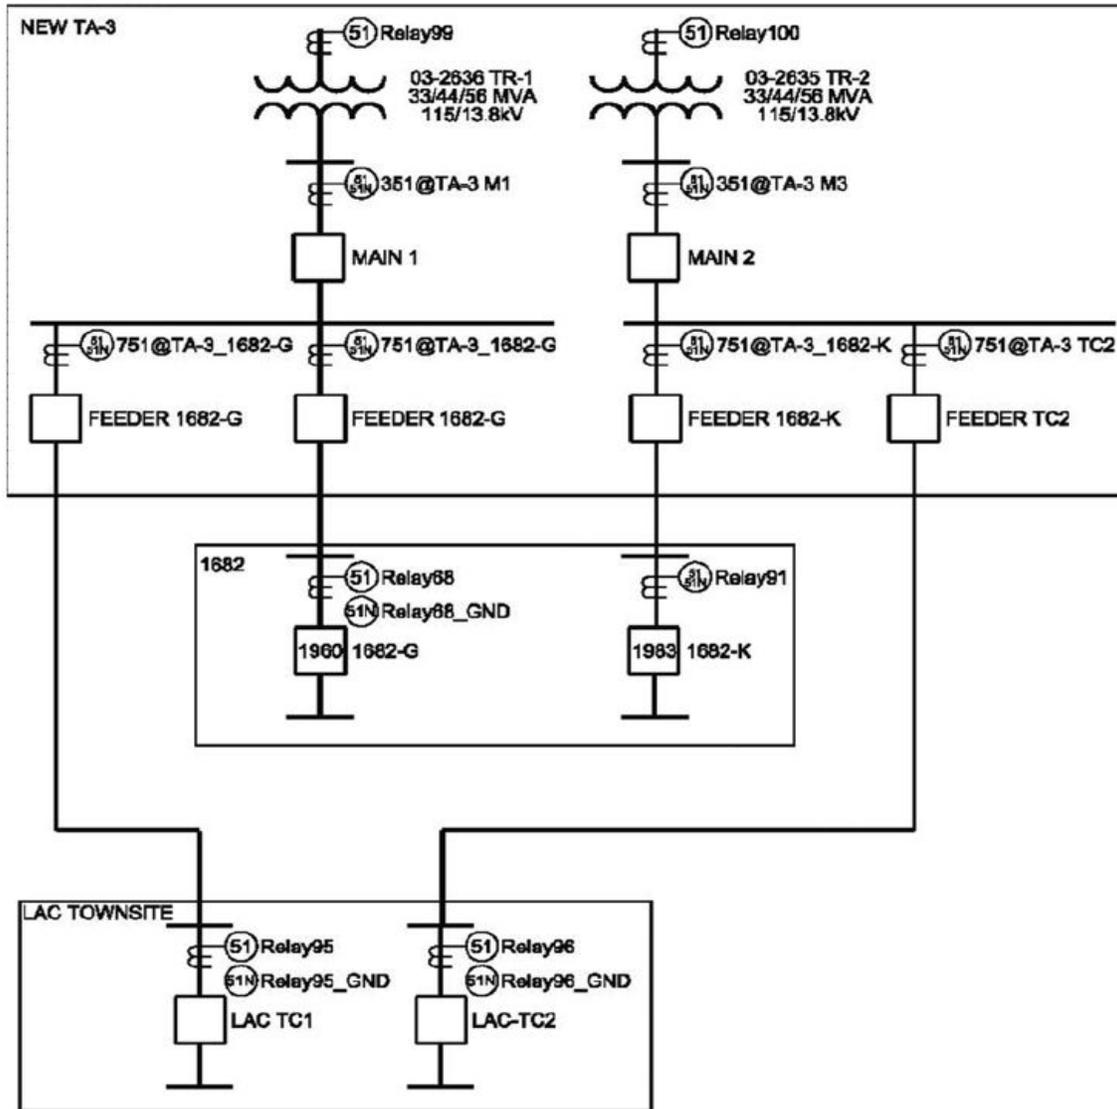
Figure 1. 115KV Transmission lines and TA-3 Substation feed into Los Alamos

Public Service Company of New Mexico (PNM) provides 115 KV transmission service into Los Alamos from two substation sources as illustrated in Figure 1. PNM also provides primary and back-up relay protection to the DOE-owned transmission lines and is the “balancing authority” for the Power Pool. The DOE owns the transmission system within Los Alamos to serve LANL and LACU electric facilities. LACU dispatchers operate the transmission system and manage the Power Pool resources 24 hours per day, 365 days per year.

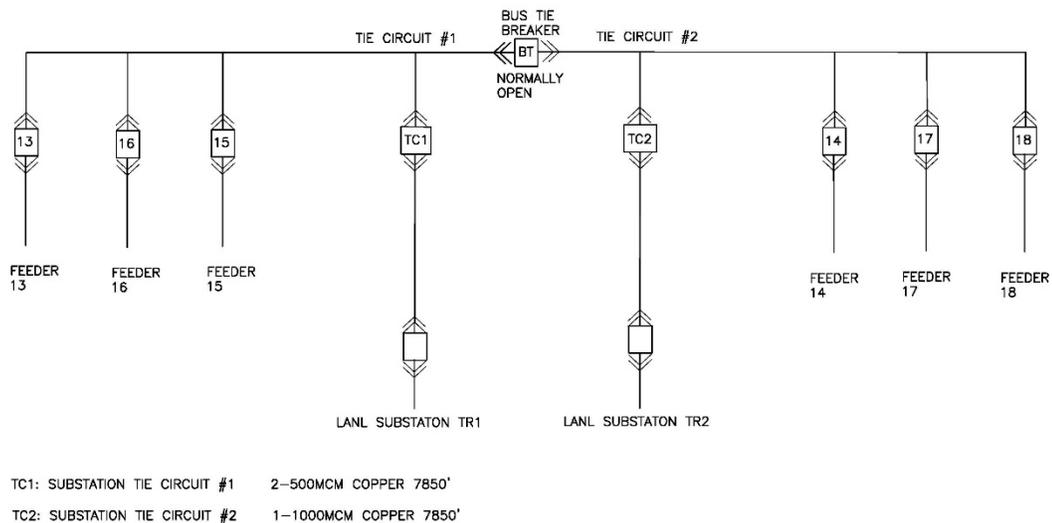
Figure 2. Los Alamos Townsite Switch Station

The LACU distribution system consists of two substations, Townsite and White Rock. The Townsite substation illustrated in Figure 2. provides power to the Los Alamos community and is fed by LANL's TA-3 substation via two 15 KV express feeders, TC-1 and TC-2; and normally fed from a 30 MVA transformer, TR-1. There is a back-up tie to a second 30 MVA transformer, TR-2. The Townsite substation bus is configured into two sections, half-bus for TC-1 and half-bus for TC-2. Upon loss of power to TC1 to TC2, LACU can manually transfer the outage bus-section to the energized bus-section.

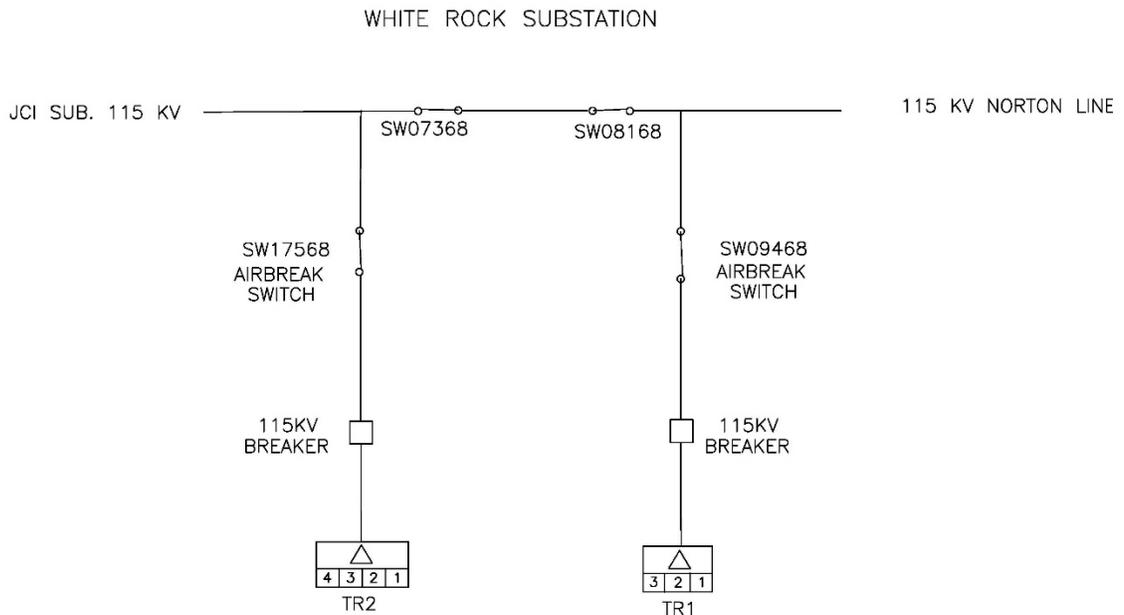
Figure 3. White Rock Substation

The White Rock substation provides power to the White Rock community and consists of primary and back-up 115KV to 12.47 KV transformers with metal-clad switchgear as illustrated in Figure 3. The primary feed TR1 was installed in 2006 and consists of a 10 MVA transformer with metal-clad switchgear. The secondary back-up feed TR2 is the original 50 year old 7.5 MVA transformer and new metal-clad switchgear installed in 2019. The TR2 transformer is also fitted with new primary side breakers. Service is transferred to TR2 when transmission line service is required by LANL or if maintenance on TR1 facilities are required.

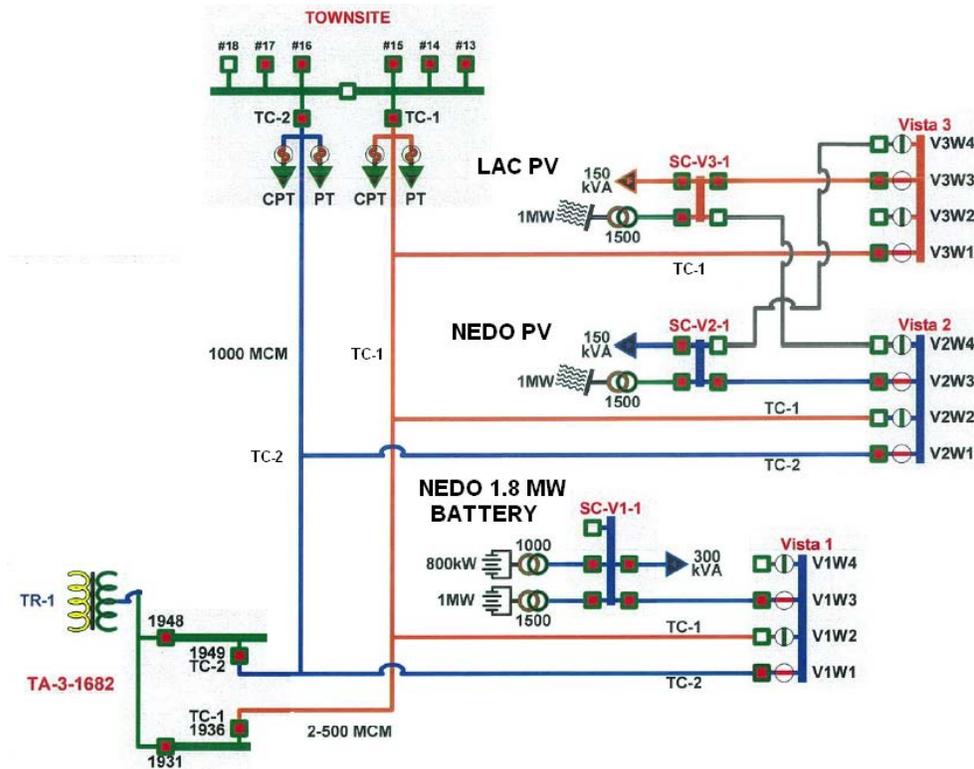
Figure 4. PVs Integration onto TC-1 and TC-2

The PV site located at the Landfill on East Jemez Road supplies 1.0 MW of energy to the local grid. LACU has long term plans to add a second 1 MW PV at a future date. The integration of the PV sources onto TC-1 and TC-2 is illustrated in Figure 4.

S&C Vista padmounted switchgear is utilized to integrate the PV and LACU generation sources onto TC-1 and TC-2. The Vista's utilize bi-directional SEL 451 (Sweitzer Engineering Lab) relays to accommodate the reverse power flow conditions from the PV.

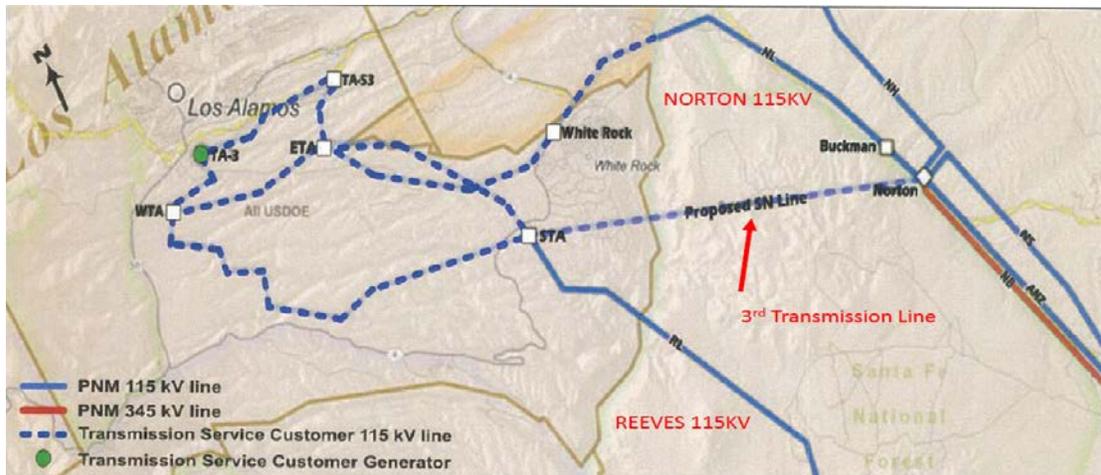
Figure 5. Regional 115KV transmission to Los Alamos

There are two 115 KV transmission lines into Los Alamos as illustrated in Figure 5. One transmission line is owned by LANL and operated by Public Service Company of New Mexico (PNM); the second line is owned and operated by PNM. The Norton line (NL line) originates at the Norton Substation west of Santa Fe and the Reeves line (RL line) originates at the B-A Substation north of Albuquerque. The two transmission lines are primarily “H” wood structures and are approximately 53 and 46 years old respectively. PNM performs an annual line patrol and maintains the transmission lines to provide reliable and continuous service for Los Alamos.

The RL and NL transmission lines have a service capacity of 115 MVA and 130 MVA respectively and are presently loaded at 77% and 68% of capacity; under a single 115KV transmission line operating condition. (Note: Some years ago, an analysis and study was completed to determine the feasibility of constructing a third 115KV transmission line into Los Alamos. Constructing additional transmission facilities into Los Alamos would certainly make sense provided there is additional load requirements; otherwise, the cost of the new transmission line would come at a substantial cost.) From the County’s perspective, it is primarily up to LANL to determine the risk associated with a single 115KV transmission line operating condition and justify the need for the third transmission line into Los Alamos.

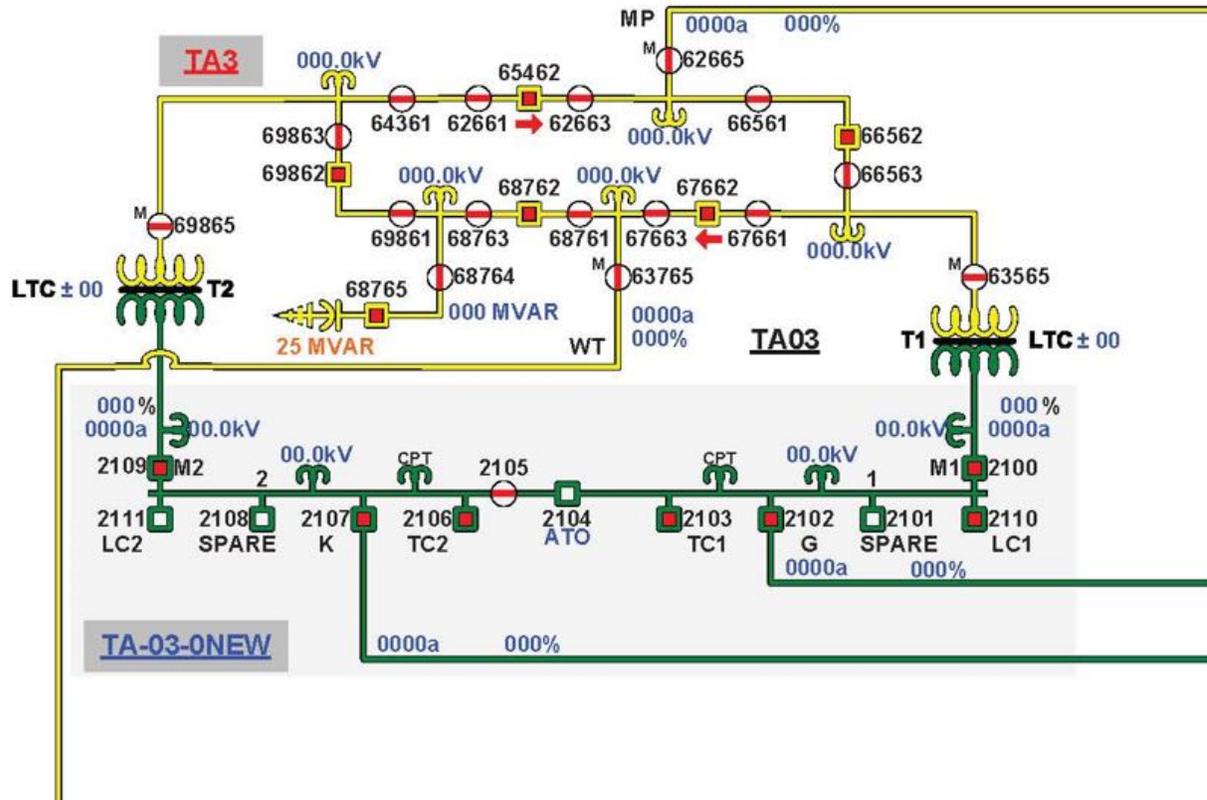
Figure 7. Green section shows TC1, TC2, LC1 and LC2 fed from T1 and T2
Draft diagram provided by LANL.

The Townsite substation is fed from LANL's TA3 substation which is served by LANL's WTA substation (WT line) and TA53 substation (MP line). However, the Townsite substation is fed at *distribution voltages* (13.2 KV) and would be considered as having less reliable transmission service simply because it isn't tied to the 115 KV transmission system directly.

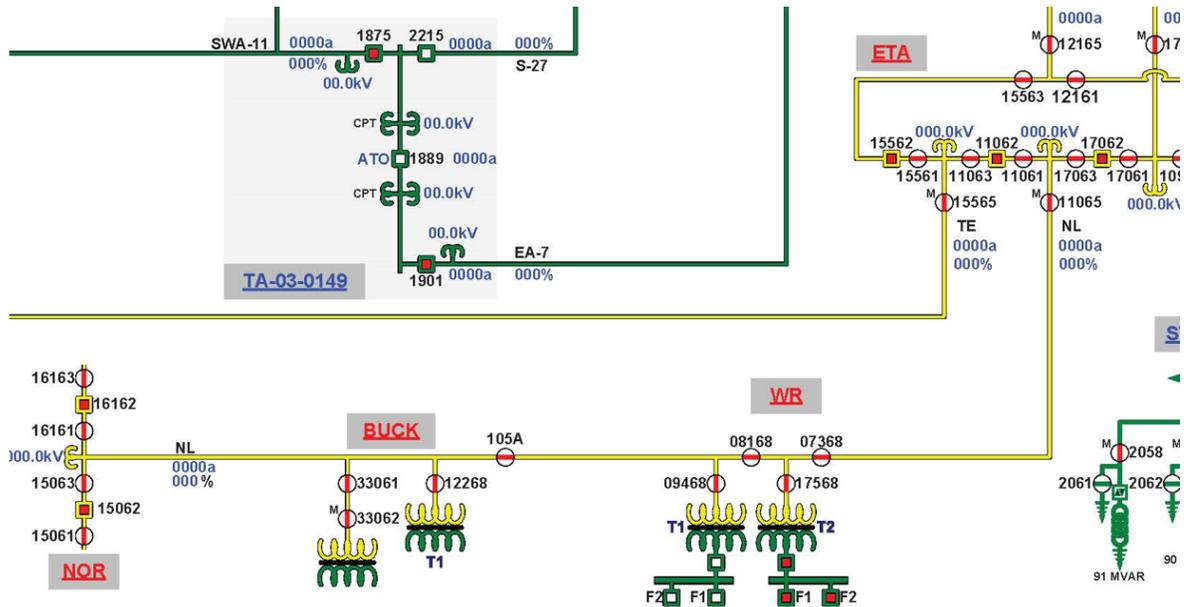
Figure 8. Lower section shows White Rock Substation (WR) Draft diagram provided by LANL

The White Rock substation is fed from PNM's Norton substation (NL line) and via LANL's ETA substation (NL' line). The substation is fed directly from the looped 115 KV transmission system, has redundant transformers and therefore, can be considered as having very reliable transmission service.

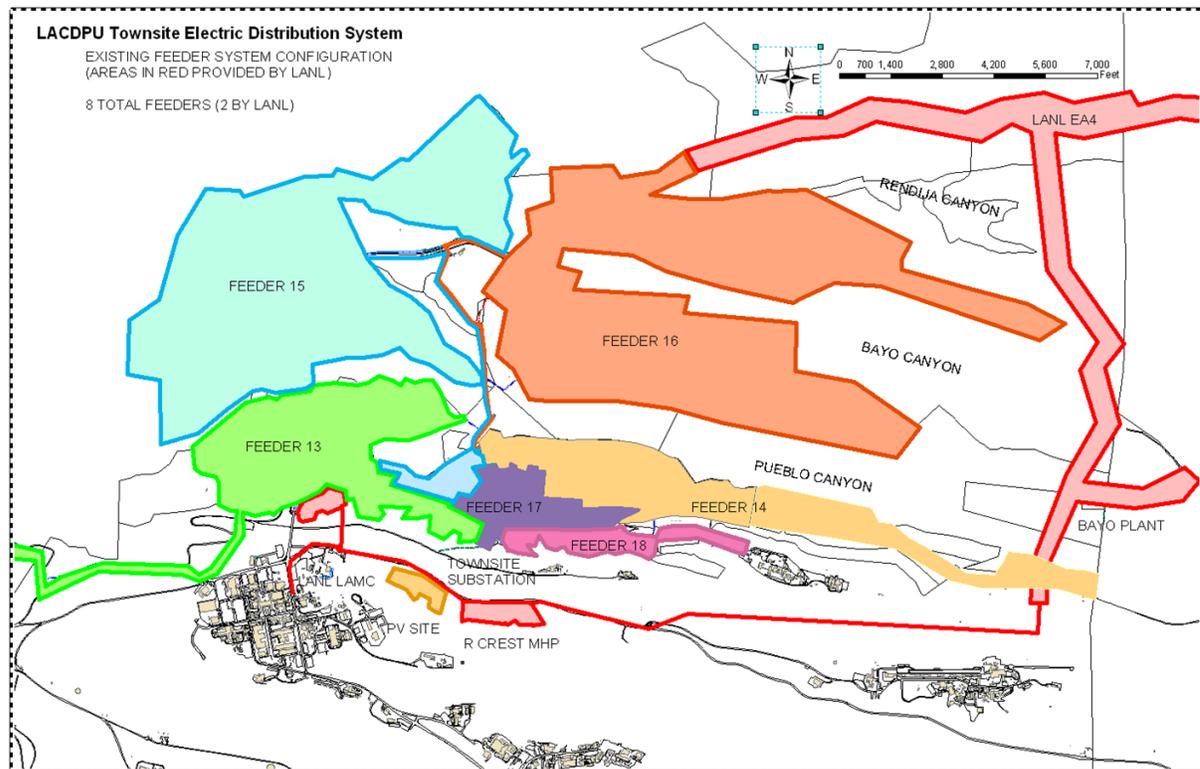
Figure 9. Existing Los Alamos distribution area

The Townsite switchgear substation (Townsite) has six (6) feeders, #13, #14, #15, #16, #17, and #18. In addition, LANL provides *primary metering* points to LACU to serve other LAC customers via LANL distribution lines including Royal Crest mobile home park, NM Consortium Building, Los Alamos Medical Center (LAMC), Ski Hill, Pueblo & Rendija Canyons, and Totavi in San Idelfonso Pueblo. Overall, eight (8) distribution feeders serve the Los Alamos community as illustrated in Figure 9.

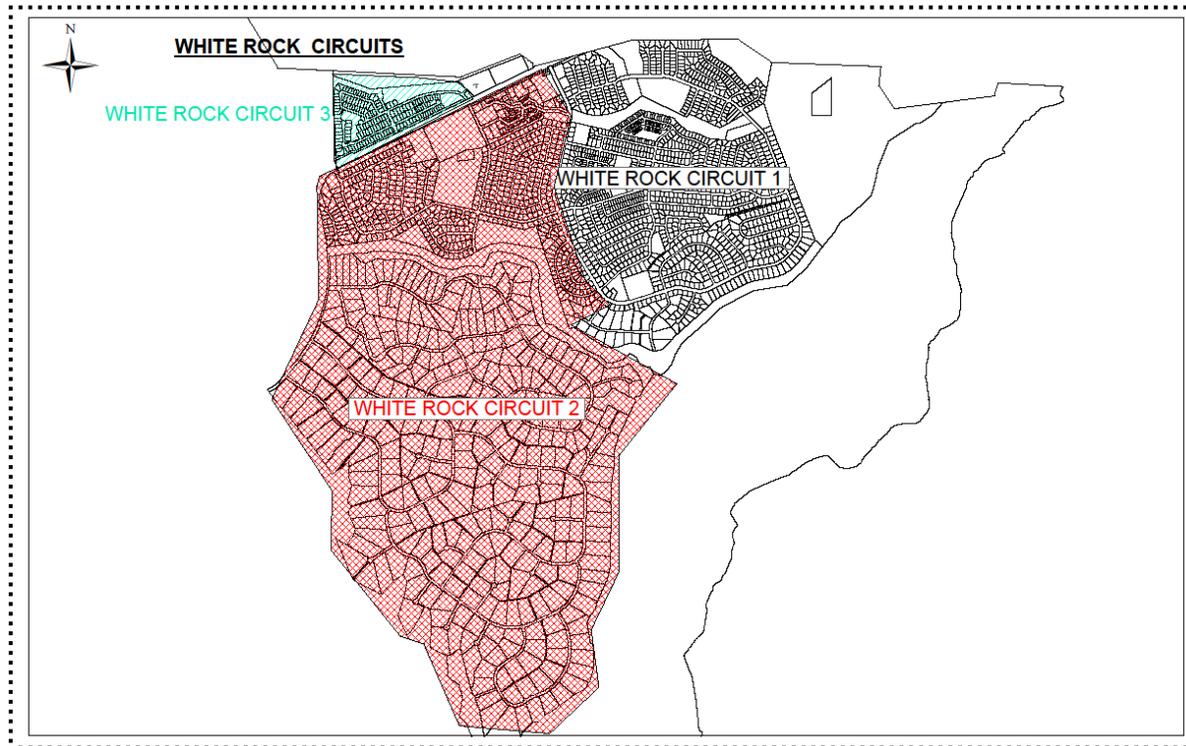
Figure 10. White Rock distribution area

The White Rock community is served by the White Rock substation as illustrated in Figure 10. The substation was upgraded during 2006 with the installation of a new 10 MVA transformer and the addition of a new 15KV metal-clad distribution switchgear bus. The substation transformer is presently operating at 60% capacity during the winter peaks. The new switchgear substation contains four circuit breakers for Feeders WR1, WR2, WR3 and one spare. The substation includes an older 7.5 MVA transformer and the new 15KV switchgear substation bus installed in FY20. The 7.5 MVA transformer and switchgear is utilized when LANL requires 115KV transmission line outage on the Unit TR2 side of the substation. From a transformer reliability perspective, having two transformers is certainly a plus. From a switchgear bus reliability perspective, having the spare 7.5 MVA transformer tied to the new switchgear is the best and only alternative.

On the distribution side, the WR1 and WR2 feeders can be paralleled within a quarter mile but it has limited use because each feeder remains mostly radial. An ideal looped configuration is when the feeders can be paralleled at each end. For example, the WR2 feeder was looped during 2013 with the construction of the mile long WR2 UG Feeder tie. The project consisted of a new UG power line along SR 4 with new loops to La Senda areas A and B, and Pajarito Acres 1 and 2. The addition of the WR3 feeder provides a tie between WR2 and WR3 on State Road 4.

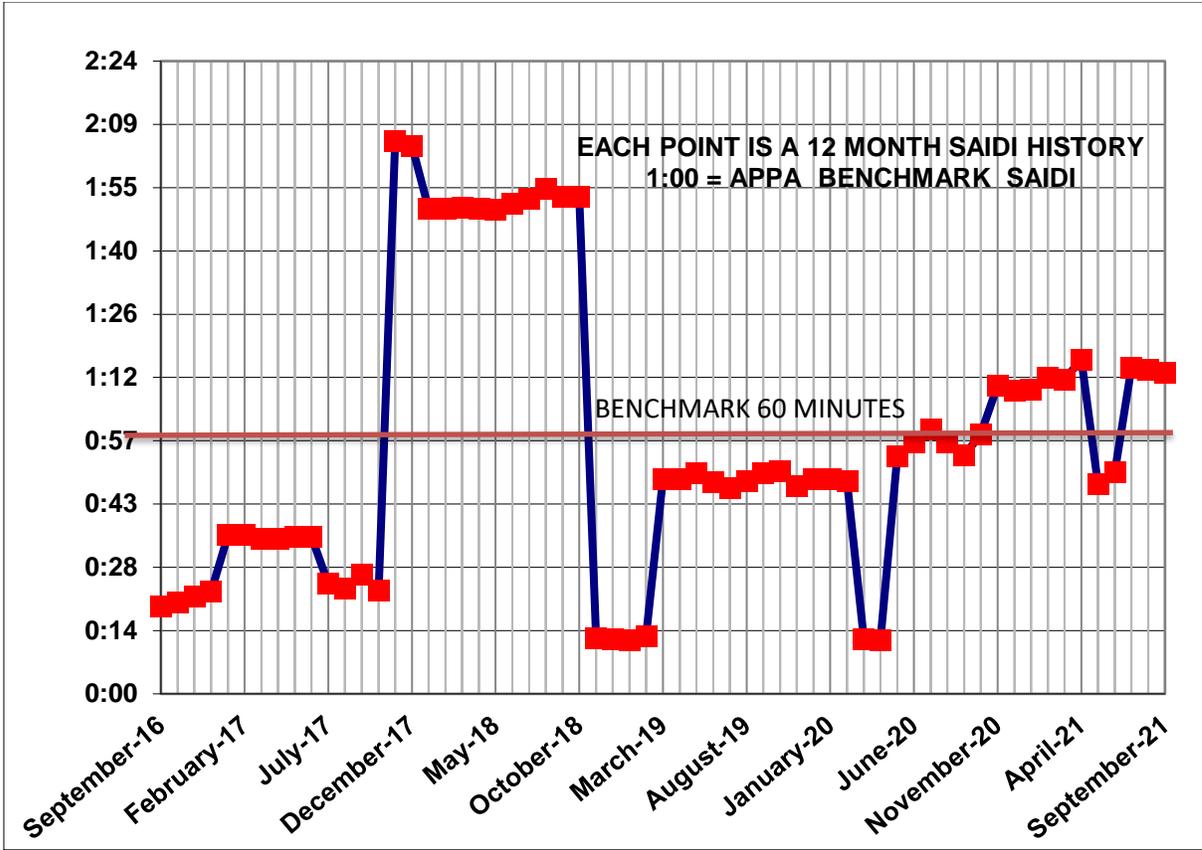
Figure 11. Graph of LAC SAIDI with 60-minute TARGET

The calculations are based on a 12-month history. All outages' effects will remain in the calculations for one year as demonstrated in Figure 11.

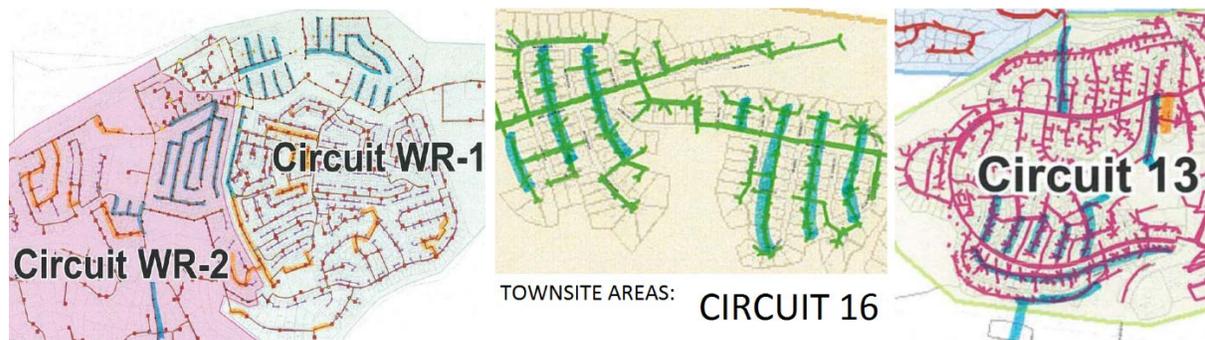
Figure 12. Areas not readily accessible

The OH and UG systems have repair and replacement challenges which may impact the SAIDI as replacement projects are underway. Figure 12. illustrates a map area of inaccessible areas due to right-of-way encroachment or customer blockage. Having inadequate work access or having to work around landscaped areas, etc., make it difficult for LACU to replace rotten poles and overloaded transformers. For the UG system, having to dig in and around areas congested with buried utilities makes it difficult to dig for routine repairs; more so when having to install replacement lines.

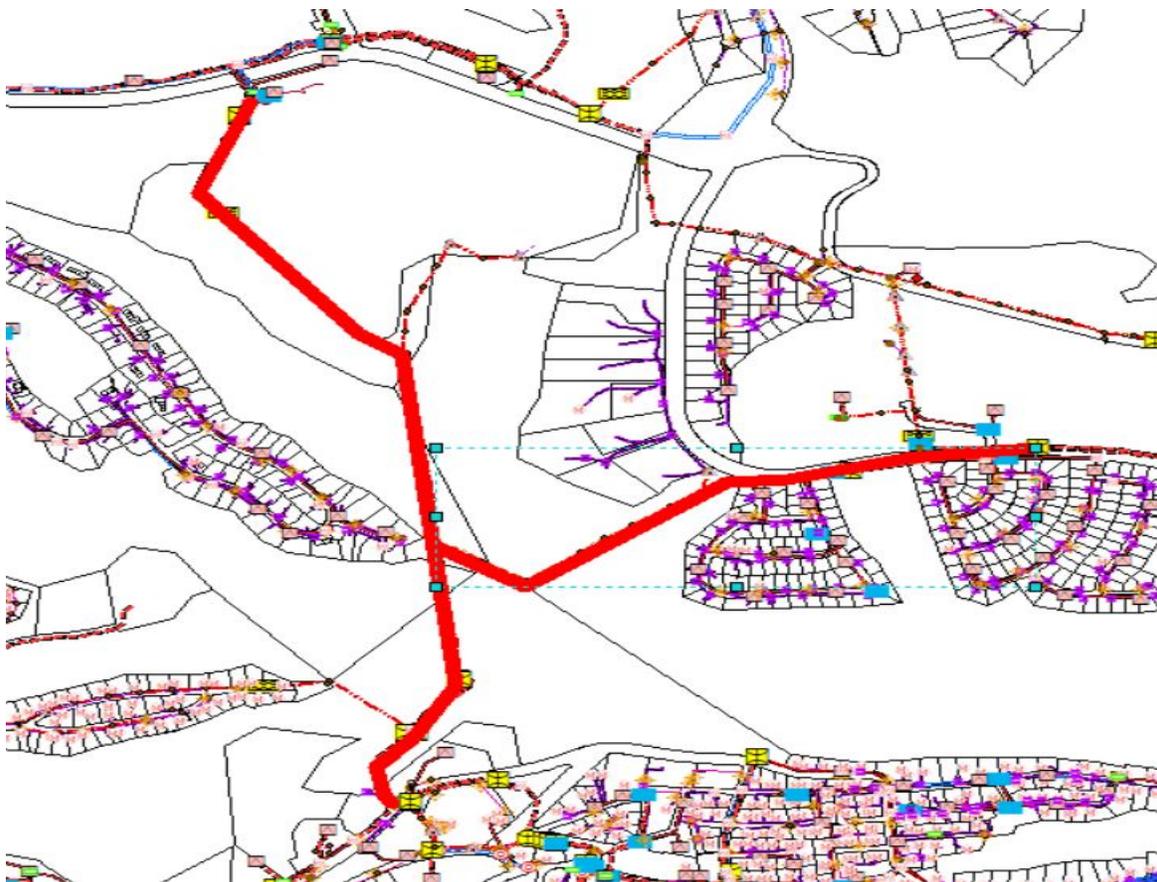
Figure 13. Pole and Conductor Replacement Project 2015

The department hired contractors to replace overhead line sections across canyons from Canyon Road to Diamond Drive and San Idelfonso. Figure 13. shows OH line sections replaced. The department also replaces poles in a continuous effort to maintain the system. Sections of the overhead conductor wire which have been in service over 50 years; particularly those areas which contain obsolete CWC (copper-weld-copper) wire. The replacement of these sections is an ongoing process in house.

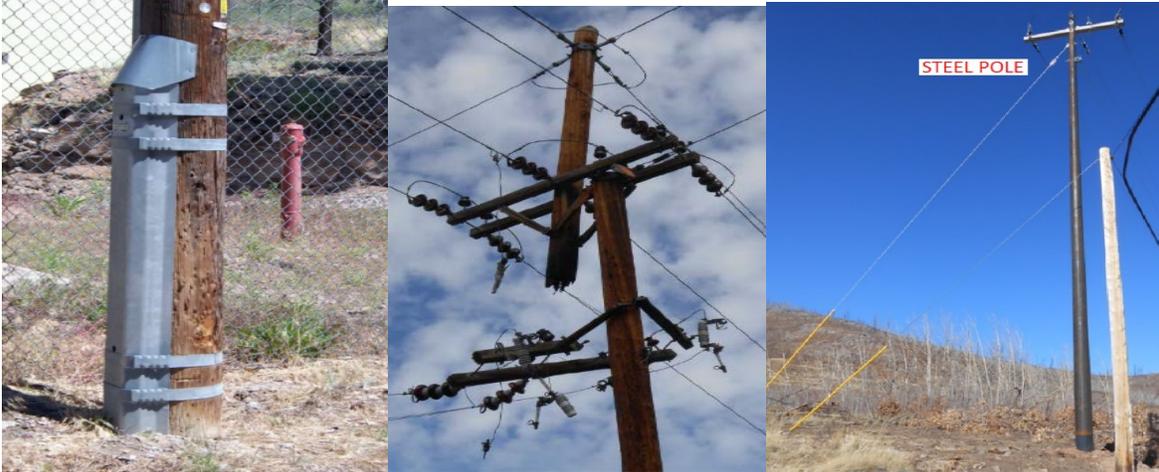
Figure 14. Typical braced pole & backbone broken pole; & new Steel Pole

what a wood pole type Douglas fir weighs; but cost twice as much. Figure 14. illustrates a typical braced pole and a new steel pole.

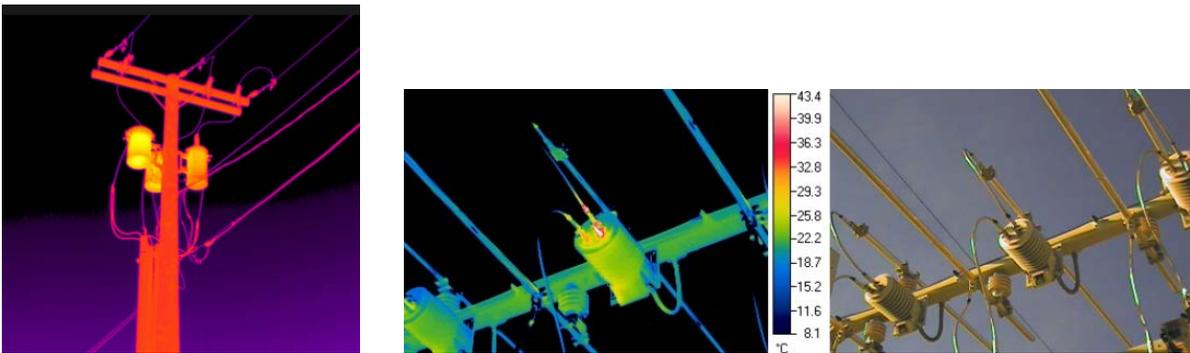
Figure 15. Infra-red picture for transformer pole & air break switch

During the winter, the department will continue to *infra-red* critical sections of the underground and overhead systems to look for hot-spots as illustrated in Figure 15. Hot spots are areas that have loose connections leading to high-resistant points; these points will eventually burn up, fail, and cause a power outage.

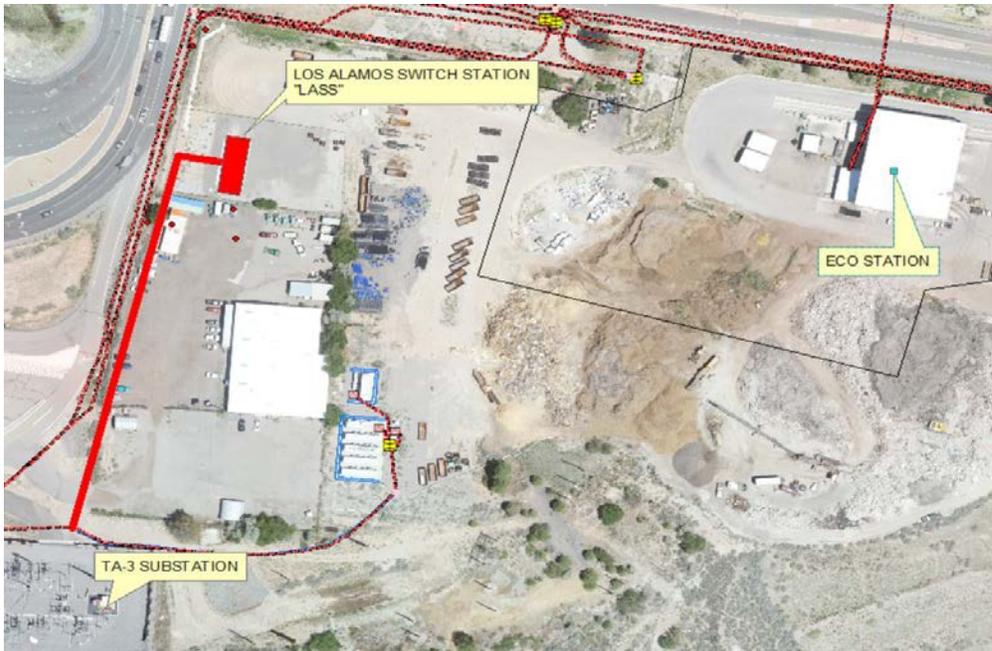
Figure 17. LASS station Location Relative to LANL

The top reliability project for LACU is the construction of the new LASS Substation addition near the County landfill as illustrated in Figure 17. The LASS Substation is needed to maintain the SAIDI target into the future. LASS is also critical to the supply of steady and reliable electric power to the residents of the Los Alamos Townsite; more so if the Townsite area is expected to grow electrically.

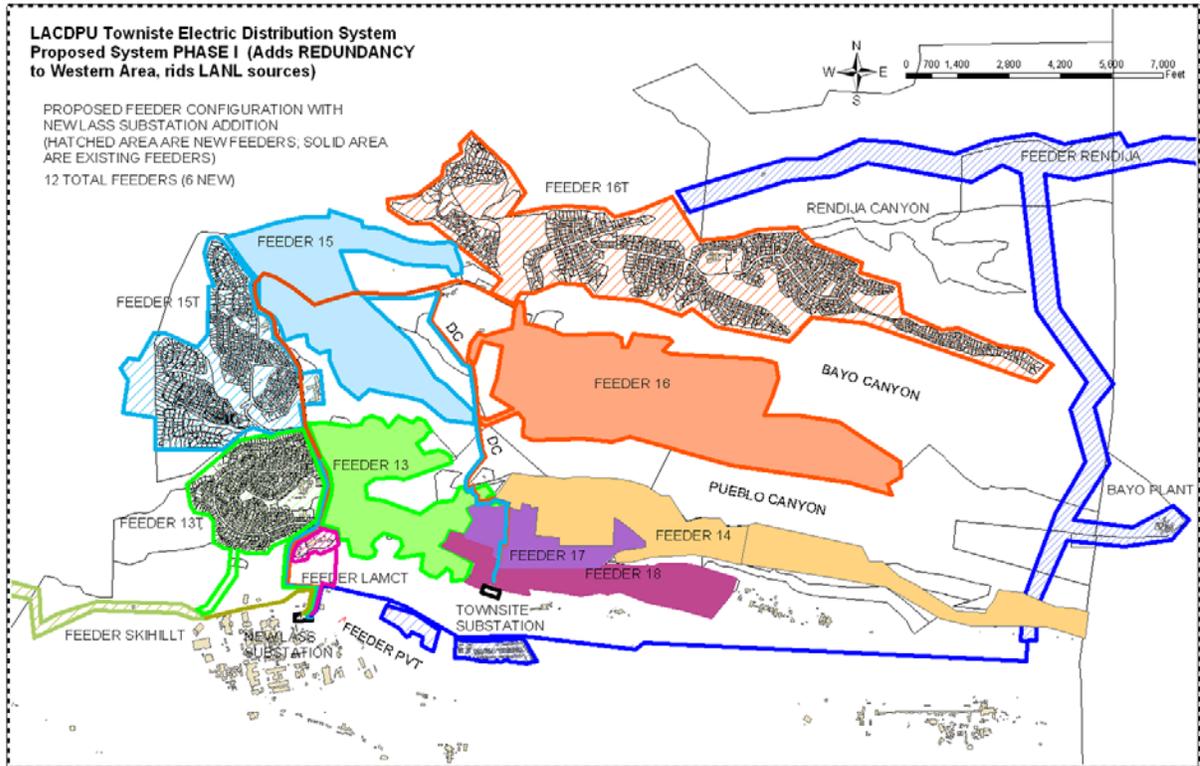
Figure 18. Los Alamos distribution area with LASS substation addition (when compared with Figure 9.)

The LASS Substation will add feeder sources to maintain and improve the SAIDI and the system reliability in the Townsite area as illustrated in Figure 18. and as follows:

1. Reduce the number of customers on Townsite substation feeders 13, 15, & 16 (by moving half the customers on those feeders to LASS).
2. Provide new feeders 13T, 15T, 16T, S6, SM6.
3. Provide power to LACU customers with LACU power lines and not from LANL power lines, i.e., Transfer Station, LAMC (S6), Elk Ridge MH Park.

4. Add 50% additional system redundancy during scheduled or unscheduled outages to Townsite Substation Feeders. Feeders 13T, 15T, & 16T on LASS can back feed feeders on Townsite 13, 15, 16, Ski Hill and LAMC.

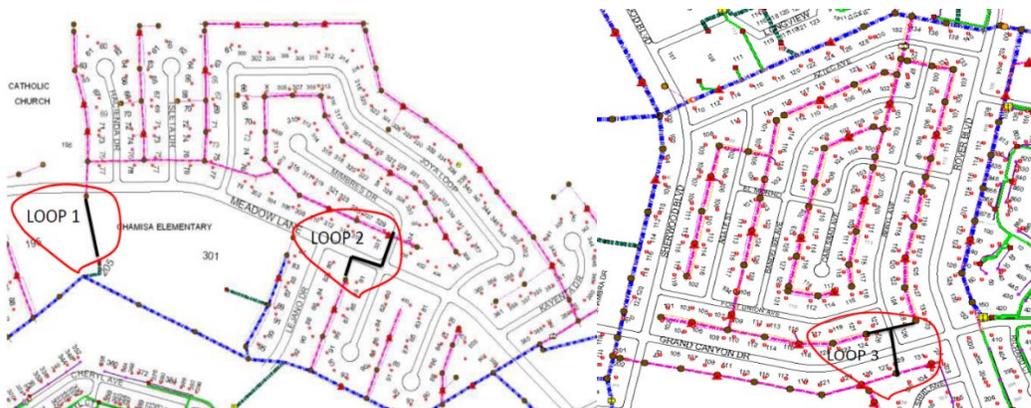
Figure 19. Single Phase Loop Addition Targets in White Rock

Major underground replacement projects or additions were constructed in the past: 0.8 mile, WR2 Loop Addition, 1.2-mile, Canyon Road Rebuild Project, and 1.0 mile, Tsikumu Village Primary Replacement Project. The three projects had become burdensome to LACU customers and affected the SAIDI year after year. The projects not only replaced the failed underground sections but also added three phase power line sections and new single phase primary loops. Each project cost in the neighborhood of \$500K and it will be difficult to sustain those type of projects in the future without impacting utility rates. Costs for materials are rising rapidly. Major underground capital replacement projects have been identified in the immediate future by the asset management team, see Appendix C. LACU is prepared to deal with major SAIDI impact projects as they may arise in the future. A list of major projects includes the Los Pueblos and Totavi area, La Senda and Pajarito Acres, Timber Ridge, La Vista and Big Rock Loop. Other long term UG projects which will provide long-term reliability improvement is the addition of new UG or OH Loops. LACU has many radial lines which power anywhere from 30 to 100 customers; a failure on the radial line leaves few alternatives to restore power in a timely fashion. By identifying these long radial power lines, LACU can install new Loops within reasonable costs. Figure 19. illustrates priority areas for Loop additions in White Rock.

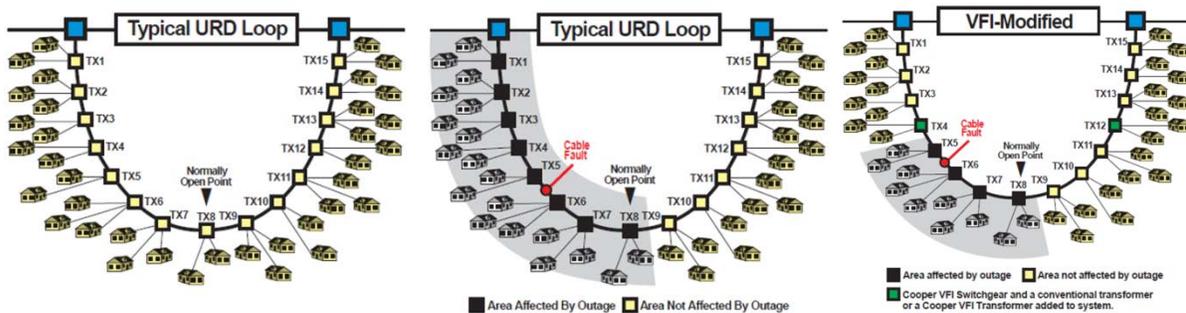
Figure 20. VFI Transformer Fault Isolation & Restoration Solution

The LACU has many underground subdivisions with single phase primary laterals with 10+ transformers configured in a daisy-chain. When LACU experiences a faulted line section, it must identify the fault, isolate it, then back feed the outage area from a new power source. Back feed is done by manually transferring electrical load with a 200-amp elbow; at least two times during the restoration process. With continual line section failures, the manually back feeding process is resulting in secondary and residual failures, i.e. elbows or other weakened points.

Therefore, LACU must look at other engineering solutions in identifying and isolating failed line sections so that no secondary or residual failures occur. Figure 20. illustrates a reasonable engineering solution (\$8K per VFI transformer) where faults can be detected, identified to smaller line segments, and allows LACU linemen to safely re-route power without utilizing elbows or fuses. The VFI solution will simply trip the interrupter in a safe manner and no secondary failures.
