# **DEPARTMENT OF PUBLIC UTILITIES**

## **ELECTRIC SYSTEM CONDITION**

### **ASSESSMENT**

The condition assessment is an ongoing effort to evaluate the physical condition of the switches, poles, transformers, and conductors. Field verification and analysis of the system connectivity, equipment identification and safety were performed.

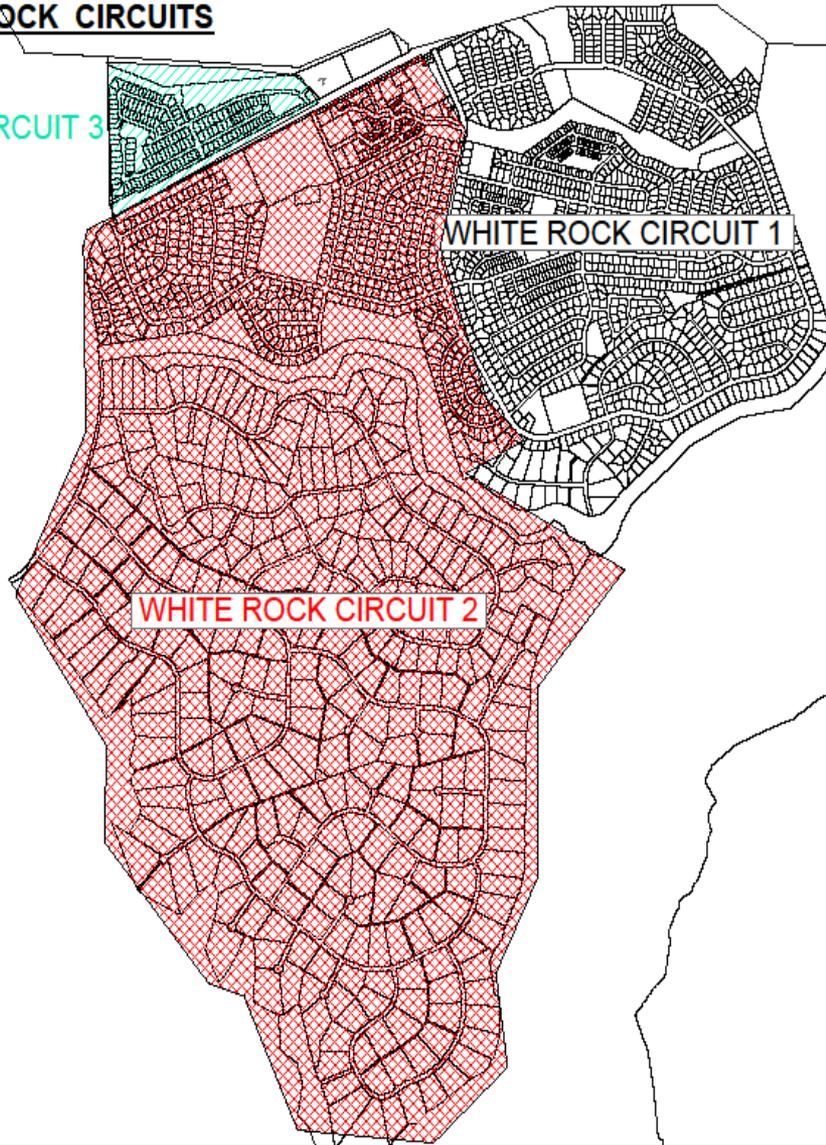
**WHITE ROCK CIRCUITS**

WHITE ROCK CIRCUIT 3

WHITE ROCK CIRCUIT 1

WHITE ROCK CIRCUIT 2

- 12.47 KV from 115KV Norton Line
- Transformers – Unit 1 5000KVA  
New Unit 2 7500 KVA
- Switchgear on Unit 2 with 3 Circuits
- New Switchgear on Unit 1 with 3 Circuits

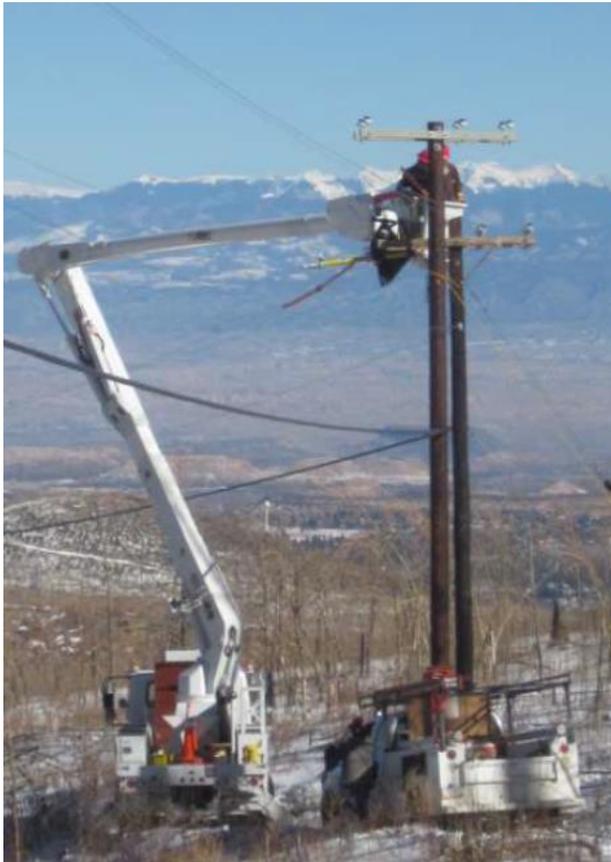
## Power Poles Replaced Since 2006

<b>Pole Series</b>	<b>Area</b>	<b>POLES REPLACED SINCE 2006</b>
<b>1000</b>	<b>Western Area</b>	<b>36</b>
<b>2000</b>	<b>Eastern Area</b>	<b>14</b>
<b>3000</b>	<b>North Community</b>	<b>60</b>
<b>4000</b>	<b>North Mesa</b>	<b>13</b>
<b>5000</b>	<b>Barranca Mesa</b>	<b>44</b>
<b>6000</b>	<b>White Rock</b>	<b>53</b>
<b>7000</b>	<b>Pajarito Acres</b>	<b>22</b>
<b>8000</b>	<b>Ski Hill</b>	<b>18</b>
<b>9000</b>	<b>S-18</b>	<b>26</b>
<b>Grand Totals</b>		<b>286</b>

- 2386 Poles
- Inspected for Structural Integrity and Treated in 2006 and 2013
  - 286 Rejects (12%)
  - 160 Priority (7%)
  - Useful Life 60+ Years if Treated in Regular Intervals
  - LACU Poles were not treated regularly

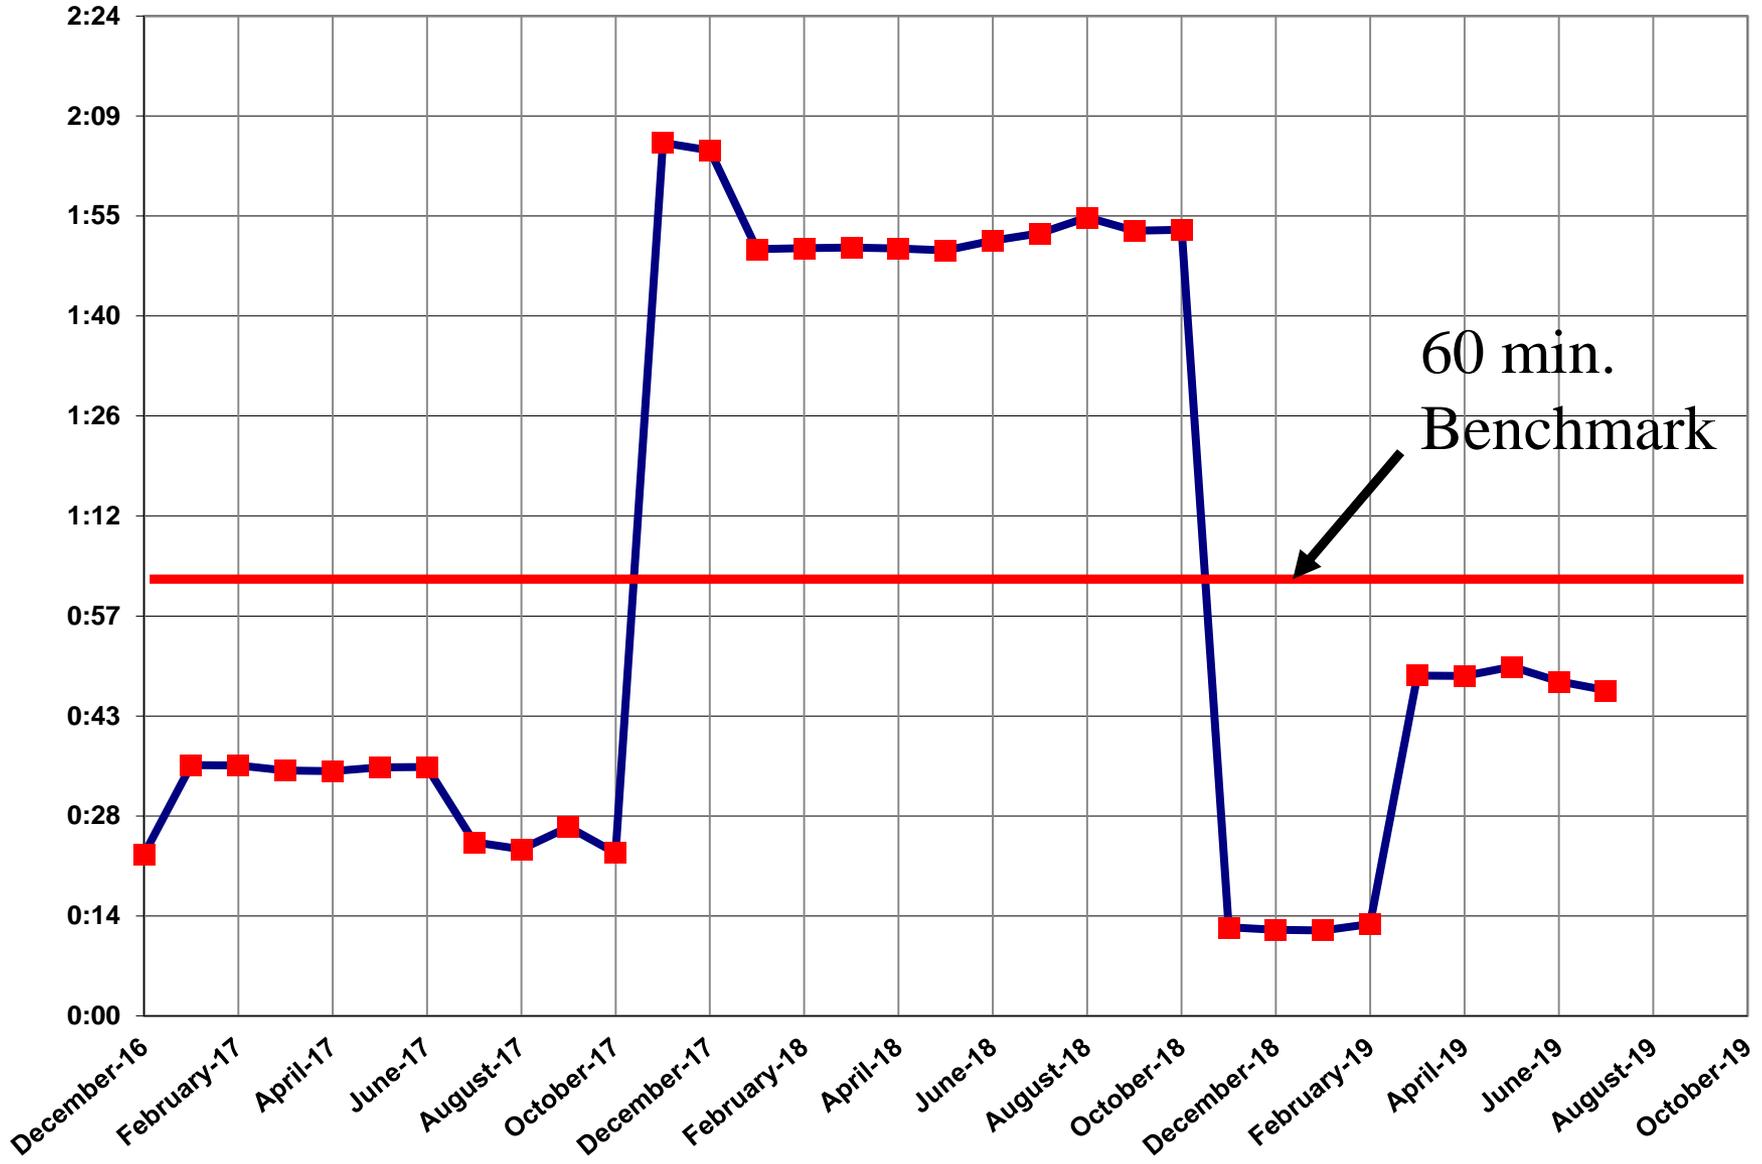
SAIDI = SYSTEM AVERAGE INTERRUPTION DURATION INDEX

The standard for measurement of system reliability according to IEEE  
And APPA. Our benchmark for reliability is 60 minutes.

EACH POINT IS A 12 MONTH SAIDI HISTORY  
1:00:00 = APPA BENCHMARK SAIDI

60 min.  
Benchmark
