LOS ALAMOS COUNTY DEPARTMENT OF PUBLIC UTILITIES

# FY 2023 ELECTRIC RELIABILITY PLAN

Stephen Marez, PE, PMP  
Acting Deputy Utility Manager  
Electric Distribution

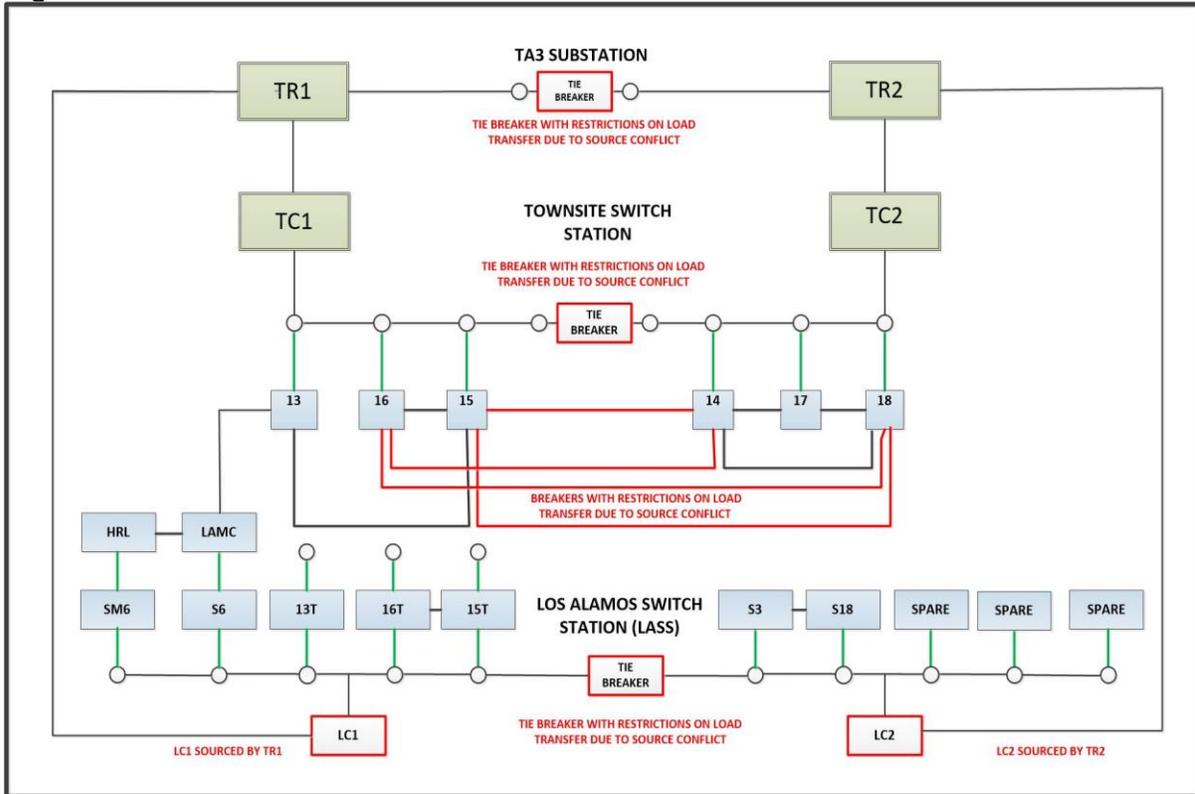
Figure 1. Los Alamos Townsite and Future Los Alamos Switch Station

The LACU distribution system is supplied by two substations, LANL TA-3 and White Rock. Figure 1. shows how the Los Alamos townsite is fed by LANL's TA-3 substation via two 15 KV express feeders, TC-1 and TC-2. The Townsite switch station bus is configured into two sections, half-bus for TC-1 and half-bus for TC-2. Upon loss of power to TC1 or TC2, LACU can manually transfer the outage bus-section to the energized bus-section. The LASS Station will be connected as shown.

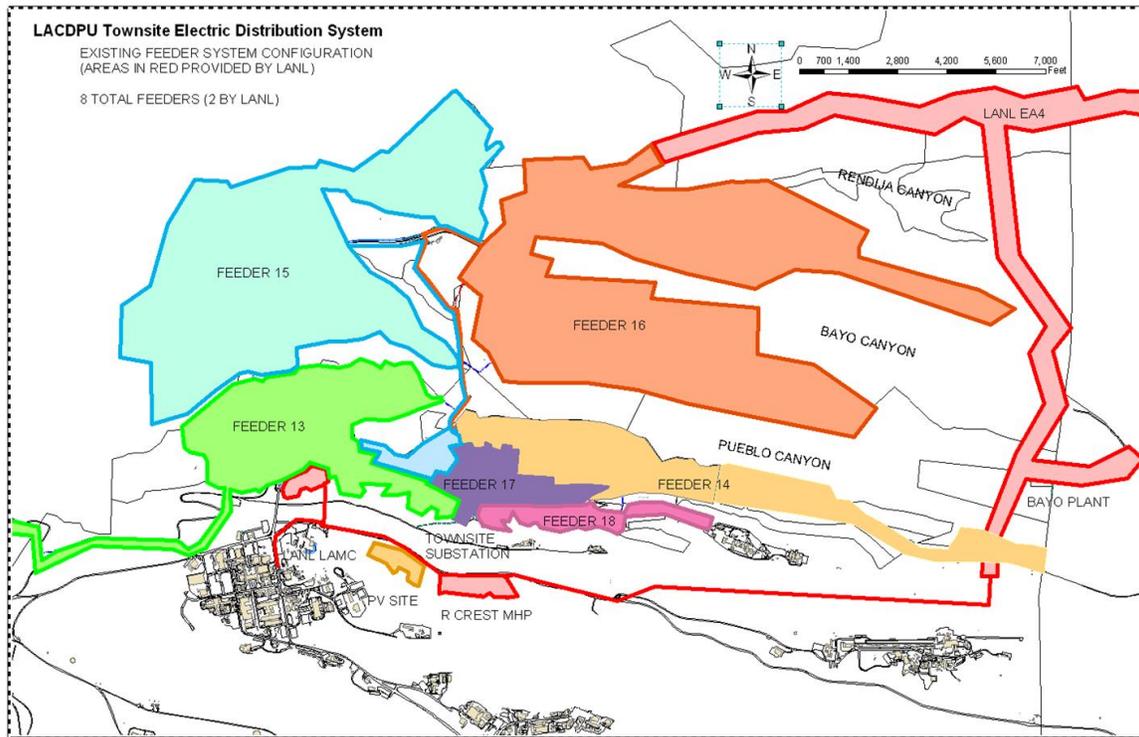
Figure 2. Existing Los Alamos Distribution Area

Figure 2. Illustrates the townsite feeder areas.

The Townsite switchgear substation (Townsite) has six (6) feeders, #13, #14, #15, #16, #17, and #18. In addition, LANL provides *primary metering* points to LACU to serve other LAC customers via LANL distribution lines including Royal Crest mobile home park, NM Consortium Building, Los Alamos Medical Center (LAMC), Ski Hill, Pueblo & Rendija Canyons, and Totavi in San Idelfonso Pueblo. Overall, eight (8) distribution feeders serve the Los Alamos community as illustrated in Figure 2.

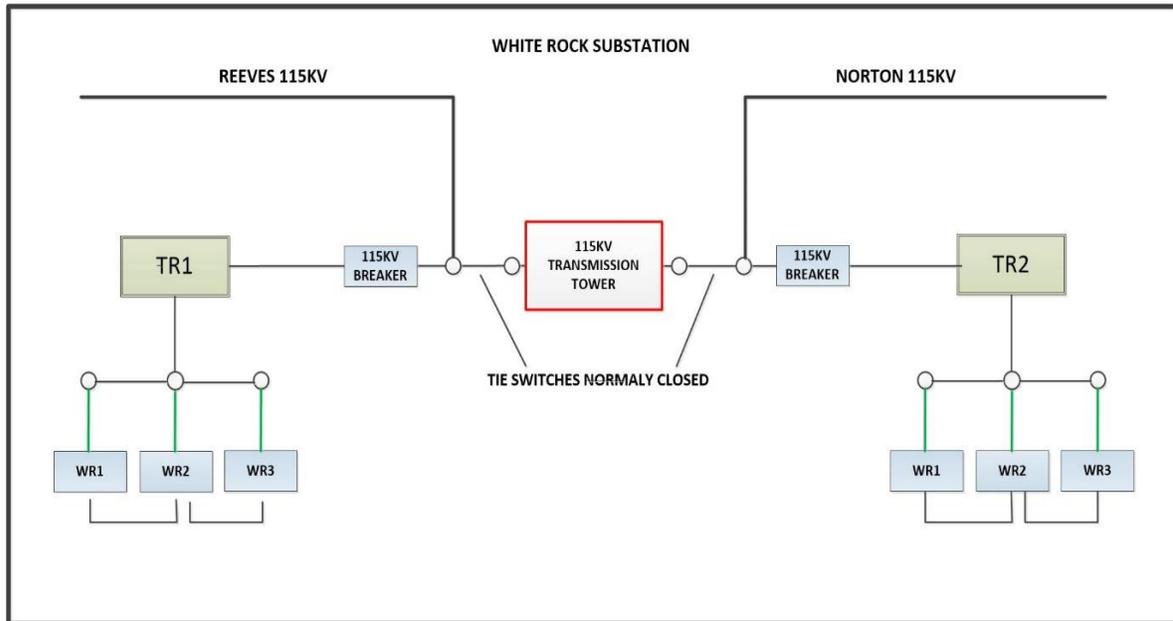
Figure 3. White Rock Substation

The White Rock substation provides power to the White Rock community and consists of primary and back-up 115KV to 12.47 KV transformers with metal-clad switchgear as illustrated in Figure 3. The primary feed TR1 was installed in 2006 and consists of a 10 MVA transformer with metal-clad switchgear. The secondary back-up feed TR2 is the original 50 year old 7.5 MVA transformer and new metal-clad switchgear installed in 2019. The TR2 transformer is also fitted with new primary side breakers. Service is transferred to TR2 when transmission line service is required by LANL or if maintenance on TR1 facilities are required. Switching between the TR1 and TR2 systems is done manually by paralleling both systems. LACU has a switching procedure in place to ensure the paralleling process is conducted safely. Having the back-up substation transformer has great reliability value. One issue in the station is the failure of the load tap changer on unit 1. Because of the age of the unit , it is difficult to find replacement parts.

The White Rock substation was upgraded during 2006 with the installation of a new 10 MVA transformer and the addition of a new 15KV metal-clad distribution switchgear bus. The substation transformer is presently operating at 60% capacity during the winter peaks. The new switchgear substation contains four circuit breakers for Feeders WR1, WR2, WR3 and one spare. The substation includes an older 7.5 MVA transformer and the new 15KV switchgear substation bus installed in FY20. The 7.5 MVA transformer and switchgear is utilized when LANL requires 115KV transmission line outage on the Unit TR2 side of the substation. From a transformer reliability perspective, having two transformers is certainly a plus. From a switchgear bus reliability perspective, having the spare 7.5 MVA transformer tied to the new switchgear is the best and only alternative.

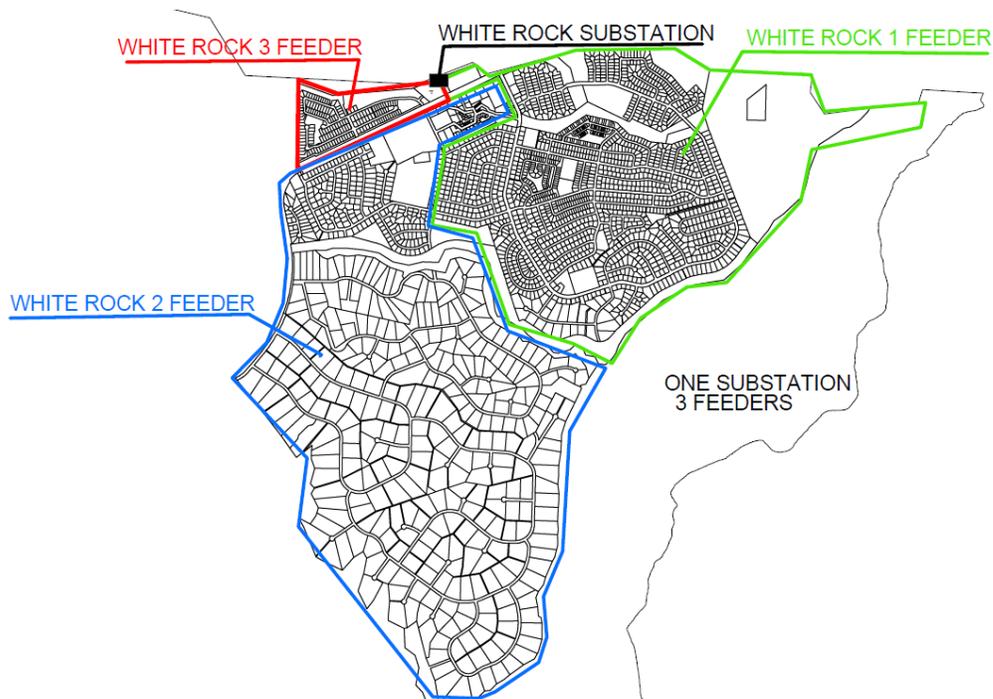
Figure 4. White Rock Distribution Areas

Figure 4. Illustrates the White Rock Feeder Areas

looped during 2013 with the construction of the mile long WR2 UG Feeder tie. The project consisted of a new UG power line along SR 4 with new loops to La Senda areas A and B, and Pajarito Acres 1 and 2. The addition of the WR3 feeder provides a tie between WR2 and WR3 on State Road 4.

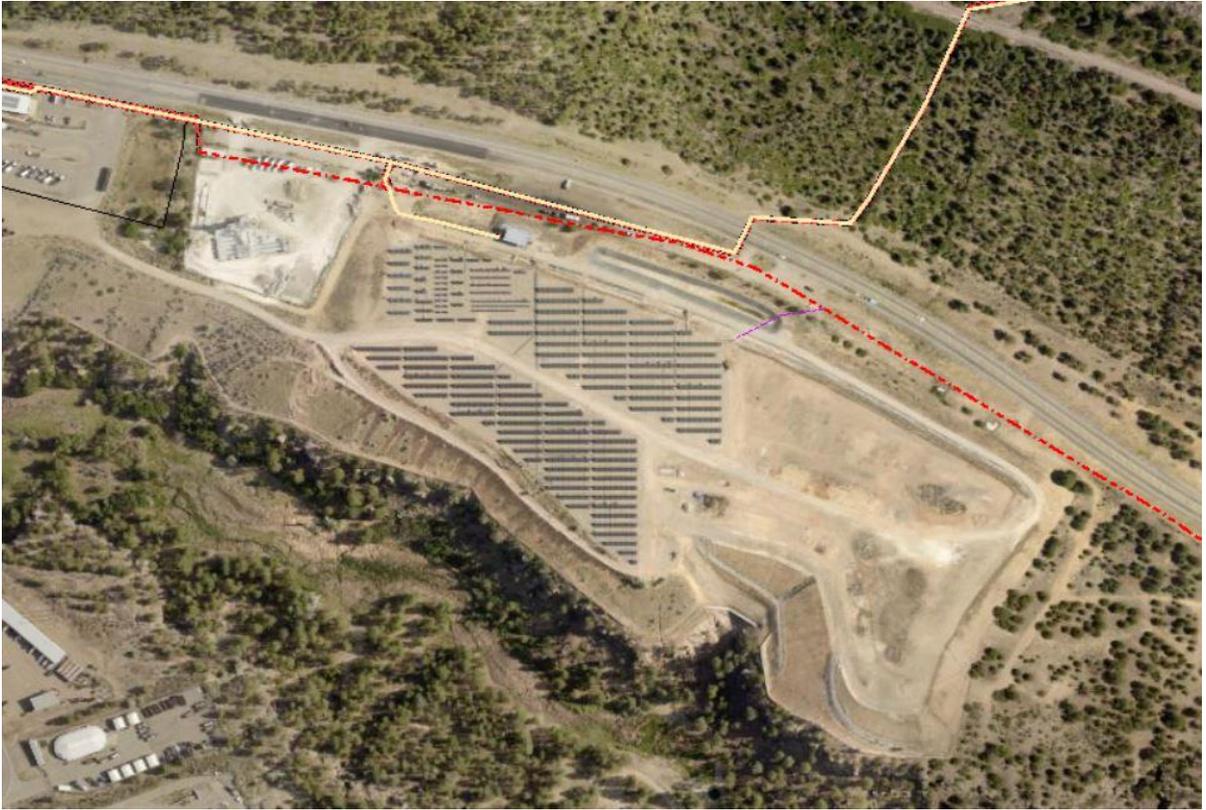
Figure 5. PV site

The PV site located at the Landfill on East Jemez Road supplies 1.0 MW of energy to the local grid. LACU has long term plans to add a second 1 MW PV at a future date. The integration of the PV sources onto TC-1 and TC-2 is illustrated in Figure 4.

S&C Vista padmounted switchgear are utilized to integrate the PV and LACU generation sources onto TC-1 and TC-2. The Vista's utilize bi-directional SEL 451 (Sweitzer Engineering Lab) relays to accommodate the reverse power flow conditions from the PV.

The PV site is operated by a Toshiba control system called micro-EMS. The micro-EMS will optimize the PV outputs under varying scenarios with the primary goal to make the PV dispatchable (and thus reliable). LACU does have the capability to provide emergency power to some of its customers upon complete loss of 115KV transmission power to Los Alamos ( This procedure has not been tested and would require full cooperation and control from LANL). The battery site is now not in operation. The PV site is operating at lower capacity due to the failure of an inverter. Figure 5. Illustrates the PV site location.

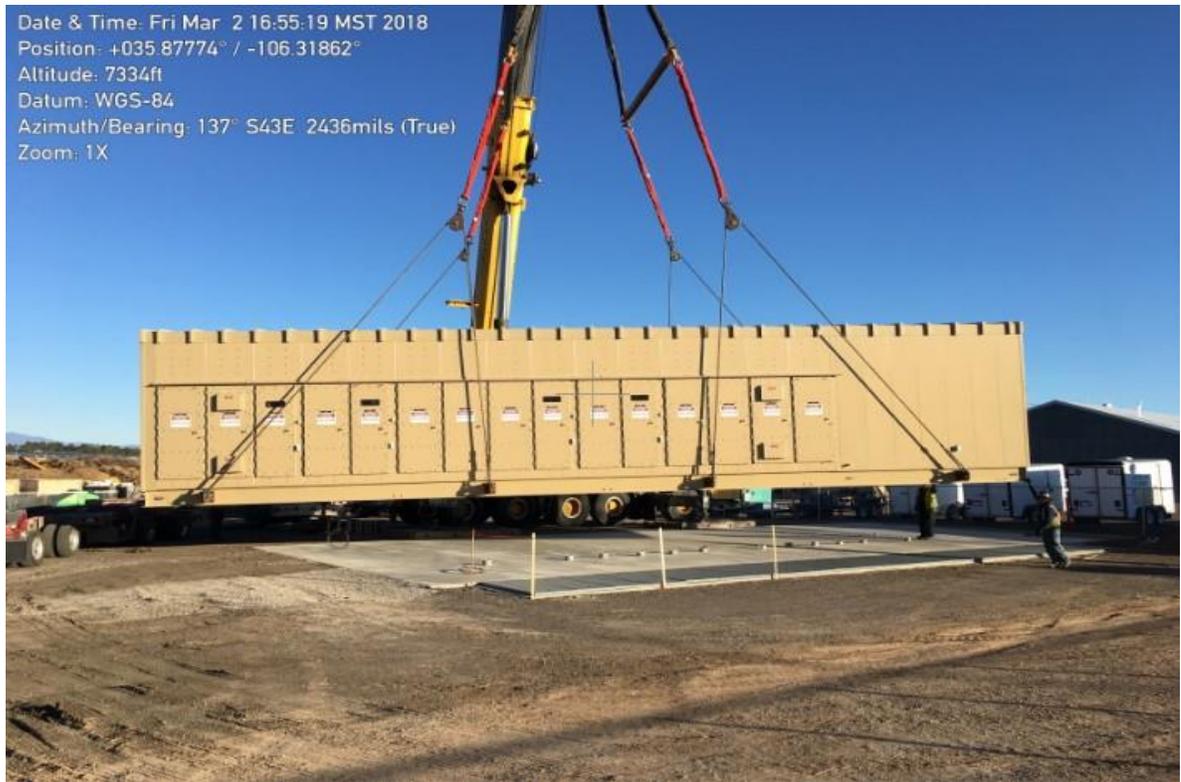
Figure 6.

During the installation of the LANL TA-3 substation replacement project, LACU added a second switching substation, Los Alamos Switchgear Substation, "LASS". The LASS substation is installed next to the Eco Center site. The new LASS substation was installed in December of 2018 awaiting the completion of the new TA-3 Substation and the installation of new LC1 and LC2 feeders to connect the two stations. The installation of the LASS feeders LC-1 and LC-2 are scheduled for Spring FY23. Procurement is in the process of purchasing a new cable pulling machine. The lead time on the new machine is 4 months. The connection should be completed by Fall 2023.

Figures 6 ,7,8,9 show the Los Alamos Switch Station Installation.

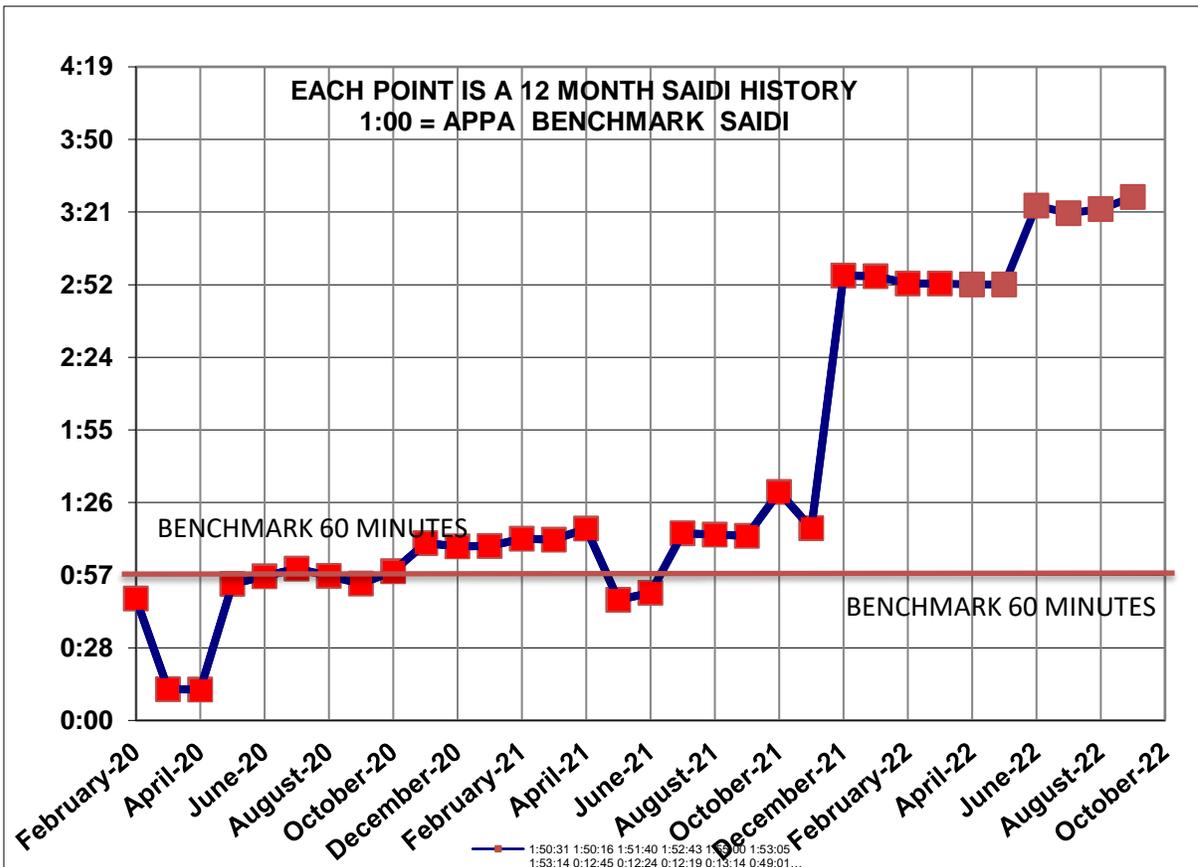
The calculations are based on a 12-month history. All outages' effects will remain in the calculations for one year as demonstrated in Figure 10.

Figure 10. Graph of LAC SAIDI with 60-minute TARGET

Tables 8 & 9 & 10 below summarize the system reliability improvement projects (SRIP) completed by LACU since 2011 and Figure 8 in page 18 illustrates the SAIDI over the same period. As illustrated, LACU can't overlook the positive impacts of the SRIP with the SAIDI. Also, the SRIP helped mitigate and correct system deficiencies which would otherwise have impacted the deficient SAIDI even more.

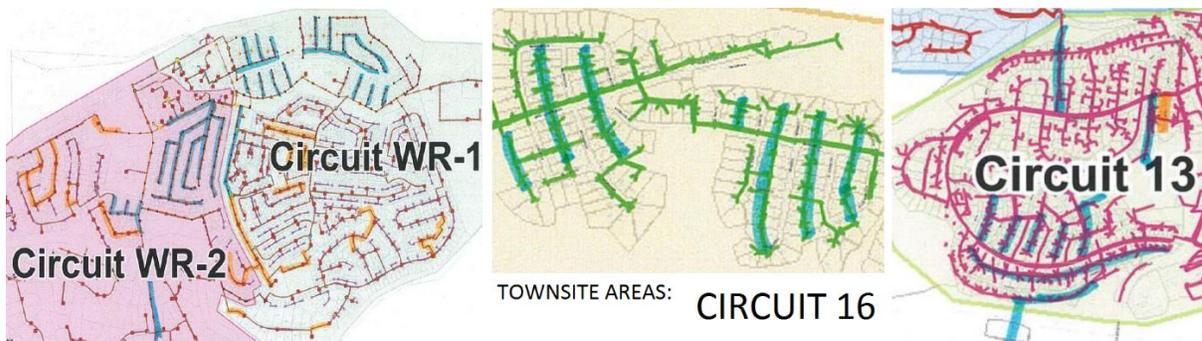
The OH and UG systems have repair and replacement challenges which may impact the SAIDI as replacement projects are underway. Figure 11. illustrates a map area of inaccessible areas due to right-of-way encroachment or customer blockage. Having inadequate work access or having to work around landscaped areas, etc., make it difficult for LACU to replace rotten poles and overloaded transformers. For the UG system, having to dig in and around areas congested with buried utilities makes it difficult to dig for routine repairs; more so when having to install replacement lines.

Figure 11. Areas not readily accessible

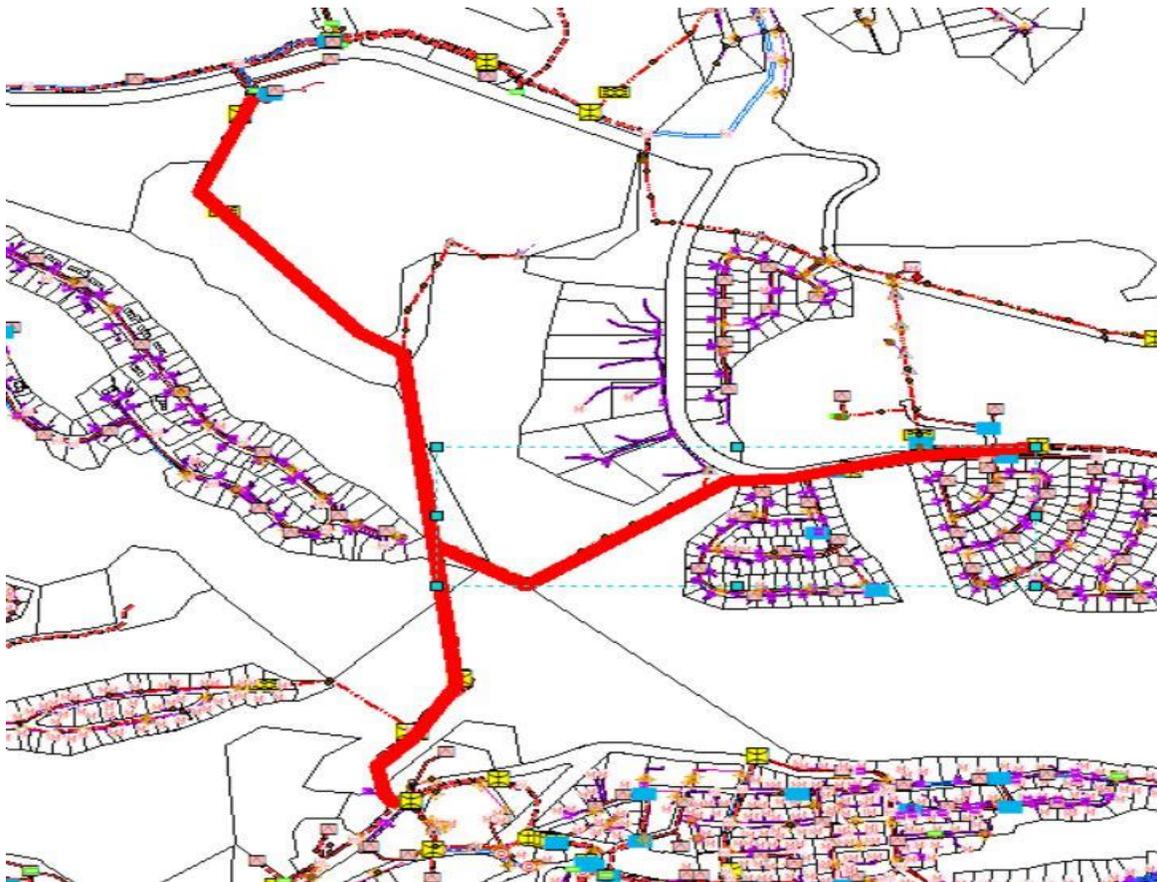
The department hired contractors to replace overhead line sections across canyons from Canyon Road to Diamond Drive and San Idelfonso. Figure 12. shows OH line sections replaced. The department also replaces poles in a continuous effort to maintain the system. Sections of the overhead conductor wire which have been in service over 50 years; particularly those areas which contain obsolete CWC (copper-weld-copper) wire. The replacement of these sections is an ongoing process in house.

Figure 12. Pole and Conductor Replacement Project 2015

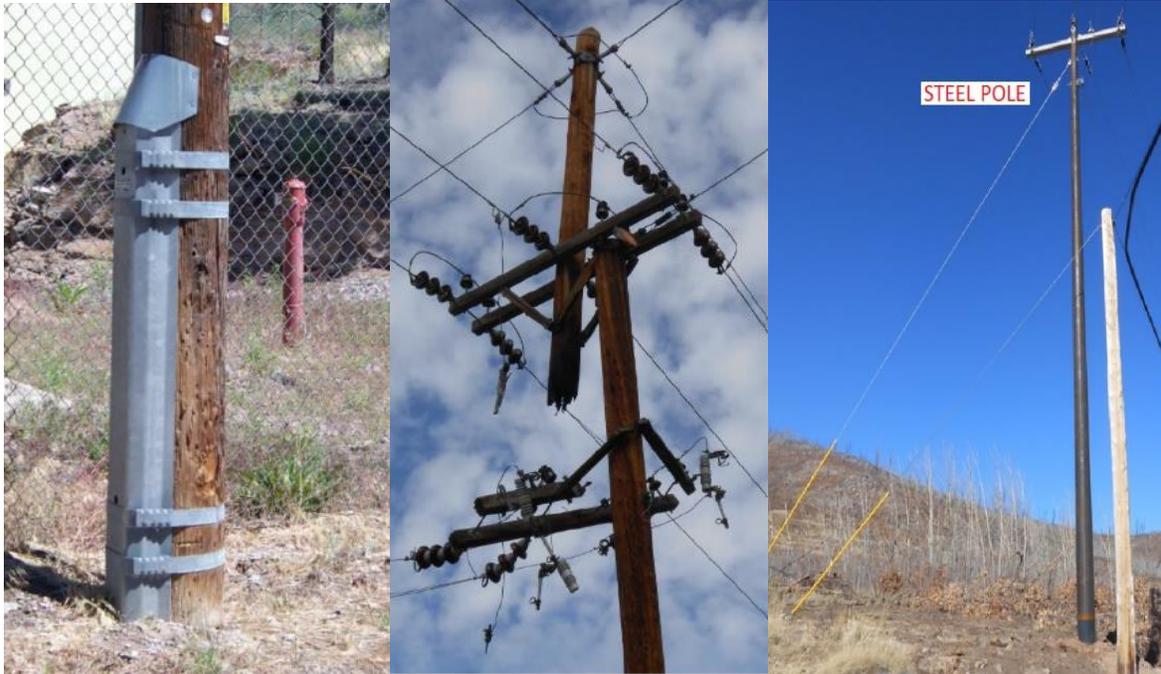
Inspections were performed again in 2013, 2018, and 2021 all system poles were re-inspected and treated again; approximately 150 poles were rejected. In 2013 LACU started an overhead maintenance crew to primarily focus on overhead pole & cross-arm replacement and tree trimming. To date, LACU’s in-house crews have replaced over 250 utility poles. To replace rejected and braced poles at inaccessible locations as illustrated in Figure 11., the department purchased a back-yard pole setting unit and purchased a truck load of steel poles. Steel poles weigh approximately 50% of what a wood pole type Douglas fir weighs; but cost twice as much. Figure 13. illustrates a typical braced pole and a new steel pole.

Figure 13. Typical braced pole & backbone broken pole; & new Steel Pole

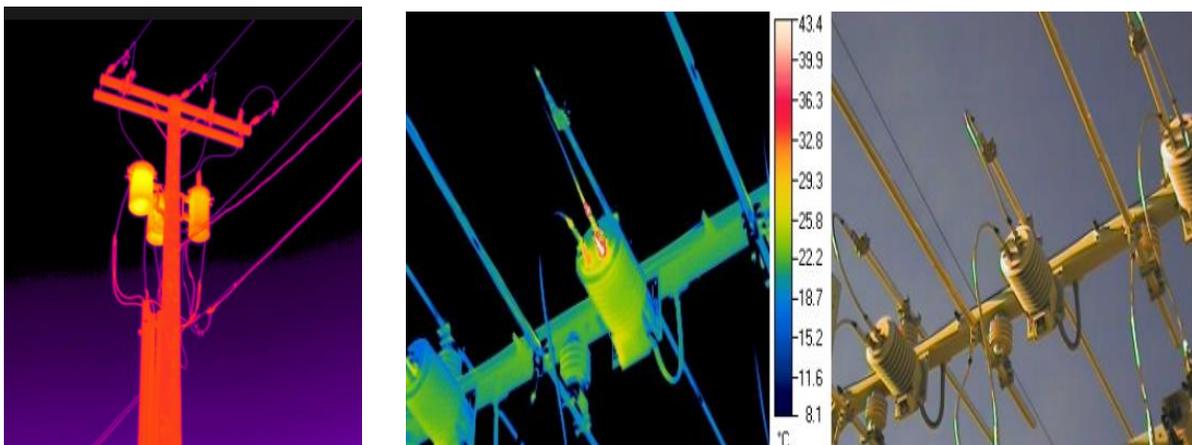
During the winter, the department will continue to *infra-red* critical sections of the underground and overhead systems to look for hot spots as illustrated in Figure 14. Hot spots are areas that have loose connections leading to high-resistant points; these points will eventually burn up, fail, and cause a power outage.

Figure 14. Infra-red picture for transformer pole & air break switch

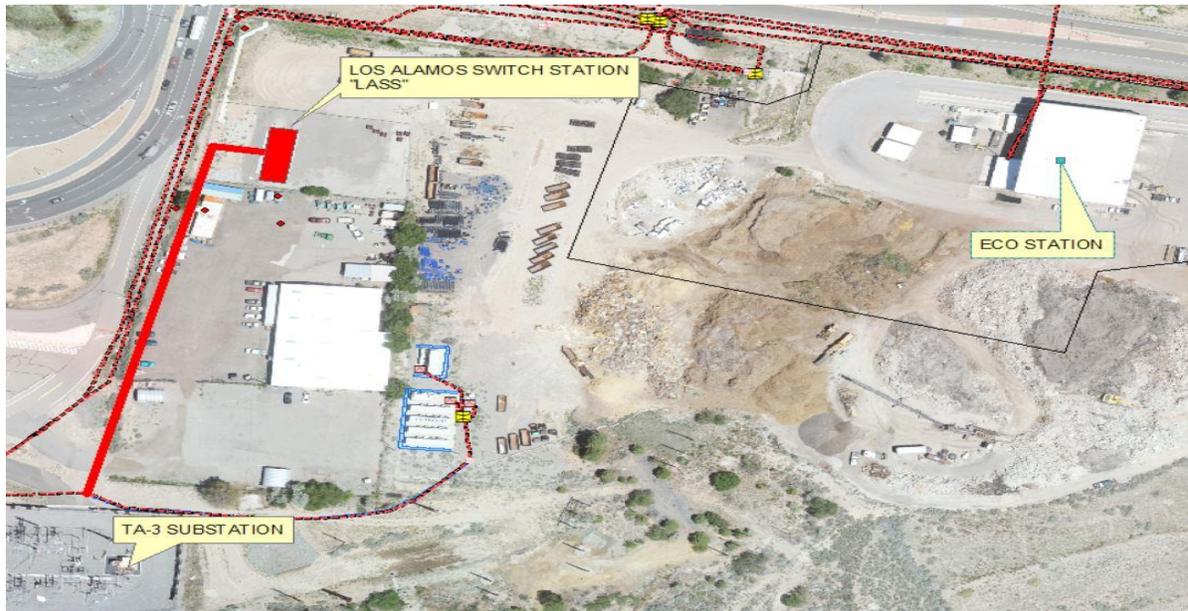
The top reliability project for LACU is the construction of the new LASS Substation addition near the County landfill as illustrated in Figure 17. The LASS Substation is needed to maintain the SAIDI target into the future. LASS is also critical to the supply of steady and reliable electric power to the residents of the Los Alamos Townsite; more so if the Townsite area is expected to grow electrically.

Figure 17. LASS station Location Relative to LANL

The LASS substation will relieve load from the existing Townsite Substation. The station will tie to TA-3 on breakers LC1 and LC2. Under existing conditions and for a TC1 feeder outage, the Townsite peak demand exceeds the TC2 feeder ampacity rating as illustrated in Table 5. below. The loading condition may worsen as Los Alamos County succeeds in bringing in electrical growth addition at the former 901 Trinity Site and DP Road.

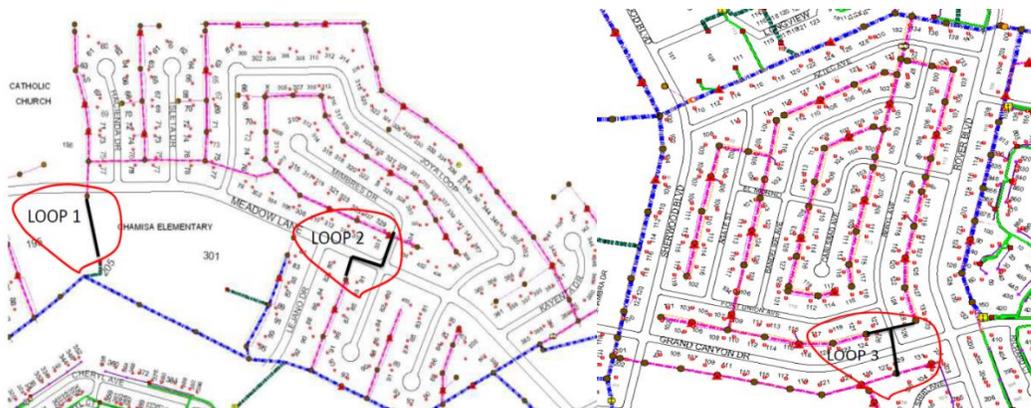
Major underground replacement projects or additions were constructed in the past: 0.8 mile, WR2 Loop Addition, 1.2-mile, Canyon Road Rebuild Project, and 1.0 mile, Tsikumu Village Primary Replacement Project. The three projects had become burdensome to LACU customers and affected the SAIDI year after year. The projects not only replaced the failed underground sections but also added three phase power line sections and new single phase primary loops. Each project cost in the neighborhood of \$500K and it will be difficult to sustain those type of projects in the future without impacting utility rates. Costs for materials are rising rapidly. Major underground capital replacement projects have been identified in the immediate future by the asset management team, see Appendix C. LACU is prepared to deal with major SAIDI impact projects as they may arise in the future. A list of major projects includes the Los Pueblos and Totavi area, La Senda and Pajarito Acres, Timber Ridge, La Vista and Big Rock Loop. Other long term UG projects which will provide long-term reliability improvement is the addition of new UG or OH Loops. LACU has many radial lines which power anywhere from 30 to 100 customers; a failure on the radial line leaves few alternatives to restore power in a timely fashion. By identifying these long radial power lines, LACU can install new Loops within reasonable costs. Figure 19. illustrates priority areas for Loop additions in White Rock.

Figure 19. Single Phase Loop Addition Targets in White Rock

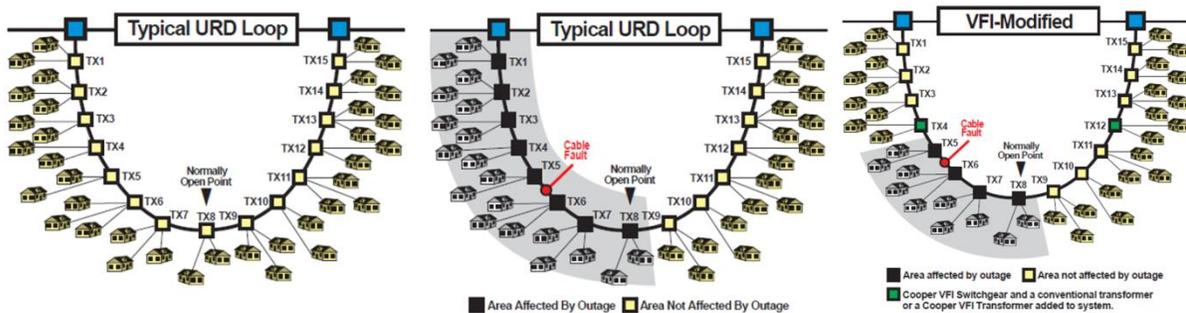
Therefore, LACU must look at other engineering solutions in identifying and isolating failed line sections so that no secondary or residual failures occur. Figure 20. illustrates a reasonable engineering solution (\$8K per VFI transformer) where faults can be detected, identified to smaller line segments, and allows LACU linemen to safely re-route power without utilizing elbows or fuses. The VFI solution will simply trip the interrupter in a safe manner and no secondary failures.

Figure 20. VFI Transformer Fault Isolation & Restoration Solution

The LACU has many underground subdivisions with single phase primary laterals with 10+ transformers configured in a daisy-chain. When LACU experiences a faulted line section, it must identify the fault, isolate it, then back feed the outage area from a new power source. Back feed is done by manually transferring electrical load with a 200-amp elbow; at least two times during the restoration process. With continual line section failures, the manually back feeding process is resulting in secondary and residual failures, i.e. elbows or other weakened points.

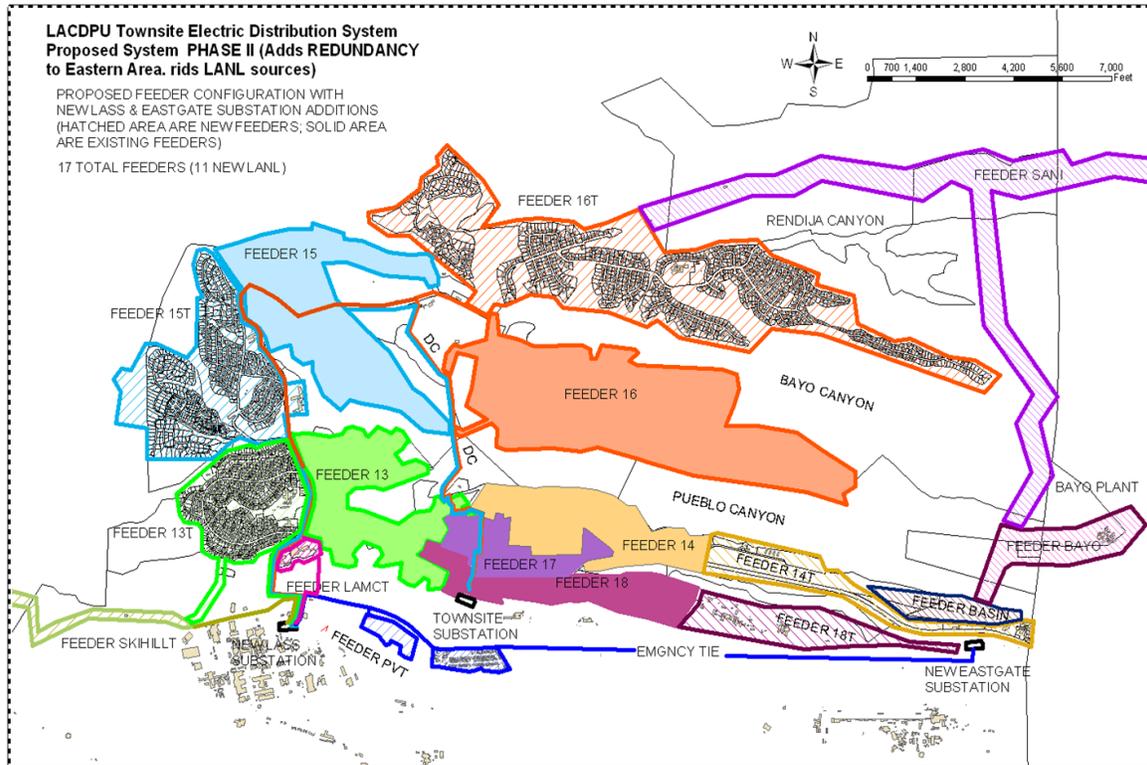
Figure 14 illustrates the added redundancy to the east side of Los Alamos with the addition of the new East gate substation. The substation adds new feeders for the DP road area (18T), Pajarito Cliffs Site, Bayo Plant, San Idelfonso, and a new feeder 14T to add redundancy to the Townsite substation's Feeder 14. This project would be in the 5–7-year outlook. An alternative prime location is the east side of TA-21. If and when the TA-21 area is converted to county ownership.

Figure 21. Los Alamos distribution area with LASS and East gate substation addition (when compared with Figures 18 & 9)

The proposed East gate substation is similar in need to the LASS substation except that it provides a power source and feeder redundancy to the east side of Los Alamos. The substation need will be in proportion to the electrical needs for development along DP Road and the Camino Entrada area. The LAC-LANL jointly owned EA4 feeder is 9 miles in length and spans across rough mesa terrain from Pueblo to Rendija Canyons. The EA4 feeder provides power to the wastewater treatment Plant, water wells and pumps along Rendija Canyon, and to the San Idelfonso - Totavi area. The age and condition of the EA4 feeder, construction ability, and inaccessibility may prove to be an unreliable feeder source into the future without major capital investment. Also, power outages to the EA4 feeder may shut-down critical LAC water and wastewater treatment facilities unpredictably. Replacement costs for the EA4 feeder will exceed 2 million dollars.
