LOS ALAMOS COUNTY DEPARTMENT OF PUBLIC UTILITIES

FY 2023 ELECTRIC RELIABILITY PLAN

Stephen Marez, PE, PMP
Deputy Utility Manager
Electric Distribution

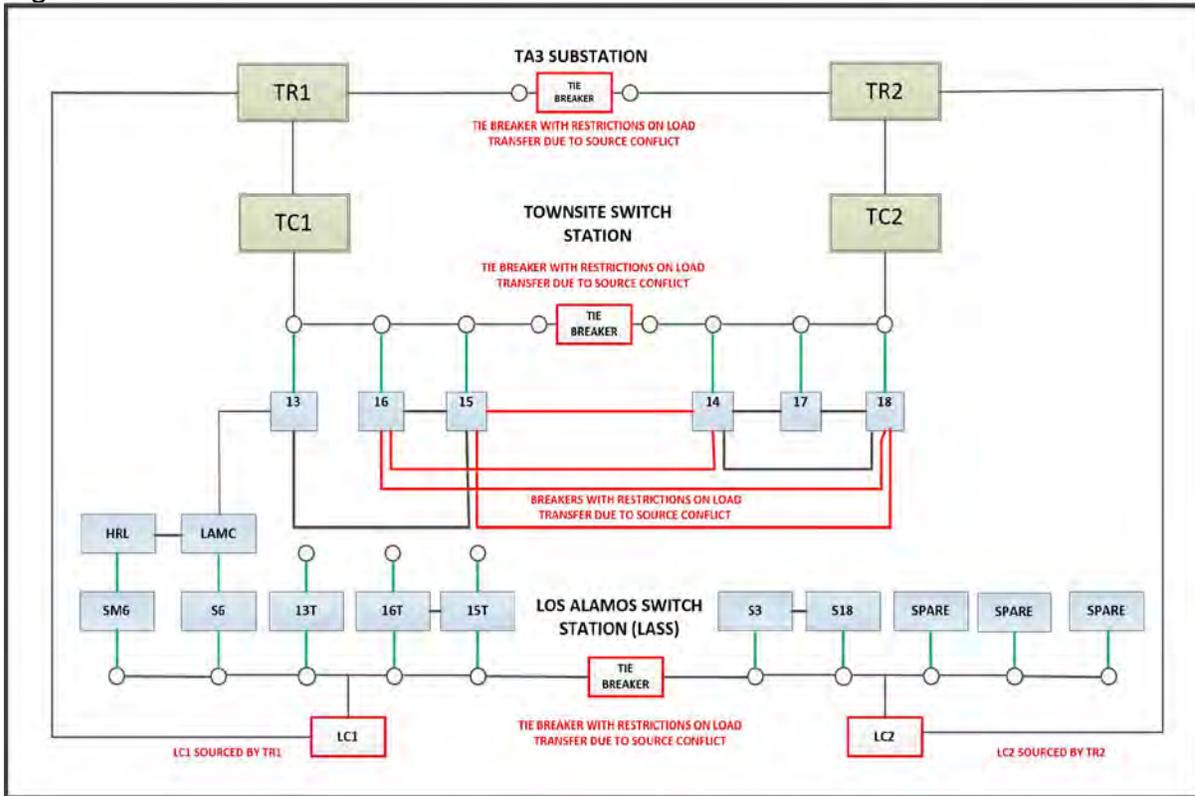
Figure 1. Los Alamos Townsite and Future Los Alamos Switch Station

The LACDPU distribution system is supplied by two substations, LANL TA-3 and White Rock. Figure 1. shows how the Los Alamos townsite is fed by LANL's TA-3 substation via two 15 KV express feeders, TC-1 and TC-2. The Townsite switch station bus is configured into two sections, half-bus for TC-1 and half-bus for TC-2. Upon loss of power to TC1 or TC2, LACDPU can manually transfer the outage bus-section to the energized bus-section. The LASS Station will be connected as shown.

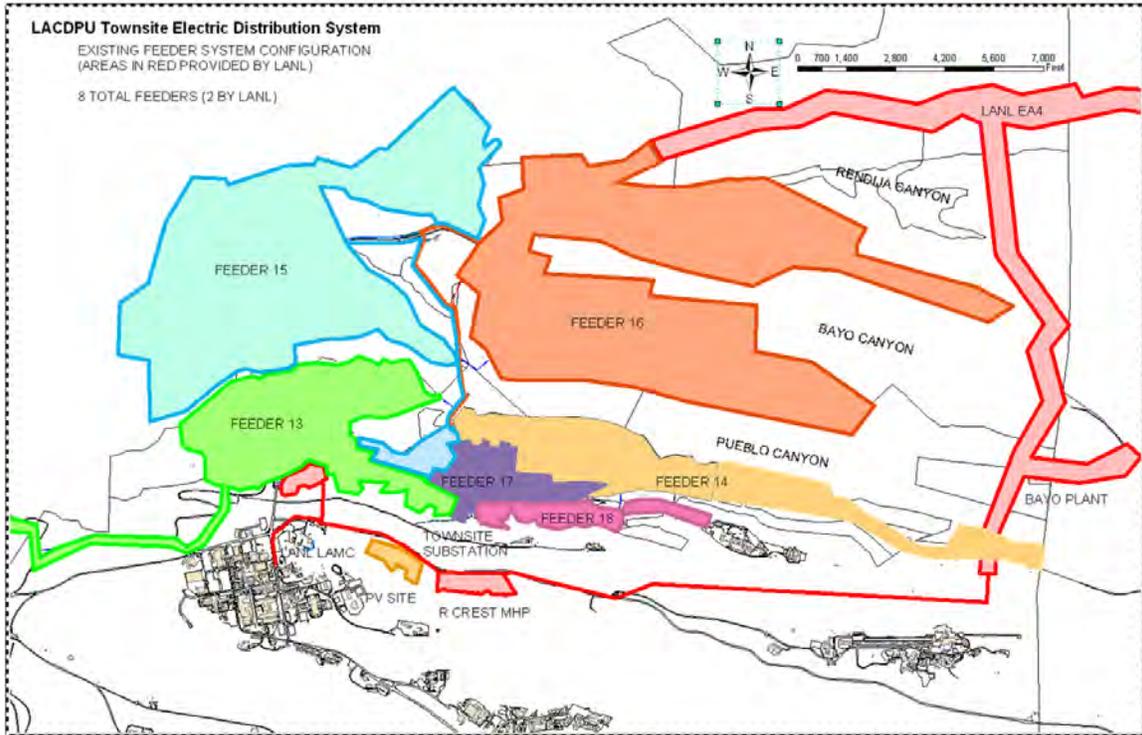
Figure 2. Existing Los Alamos Distribution Area

Figure 2. Illustrates the townsite feeder areas.

Canyons, and Totavi in San Idelfonso Pueblo. Overall, eight (8) distribution feeders serve the Los Alamos community as illustrated in Figure 2.

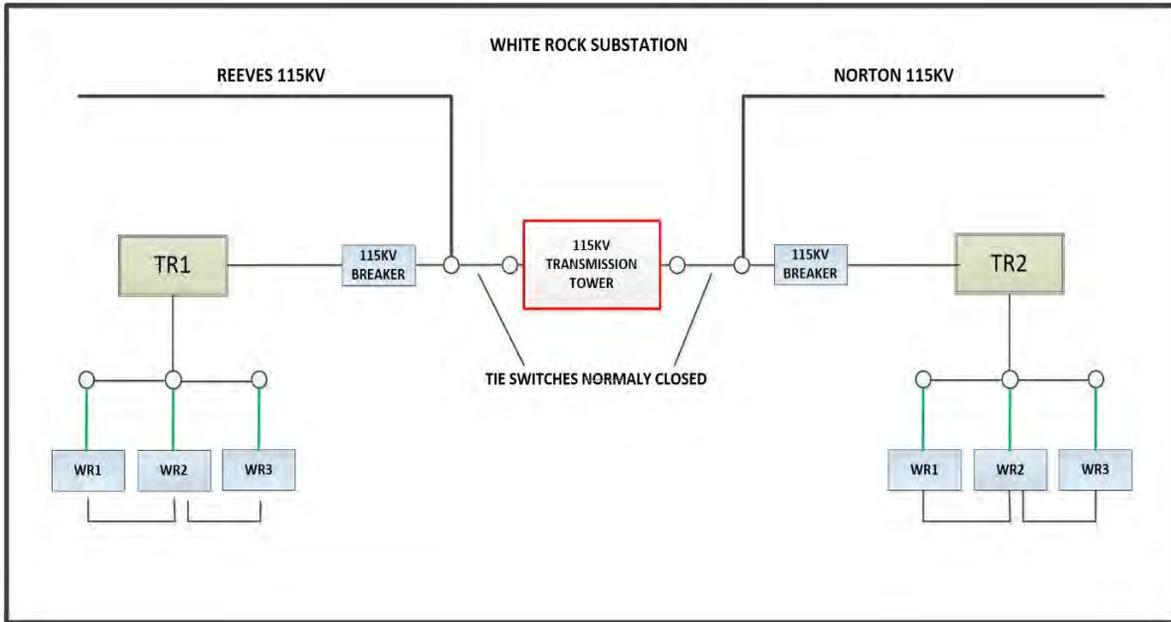
Figure 3. White Rock Substation Configuration.

The White Rock substation provides power to the White Rock community and consists of primary and back-up 115KV to 12.47 KV transformers with metal-clad switchgear as illustrated in Figure 3. The primary feed TR1 was installed in 2006 and consists of a 10 MVA transformer with metal-clad switchgear. The secondary back-up feed TR2 is the original 50 year old 7.5 MVA transformer and new metal-clad switchgear installed in 2019. The TR2 transformer is also fitted with new primary side breakers. Service is transferred to TR2 when transmission line service is required by LANL or if maintenance on TR1 facilities are required.

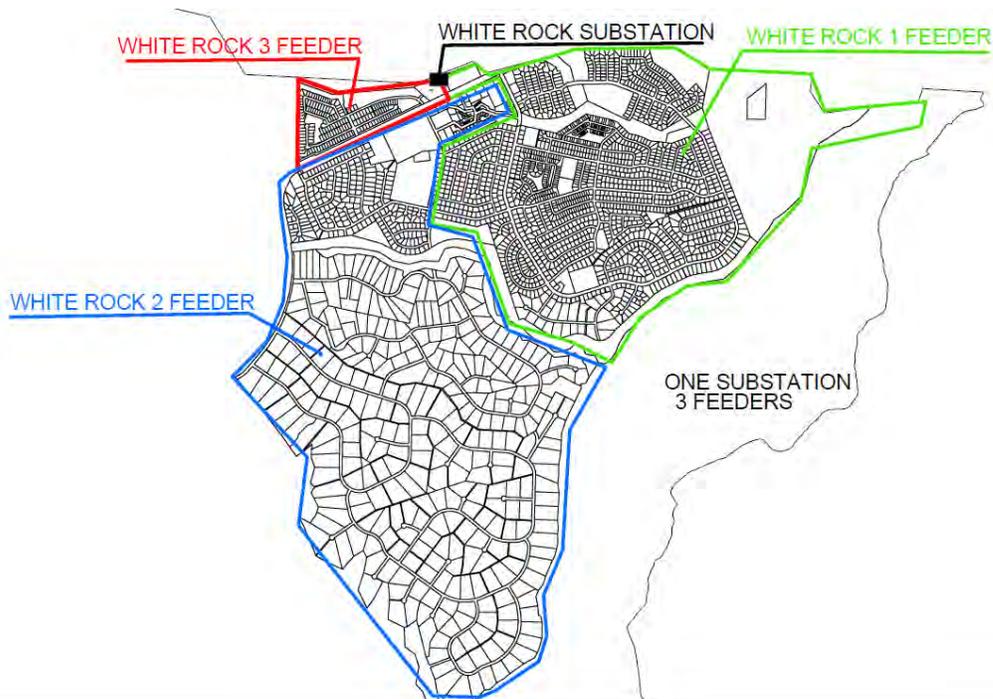
Figure 4. White Rock Distribution Areas

Circuit WR1: East of Rover, Circuit WR2: West of Rover,
Circuit WR3: El Mirador Subdivision

Figure 4. Illustrates the White Rock Feeder Areas

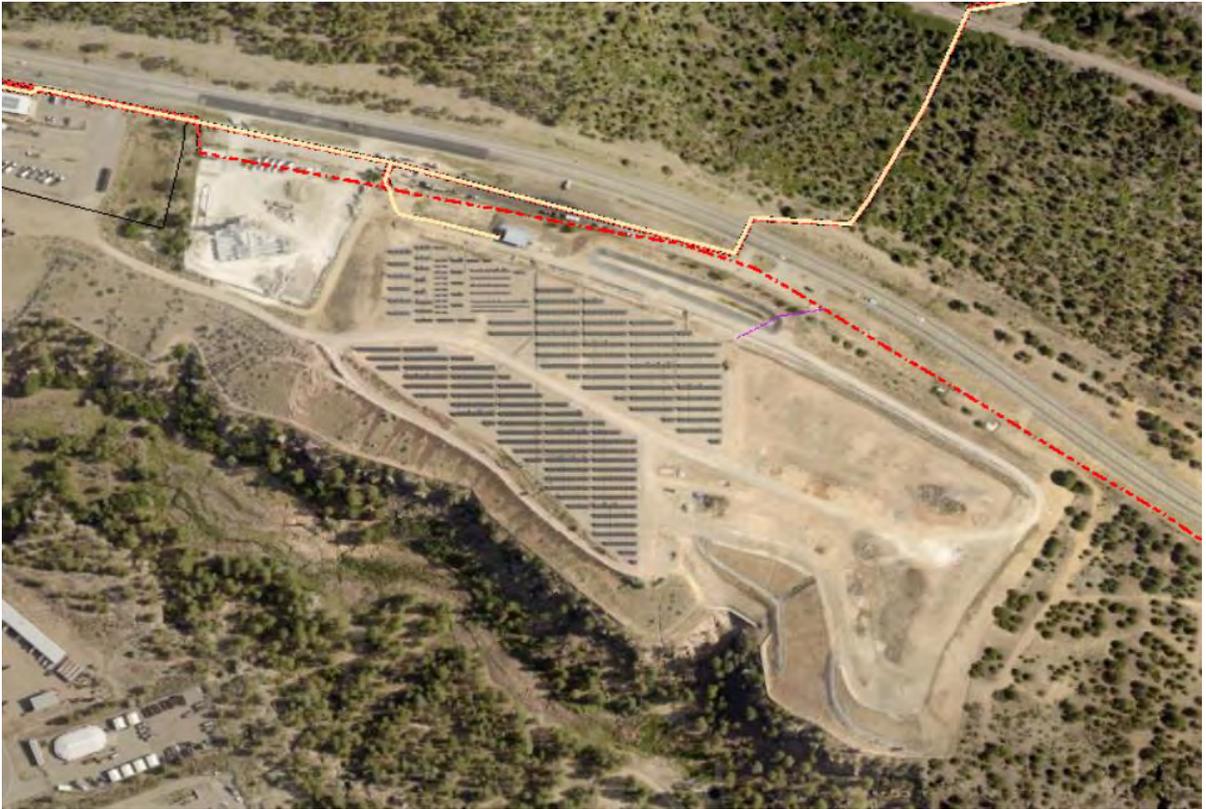
Figure 5. PV site

Figure 5. Illustrates the PV site location.

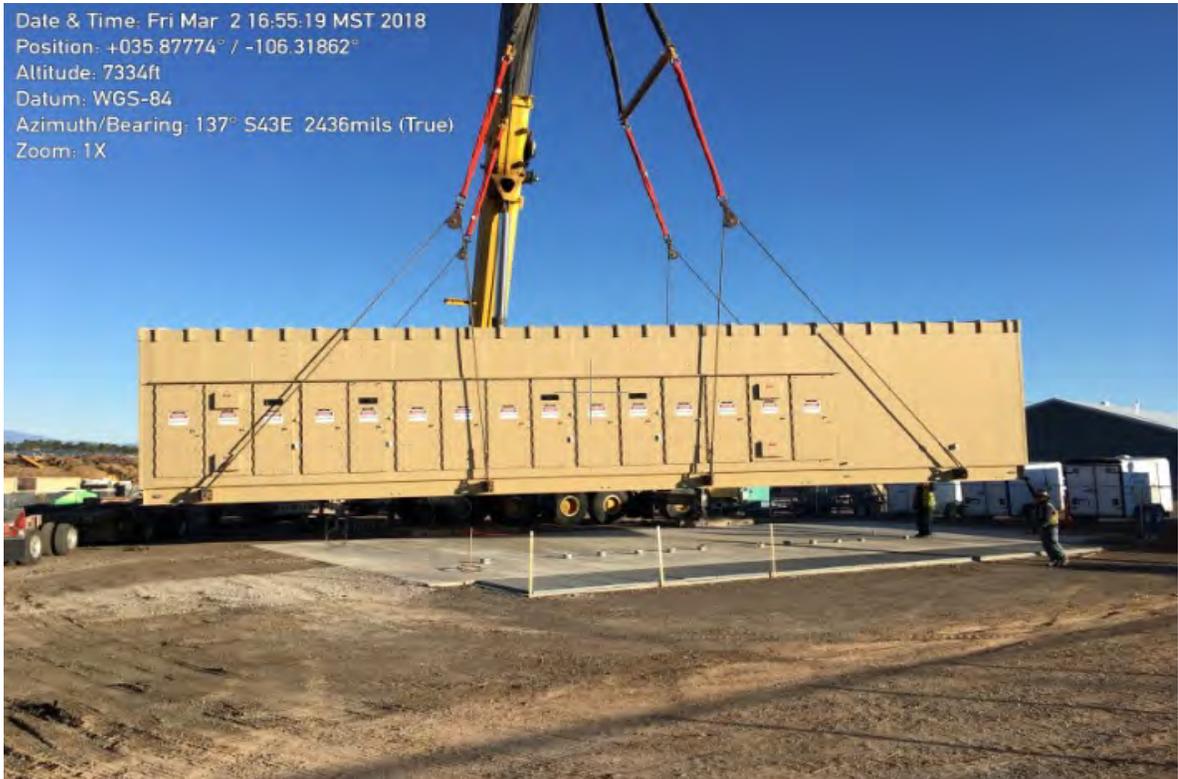
Figure 6.

Figures 6 ,7,8,9 show the Los Alamos Switch Station Installation.

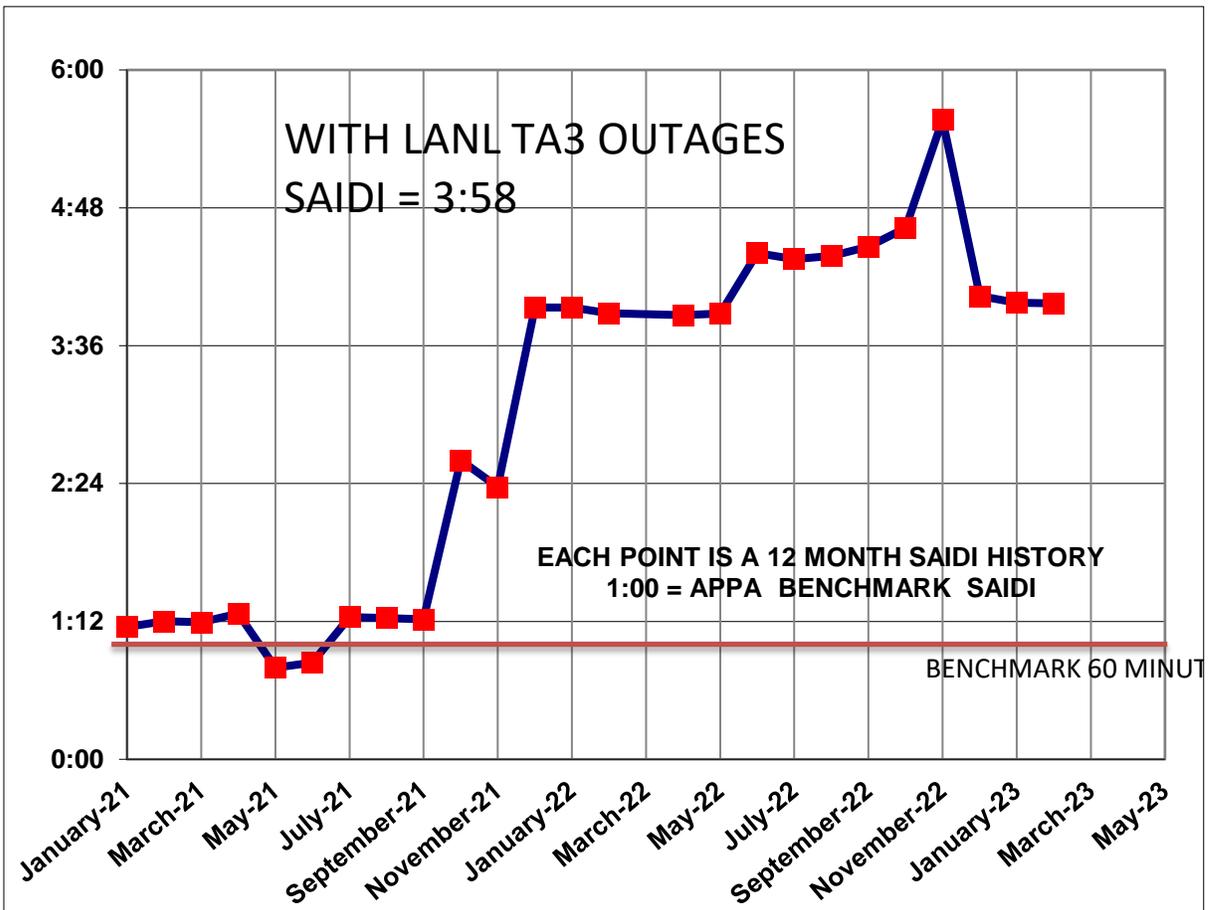
Figure 10. Graph of LAC SAIDI with 60-minute TARGET

The calculations are based on a 12-month history. All outages' effects will remain in the calculations for one year as demonstrated in Figure 10.

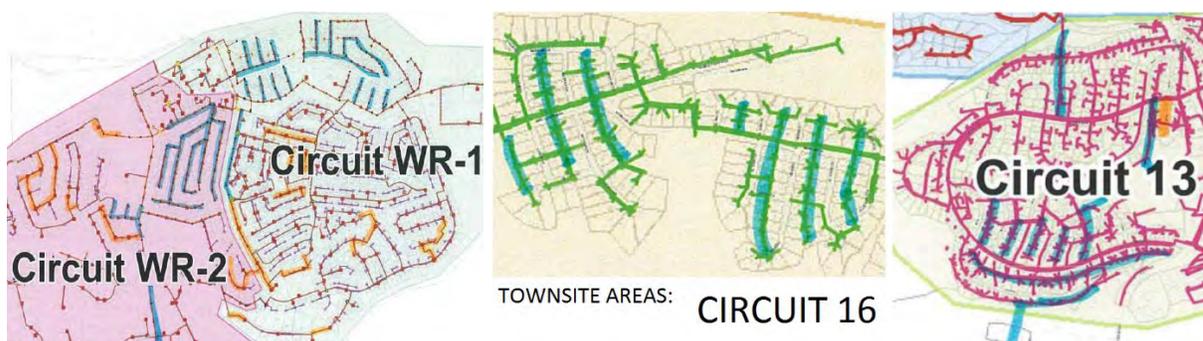
Figure 11. Areas not readily accessible

The OH and UG systems have repair and replacement challenges which may impact the SAIDI as replacement projects are underway. Figure 11. illustrates a map area of inaccessible areas due to right-of-way encroachment or customer blockage. Having inadequate work access or having to work around landscaped areas, etc., make it difficult for LACDPU to replace rotten poles and overloaded transformers. For the UG system, having to dig in and around areas congested with buried utilities makes it difficult to dig for routine repairs; more so when having to install replacement lines. The cover sheet photo illustrates the use of the back yard unit to repair lines inaccessible to service trucks.

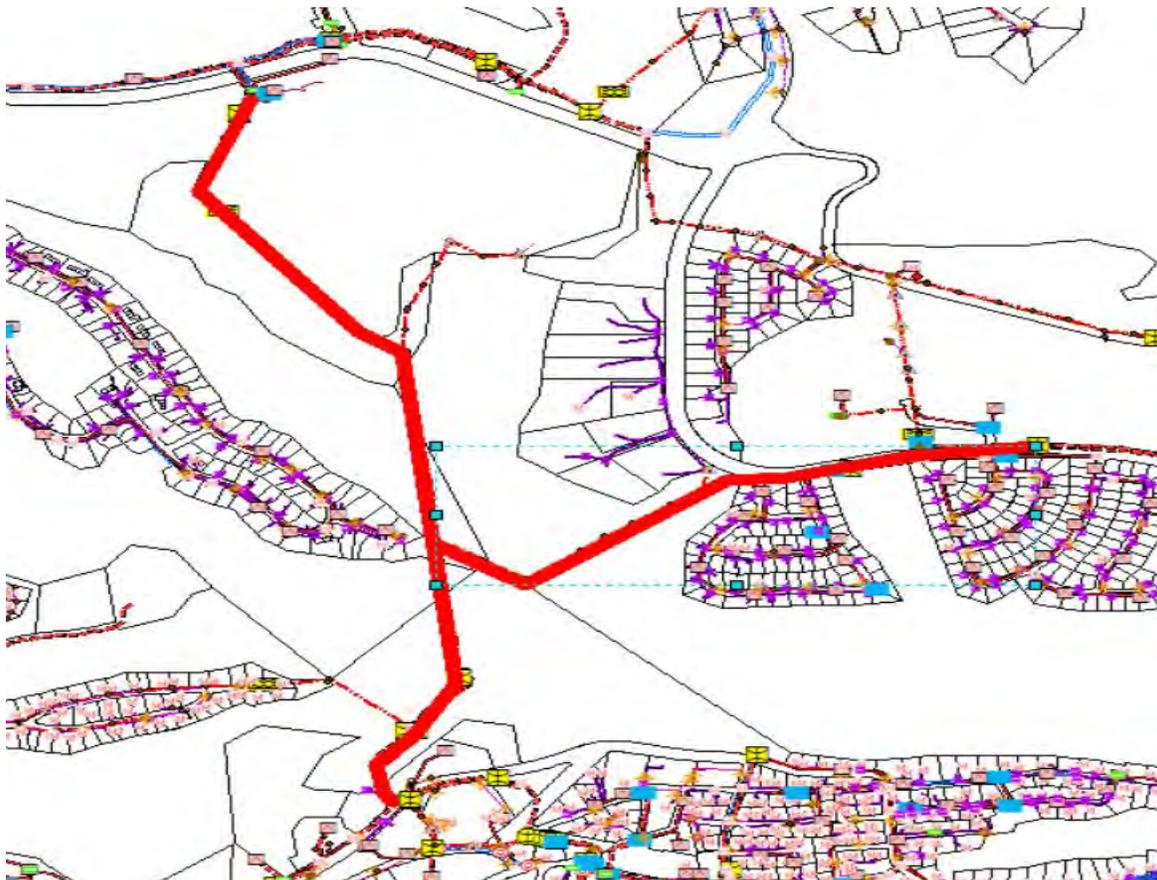
Figure 12. Pole and Conductor Replacement Project 2015

The department hired contractors to replace overhead line sections across canyons from Canyon Road to Diamond Drive and San Idelfonso. Figure 12. shows OH line sections replaced. The department also replaces poles in a continuous effort to maintain the system. Sections of the overhead conductor wire which have been in service over 50 years; particularly those areas which contain obsolete CWC (copper-weld-copper) wire. The replacement of these sections is an ongoing process in house.

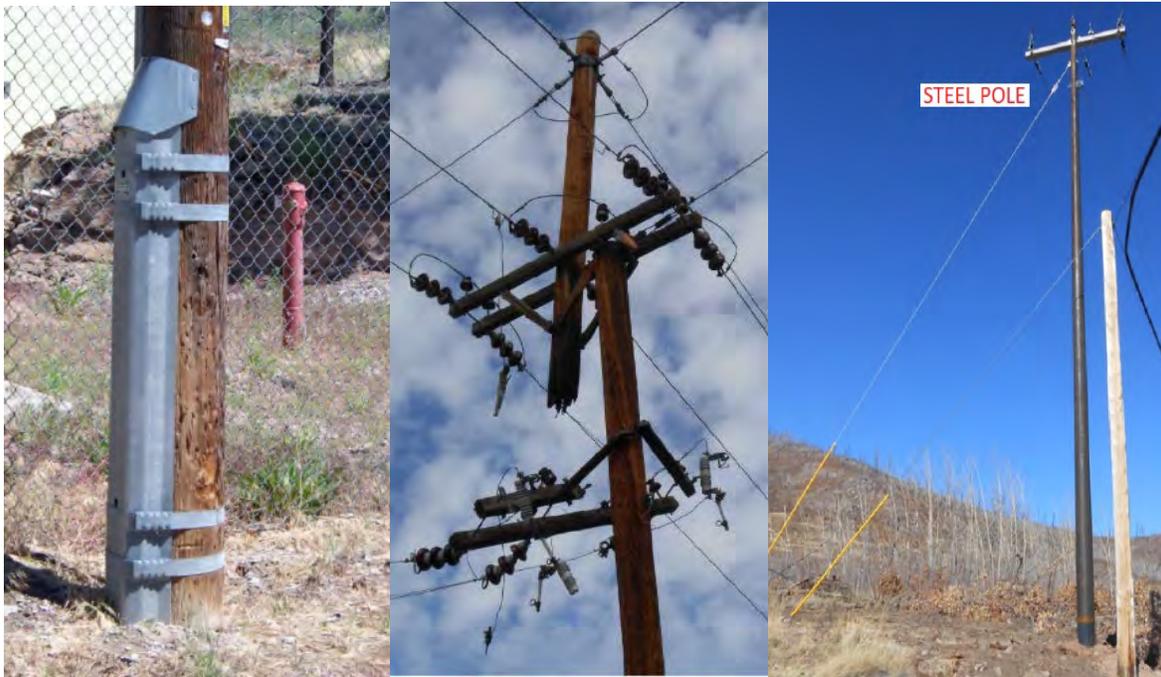
Figure 13. Typical braced pole & backbone broken pole; & new Steel Pole

Inspections were performed again in 2013, 2018, and 2021 all system poles were re-inspected and treated again; approximately 150 poles were rejected. In 2013 LACDPU started an overhead maintenance crew to primarily focus on overhead pole & cross-arm replacement and tree trimming. To date, LACDPU's in-house crews have replaced over 250 utility poles. To replace rejected and braced poles at inaccessible locations as illustrated in Figure 11., the department purchased a backyard pole setting unit and purchased a truck load of steel poles. Steel poles weigh approximately 50% of what a wood pole type Douglas fir weighs; but cost twice as much. Figure 13. illustrates a typical braced pole and a new steel pole. Future inspection contract planned for 2025.

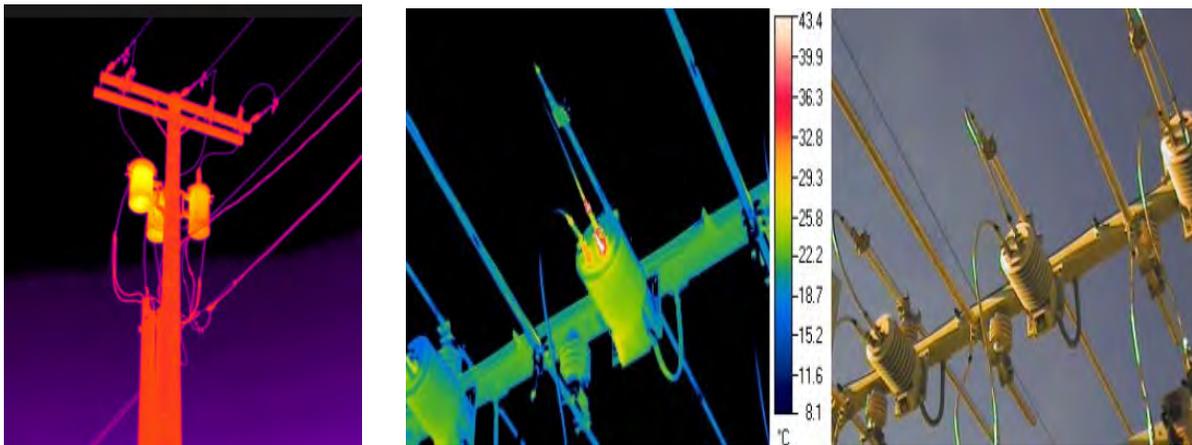
Figure 14. Infra-red picture for transformer pole & air break switch

During the winter, the department will continue to *infra-red* critical sections of the underground and overhead systems to look for hot spots as illustrated in Figure 14. Hot spots are areas that have loose connections leading to high-resistant points; these points will eventually burn up, fail, and cause a power outage.

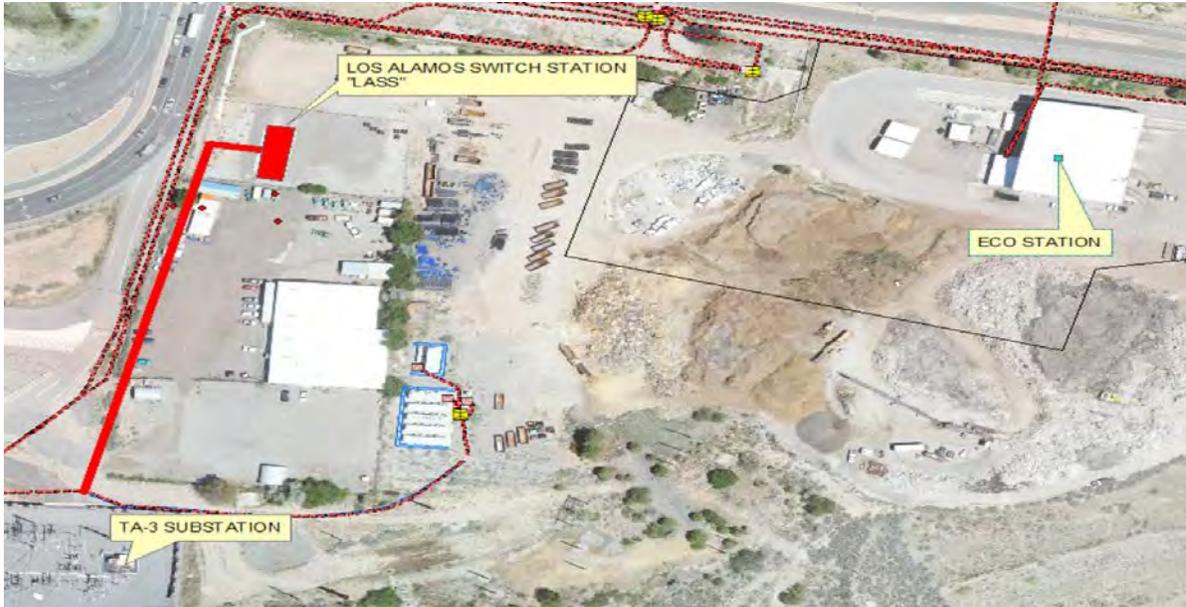
Figure 17. LASS station Location Relative to LANL

The top reliability project for LACDPU is the construction of the new LASS Substation addition near the County landfill as illustrated in Figure 17. The LASS Substation is needed to maintain the SAIDI target into the future. LASS is also critical to the supply of steady and reliable electric power to the residents of the Los Alamos Townsite; more so if the Townsite area is expected to grow electrically.

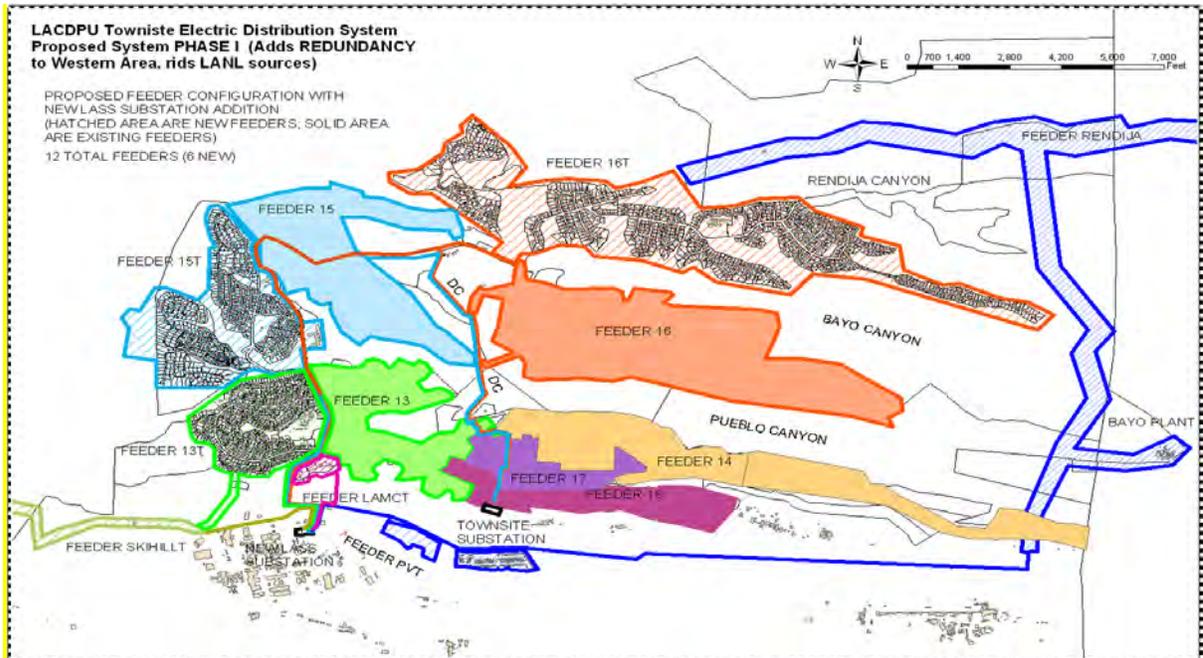
Figure 18. Los Alamos distribution area with LASS substation addition (when compared with Figure 2.)

The LASS Substation will add feeder sources to maintain and improve the SAIDI and the system reliability in the Townsite area as illustrated in Figure 18. and as follows:

1. Reduce the number of customers on Townsite substation feeders 13, 15, & 16 (by moving half the customers on those feeders to LASS).
2. Provide new feeders 13T, 15T, 16T, S6, SM6.

3. Provide power to LACDPU customers with LACDPU power lines and not from LANL power lines, i.e., Transfer Station, LAMC (S6), Elk Ridge MH Park.
4. Add 50% additional system redundancy during scheduled or unscheduled outages to Townsite Substation Feeders. Feeders 13T, 15T, & 16T on LASS can back feed feeders on Townsite 13, 15, 16, Ski Hill and LAMC.

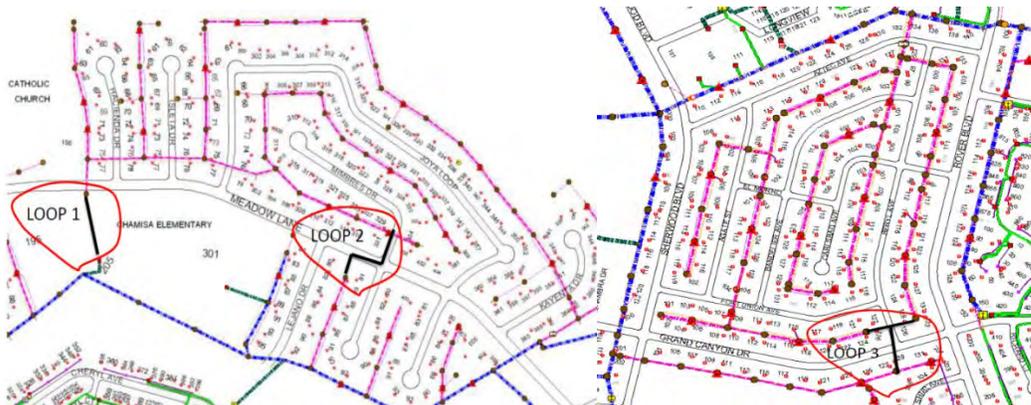
Figure 19. Single Phase Loop Addition Targets in White Rock

Other long term UG projects which will provide long-term reliability improvement is the addition of new UG or OH Loops. LACDPU has many radial lines which power anywhere from 30 to 100 customers; a failure on the radial line leaves few alternatives to restore power in a timely fashion. By identifying these long radial power lines, LACDPU can install new Loops within reasonable costs. Figure 19. illustrates priority areas for Loop additions in White Rock.

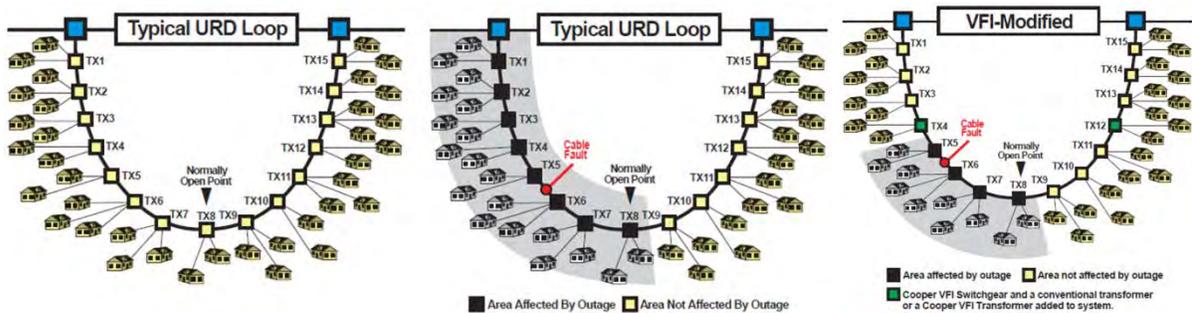
Figure 20. VFI Transformer Fault Isolation & Restoration Solution

Therefore, LACDPU must look at other engineering solutions in identifying and isolating failed line sections so that no secondary or residual failures occur. Figure 20. illustrates a reasonable engineering solution (\$8K per VFI transformer) where faults can be detected, identified to smaller line segments, and allows LACDPU

linemen to safely re-route power without utilizing elbows or fuses. The VFI solution will simply trip the interrupter in a safe manner and no secondary failures.

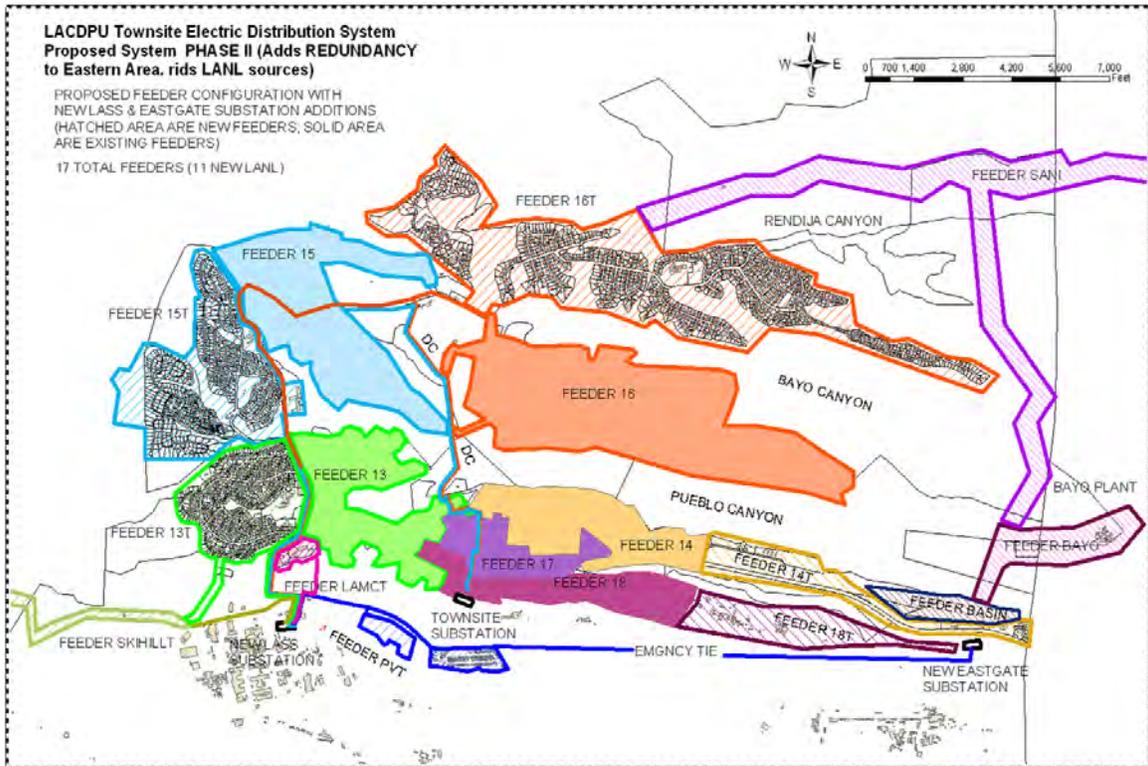
Figure 21. Los Alamos distribution area with LASS and East gate substation addition (when compared with Figures 18 & 9)

Figure 21. illustrates the added redundancy to the east side of Los Alamos with the addition of the new East gate substation. The substation adds new feeders for the DP road area (18T), Pajarito Cliffs Site, Bayo Plant, San Idelfonso, and a new feeder 14T to add redundancy to the Townsite substation's Feeder 14. This project would be in the 5–7-year outlook. An alternative prime location is the east side of TA-21. If and when the TA-21 area is converted to county ownership.
