## INCORPORATED COUNTY OF LOS ALAMOS SERVICES AGREEMENT

**Exhibit “D”**  
**Water Production Facilities Electrical and Mechanical Condition**  
**Assessment Conducted by Molzen Corbin, March 2022**  
**AGR22-68**

**ELECTRICAL AND  
MECHANICAL  
CONDITION  
ASSESSMENT**

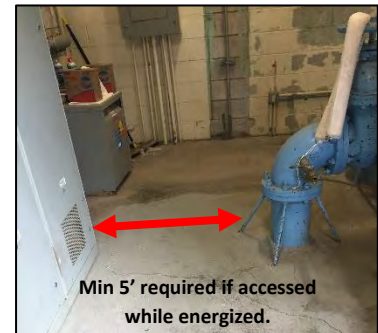
- There are electrical code clearance issues in the front of the equipment to the adjacent process piping. *National Electrical Code (NEC) Article 110.34 Working Space and Guardians*, requires 5 feet minimum.

- The age of the equipment is beyond the life expectancy.
- Lighting Panel and Step-Down Transformer:
  - The step-down transformer and lighting panel are in operational condition but are beyond their life expectancy.

- Instrumentation:
  - 8" flow meter - Krohne / Mag / Model Number = IFM 4020-D-Hart-6 LAS 2-S / Serial Number = 1217 / 03 / 2002 / Condition = GOOD.
- Mechanical:
  - 12" gate valve - Manual / MH V&F Co. / 1965 / Condition = FAIR.
  - 8" gate valve - Manual / MH V&F Co. / 1965 / Condition = FAIR / Drain Line.
- SCADA:
  - The local control panel is antiquated and beyond its life expectancy. The SCADA control are necessary to remain in place to automatically control the system until a SCADA improvements study and project is implemented.
