LOS ALAMOS COUNTY DEPARTMENT OF PUBLIC UTILITIES

2021 ELECTRIC RELIABILITY PLAN

Stephen Marez, PE, PMP
Electrical Engineering Manager,
Electric Distribution

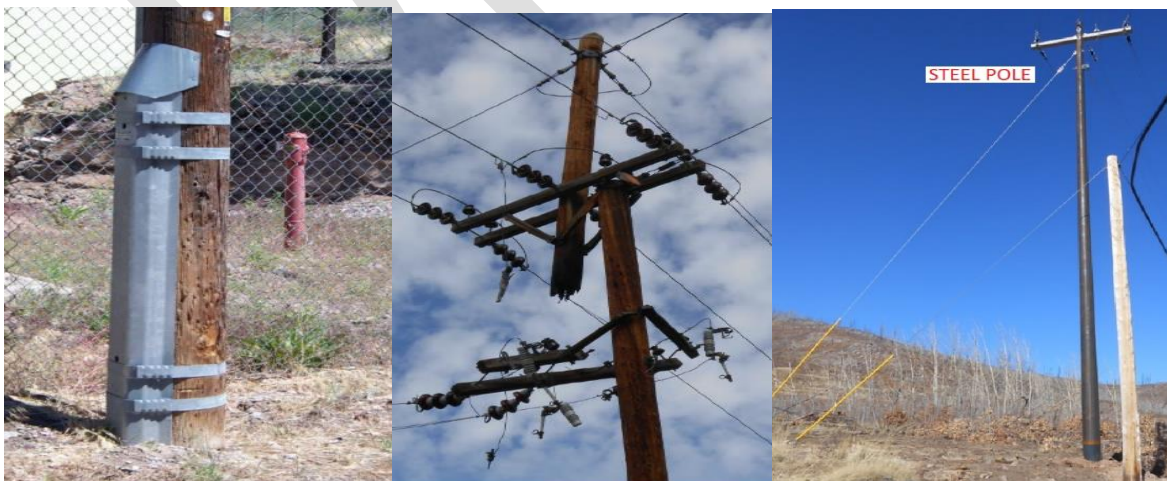
Figure 14. Typical braced pole & backbone broken pole; & new Steel Pole

Inspections were performed again in 2013, 2018, and 2021. In 2013 DPU started an overhead maintenance crew to primarily focus on overhead pole & cross-arm replacement and tree trimming. To date, DPU's in-house crews have replaced over 250 utility poles. To replace rejected and braced poles at inaccessible locations as illustrated in Figure 14., DPU purchased a back-yard pole setting unit and purchased steel replacement poles. Steel poles weigh approximately 50% of what a wood pole type Douglas fir weighs; but cost twice as much. Figure 14. illustrates a typical braced pole and a new steel pole.

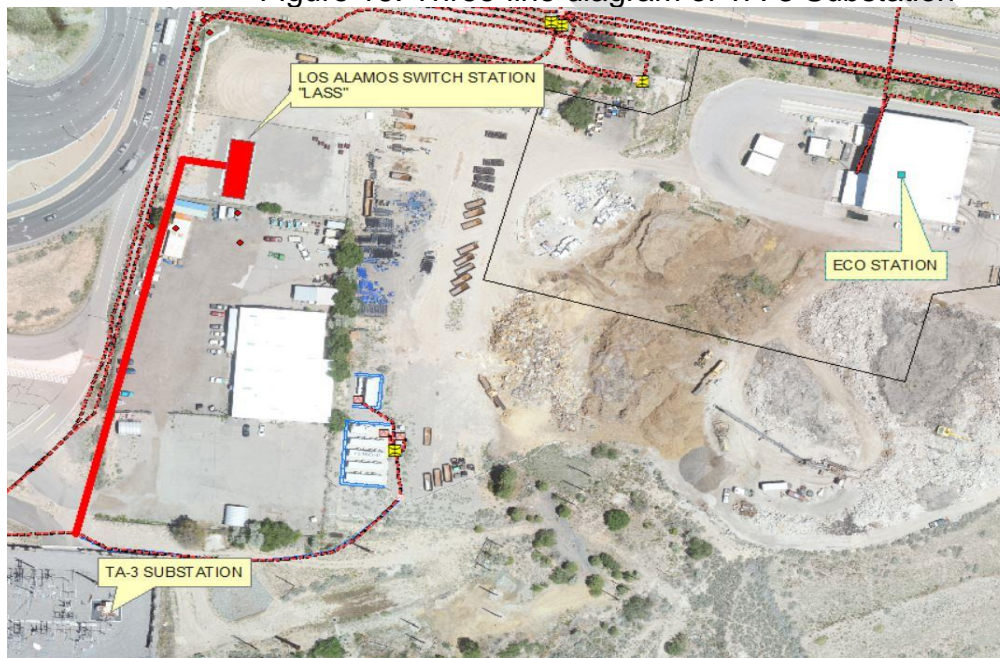
Figure 17. LASS station Location Relative to LANL

The top reliability project for DPU is the construction of the new LASS Substation addition near the County landfill as illustrated in Figure 17. The LASS Substation is needed to maintain the SAIDI target into the future. LASS is also critical to the supply of steady and reliable electric power to the residents of the Los Alamos Townsite; more so if the Townsite area is expected to grow electrically.

The LASS substation will relieve load from the existing Townsite switching station. The station will tie to TA-3 on breakers LC1 and LC2. Under existing conditions and for a TC1 feeder outage, the Townsite peak demand exceeds the TC2 feeder ampacity rating as illustrated in Table 5. below.
