# Restoration Feasibility Assessment: Los Alamos County Open Space

Report Presentation

2/9/2023

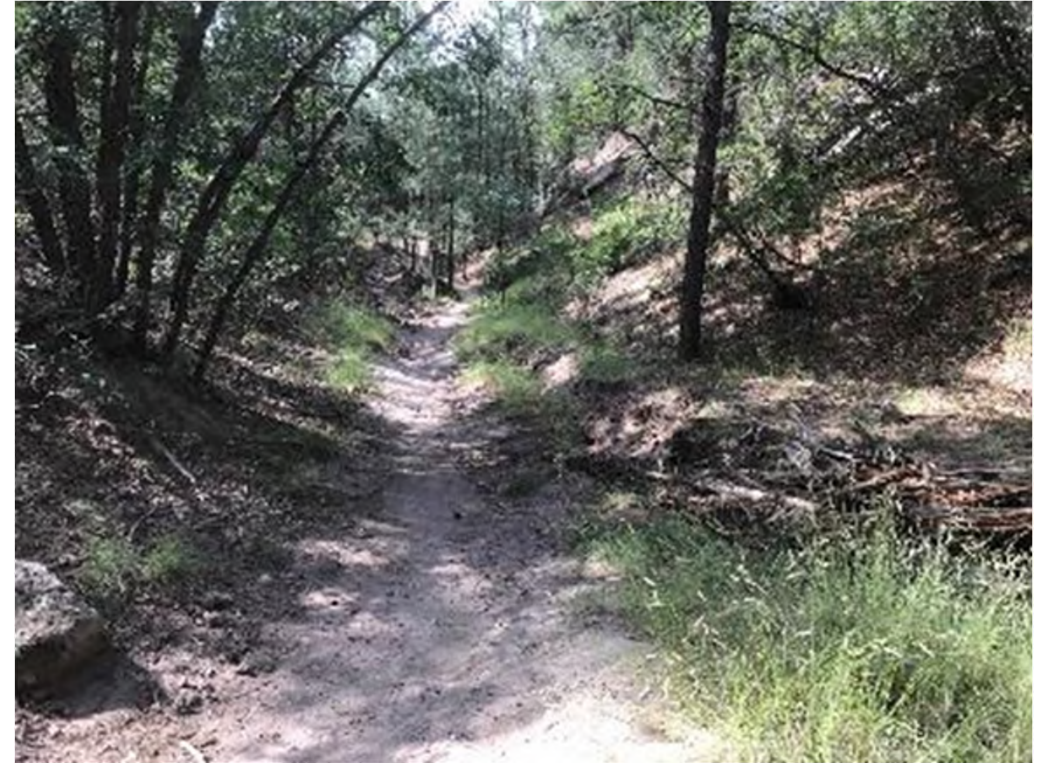
# Barranca Crossing

- Trail crossing drainage
- Channel incision
- Trail and drainage erosion
- Repair should focus on trail surface and drainage

| Area | Engineering<br>&<br>permitting | Construction<br>Ballpark | Approx.<br>Total | Notes |
|---|---|---|---|---|
| <b>Barranca Crossing</b> | NA | \$15,000 | ~\$15,000 | Machine drainage of road into Rendija, hand build one rock dams to restore trail to south |

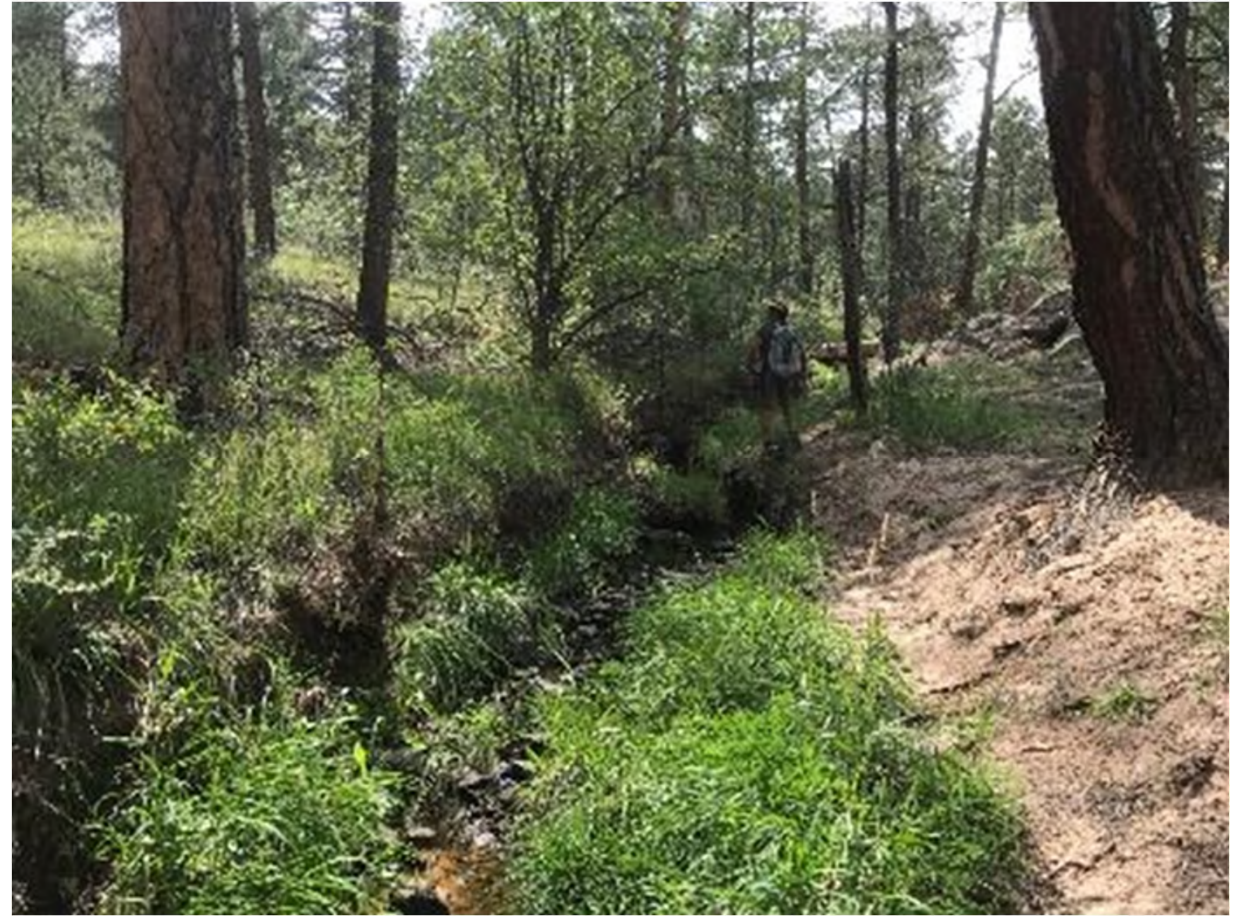
# Upper Acid Canyon

- Incised with loss of floodplain function
- Eroding banks
- Active headcut
- Some nonnative species
- Utilize machinery to build rock grade control
- Access and potentially contaminated soils are issue

| Area | Engineering<br>&<br>permitting | Construction<br>Ballpark | Approx.<br>Total | Notes |
|---|---|---|---|---|
| <b>Acid Canyon</b> | \$12,000 | \$40,000 | \$52,000 | Unknown issues with contaminants, length of project could be short or long |

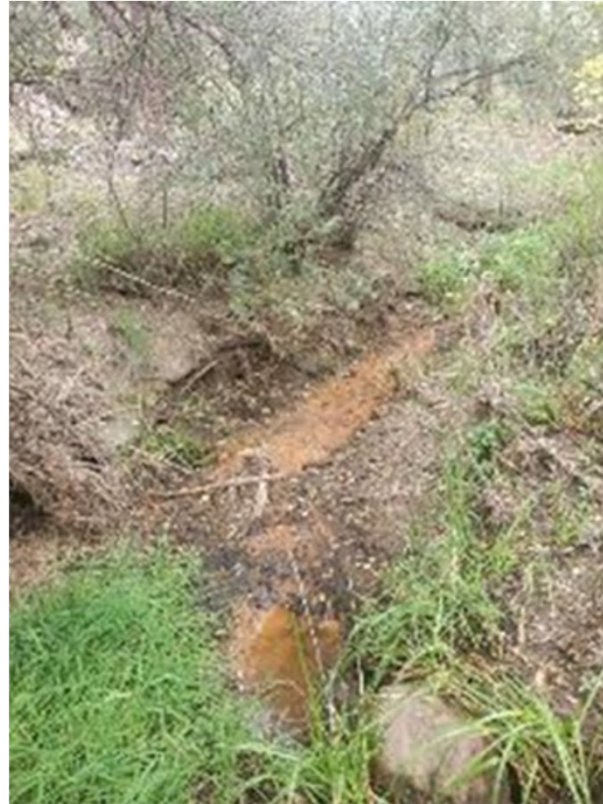
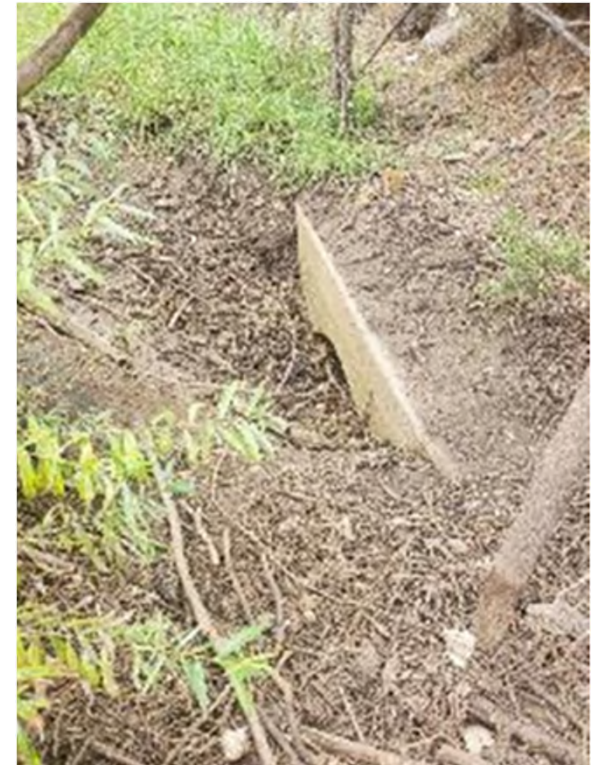
# Orange Canyon

- Channel Incision
- Excess sediment at culvert
- Utilize Rock Grade Control
- Hand crews and volunteers

| Area | Engineering<br>&<br>permitting | Construction<br>Ballpark | Approx.<br>Total | Notes |
|---|---|---|---|---|
| <b>Orange Canyon</b> | | 15,000 | | Small hand or machine built project |

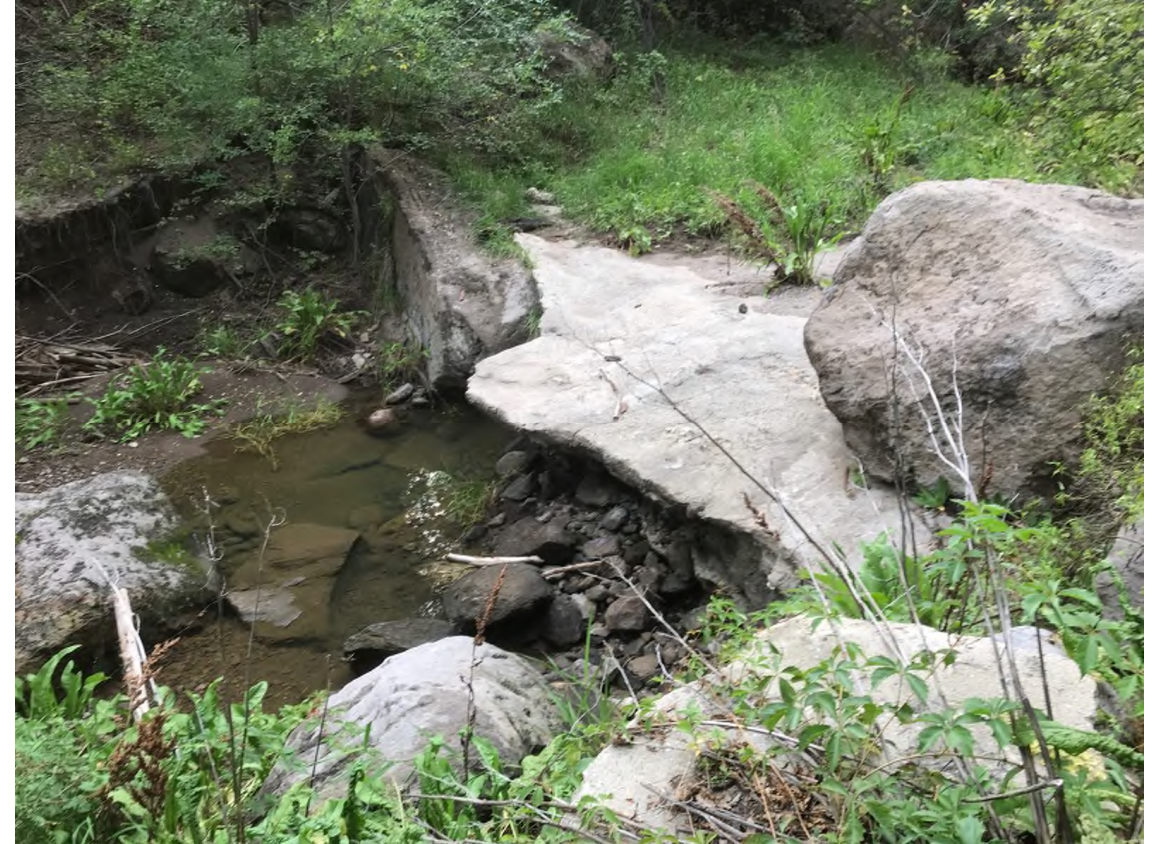
# Middle Pueblo Canyon

- Incised Channel
- Grade control at Utilities creates scour
- Treat with rebuilt grade control using large boulders and geomorphic concepts

| Area | Engineering<br>&<br>permitting | Construction<br>Ballpark | Approx.<br>Total | Notes |
|---|---|---|---|---|
| <b>Pueblo Middle</b> | \$15,000 | 60,000 | \$75,000 | Stream crossings of pipe and road could be prioritized, road access exists |

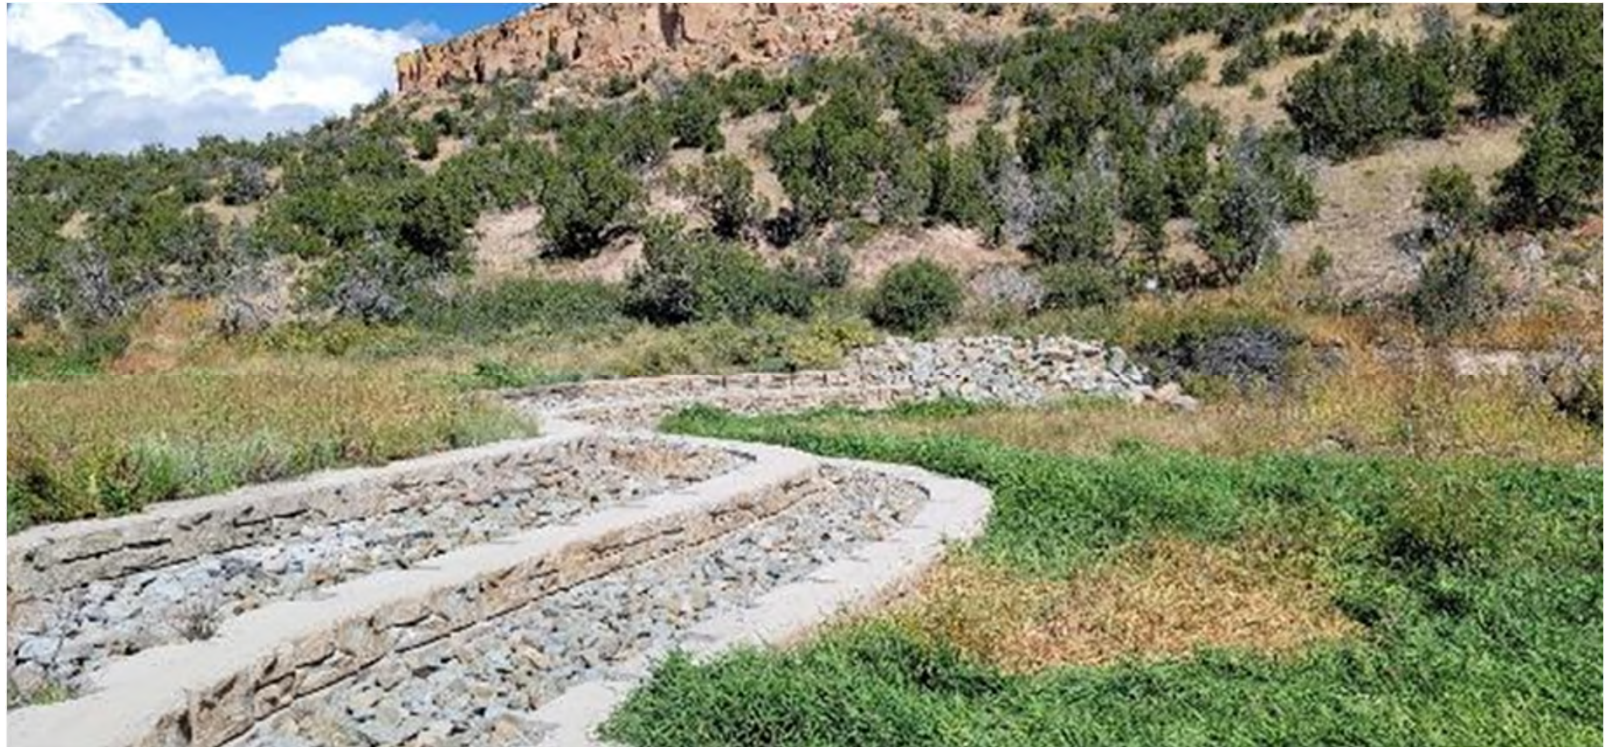
# Lower Pueblo Canyon

- High sediment supply from urban runoff
- Existing grade control
- Invasive Reed Canary Grass
- Create meandering wetland channel
- Revegetate

| Area | Engineering<br>&<br>permitting | Construction<br>Ballpark | Approx.<br>Total | Notes |
|---|---|---|---|---|
| <b>Pueblo Lower</b> | + | Included as appendix | | Phase 1 in appendix, phase II is wetland above N3B grade control |

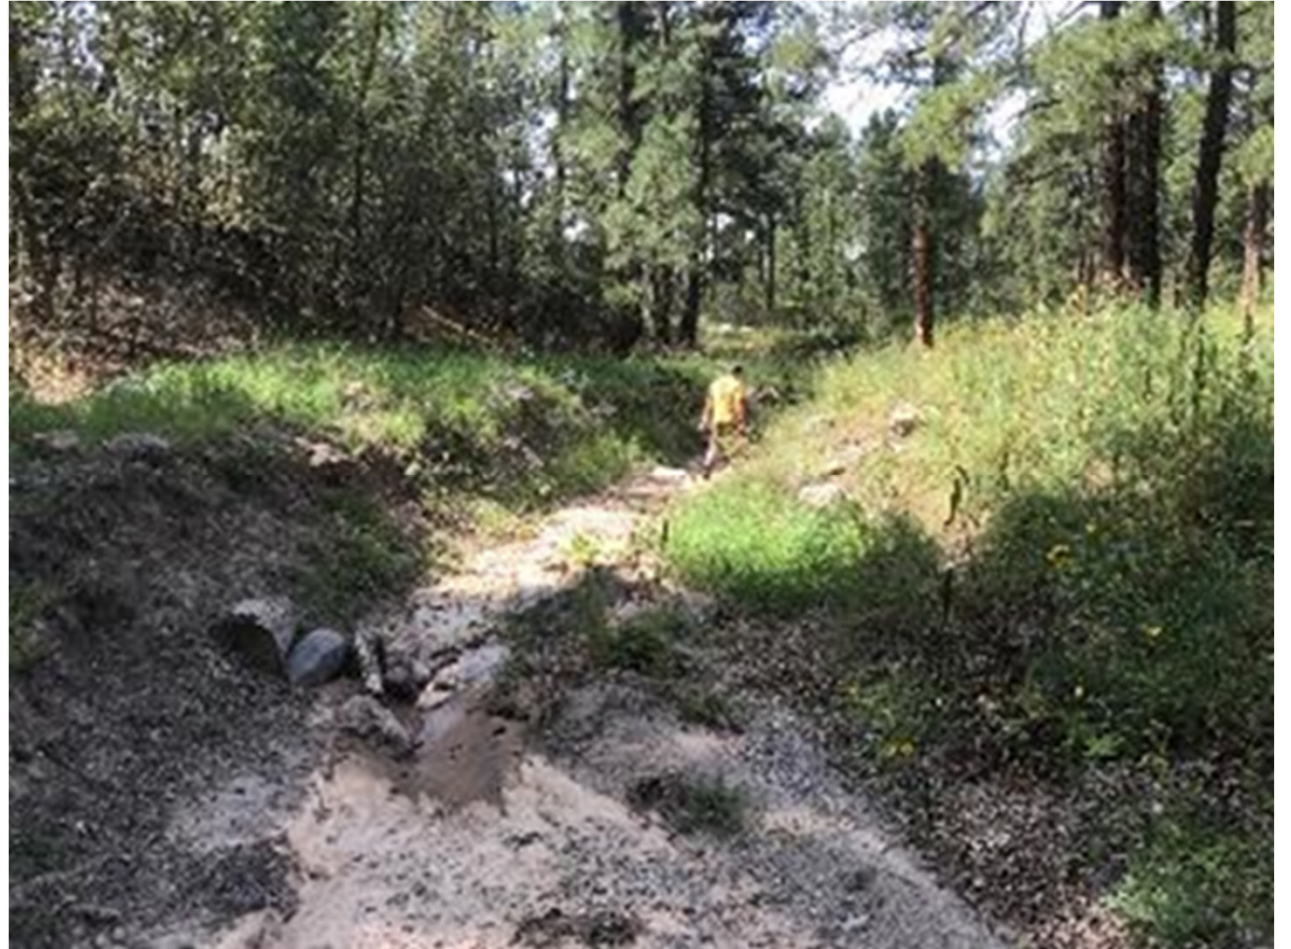
# Rendija Canyon

- Erosion through old alluvial deposit
- Requires channel restoration to appropriate dimensions

| Area | Engineering<br>&<br>permitting | Construction<br>Ballpark | Approx.<br>Total | Notes |
|---|---|---|---|---|
| <b>Rendija</b> | \$12,000 | | | |

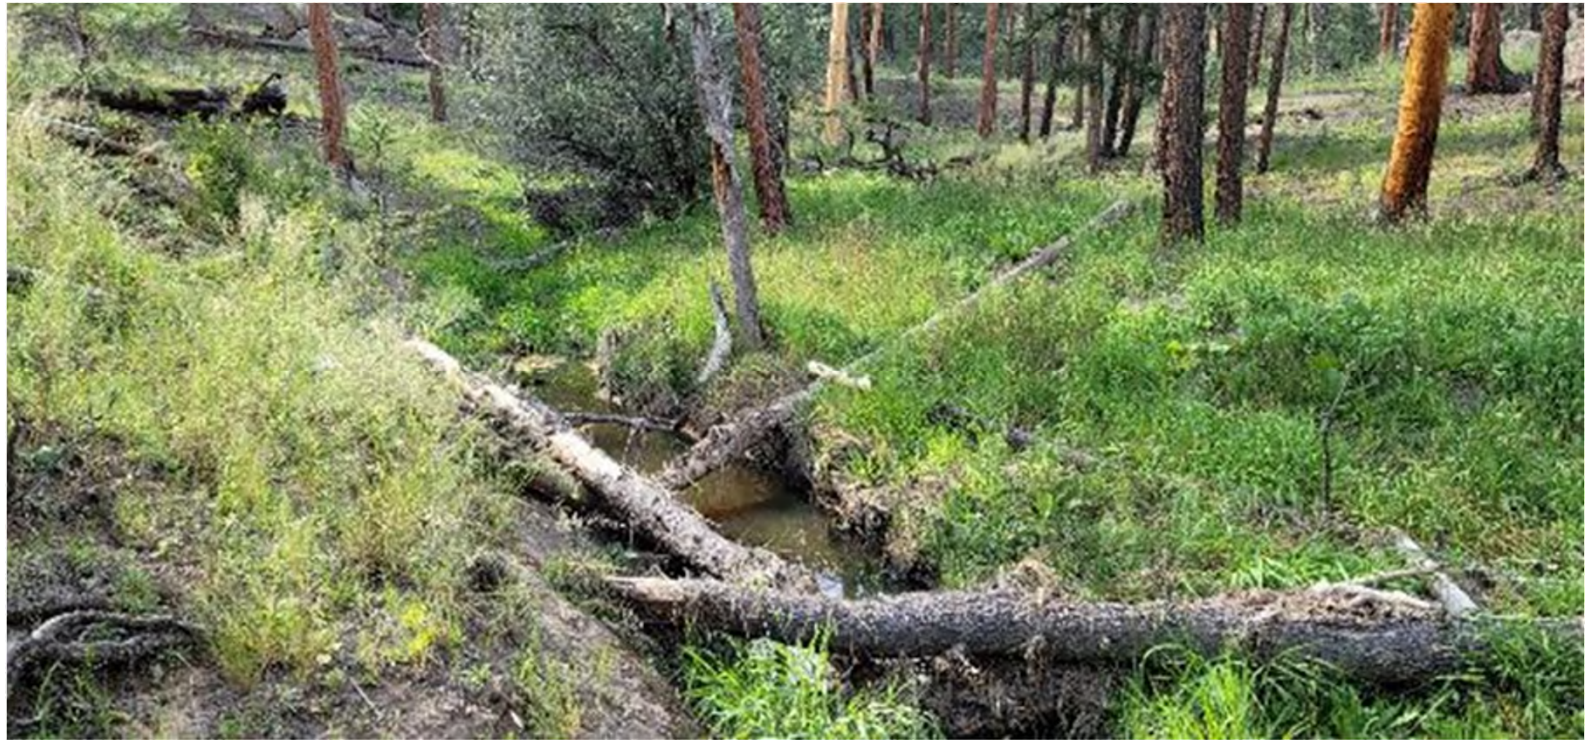
# Walnut Canyon

- Reed Canary Grass & Russian Olive Infestation
- Incision into wetland
- Weed Treatment
- Replanting
- Handbuilt Grade control

| Area | Engineering<br>&<br>permitting | Construction<br>Ballpark | Approx.<br>Total | Notes |
|---|---|---|---|---|
| <b>Walnut Canyon</b> | \$3,000 | 10,000 | \$13,000 | Headcutting and erosion control, Russian olive removal |

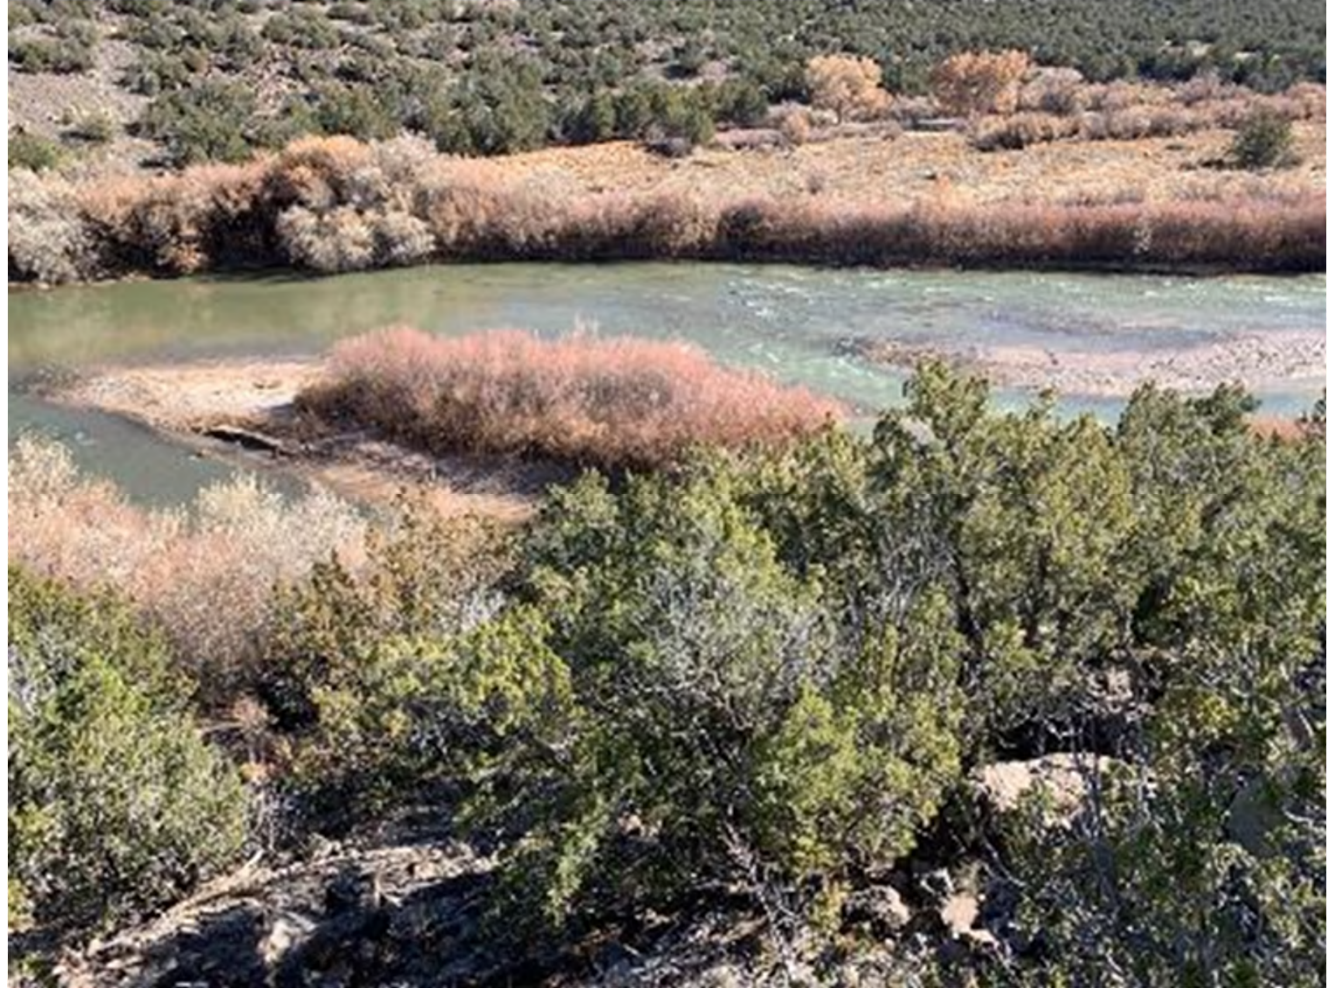
# White Rock Canyon

- Invasive Russian Olive and Tamarisk
- Remove and revegetate

| Area | Engineering<br>&<br>permitting | Construction<br>Ballpark | Approx.<br>Total | Notes |
|---|---|---|---|---|
| <b>White Rock Canyon</b> | NA | 100,000 | | Indeterminate scope, many floodplains each with differing amounts of Russian Olives, long |

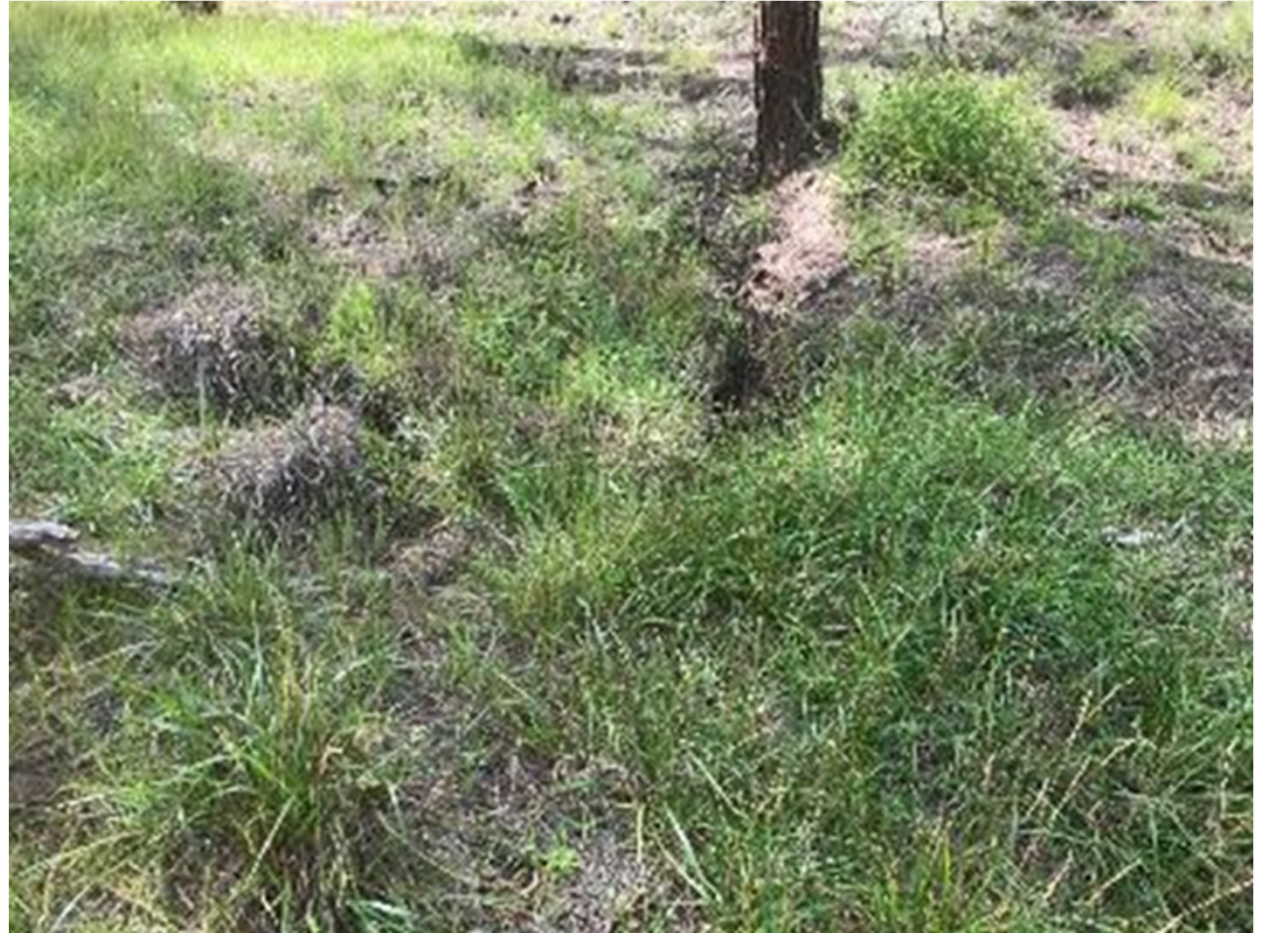
# Perched Wetlands

- Small shallow pockets of wetland plants supported by alluvial soils and runoff on hill slopes
- Erosion through fine soils
- Repair with hand build rock structures
