# APPENDICES

## **Appendix C – Trail Assessments & Maintenance Needs**

### TRAIL ASSESSMENTS AND MAINTENANCE NEEDS

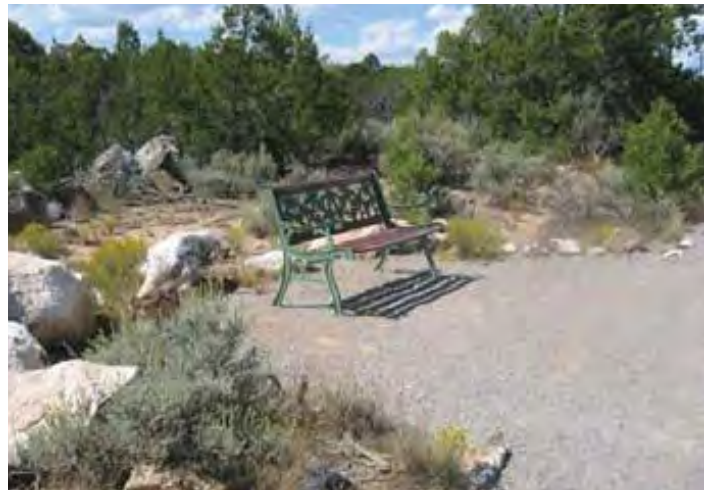
*Install benches along trail.*

1. Install benches along the trail.
2. Continue to monitor the condition of the low-water crossing.
3. Monitor the condition of the road-oil surface.
4. Monitor condition of bridge.

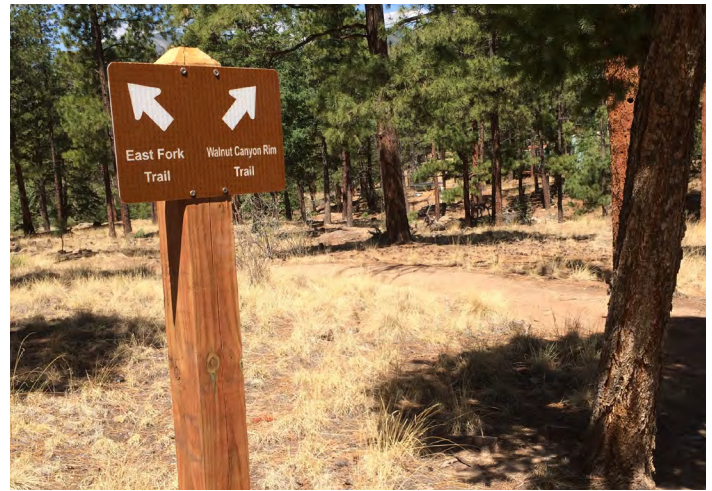
*Better mark trail as it passes through disturbed area.*

1. A trail connection should be completed between the two trail segments.
2. Better mark trail as it passes through disturbed area near golf course maintenance entrance.
3. Monitor condition of bridges.

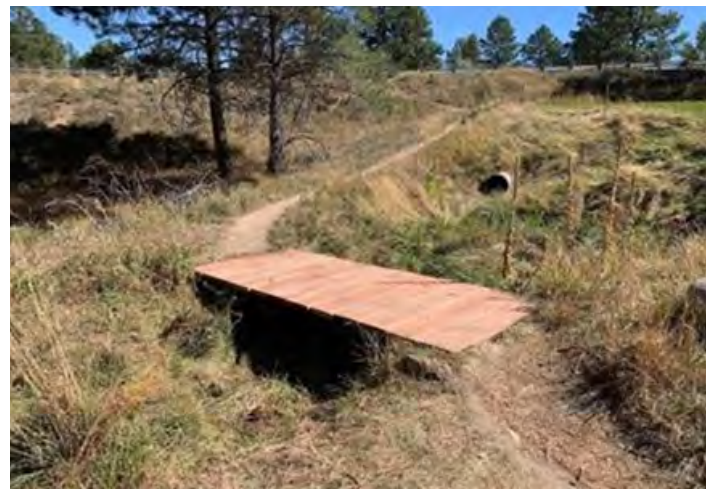
*Monitor condition of bridges.*

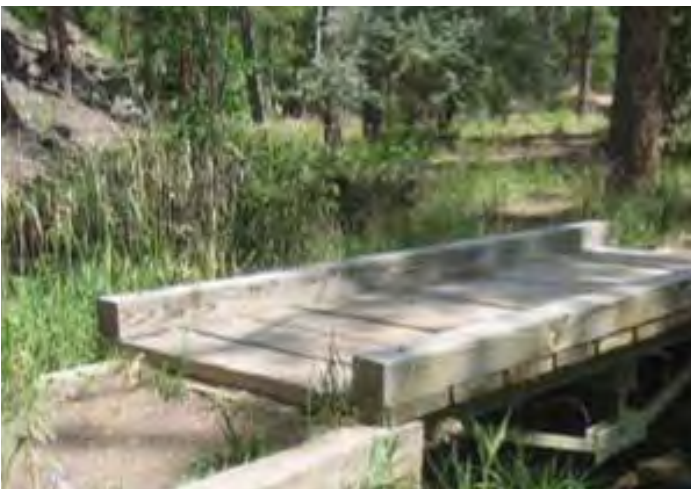
*Monitor bridge condition.*

1. Central section treadwork and install of water control structures.
2. Improve stairs near 34th Street.
3. Monitor bridge condition.
