# APPENDICES

## Appendix C – Trail Assessments & Maintenance Needs

### TRAIL ASSESSMENTS AND MAINTENANCE NEEDS

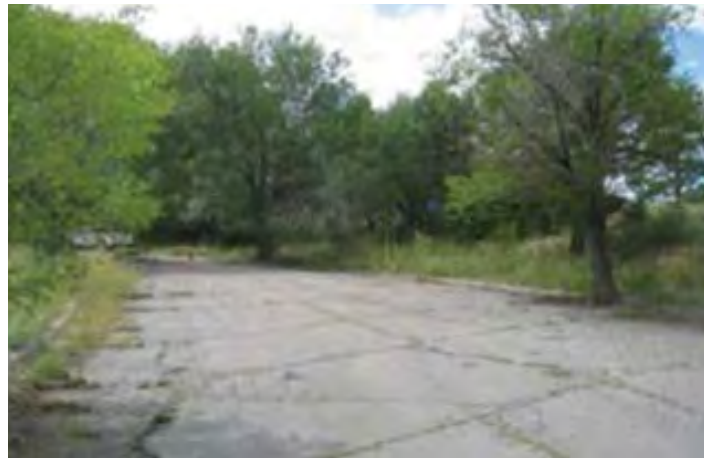
*Establish improved parking at trailhead and install mini-kiosk and repair damage from street runoff to the trail.*

1. Establish improved parking at trailhead and install mini-kiosk.
2. Monitor condition of deer trap and ancestral pueblo stairs.
3. Extend retaining wall at point where the trail drops from the mesa top.
4. Protect viewshed at trail's end.
5. Connect to Otowi Mesa Trail.

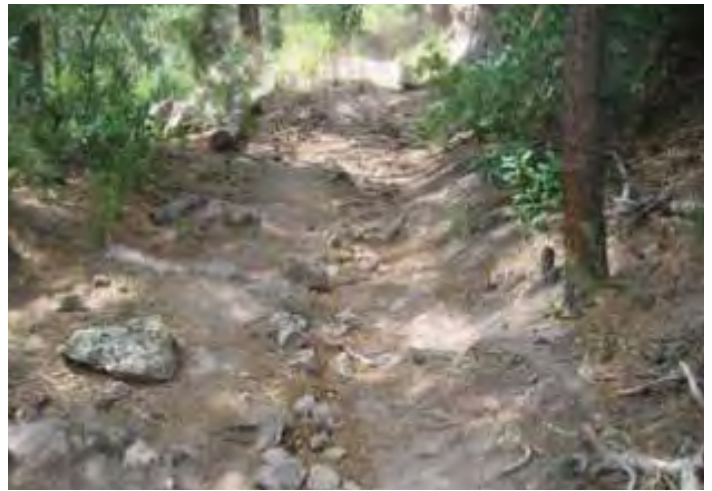
*Monitor erosion on historic portion of trail.*

1. Monitor drainage on historic stretch.
2. Use one rock dams to trap sediment on old trail route.
3. Add a stair in the steep part of the descent.
4. Continue to monitor condition of Homestead Bridge.

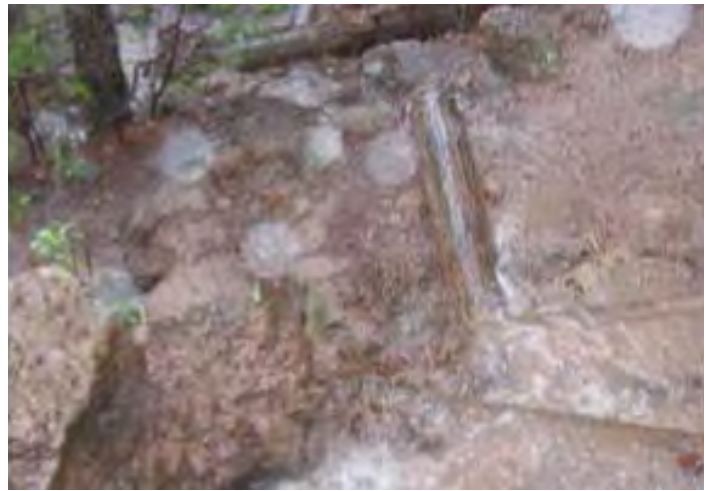
*Water flowing down the Ranch School Trail.*

1. Landscape trailhead area with native plants.
2. Divert water from Aquatic Center runoff off of the trail.
3. Monitor the condition of the stonewall switchback on an annual basis.
4. Rebuild the bridge over Pueblo Canyon.

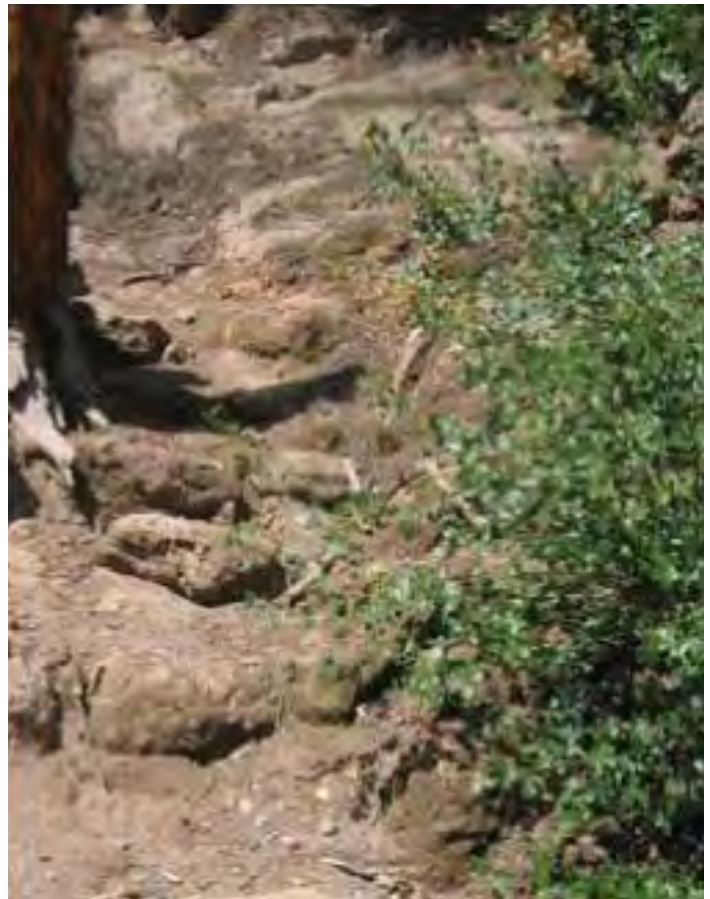
*Improve stairs near 34th Street.*

1. Central section treadwork and install of water control structures.
2. Improve stairs near 34th Street.
3. Monitor bridge condition.

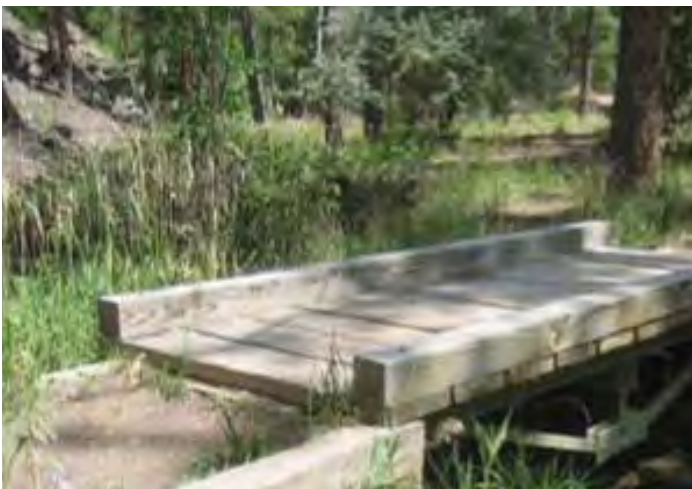
*Monitor bridge condition.*

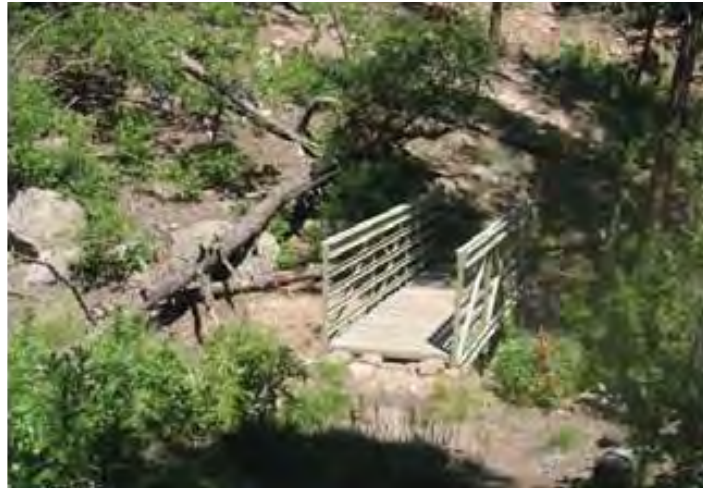
*Monitor condition of bridge.*

1. Monitor condition of bridges.

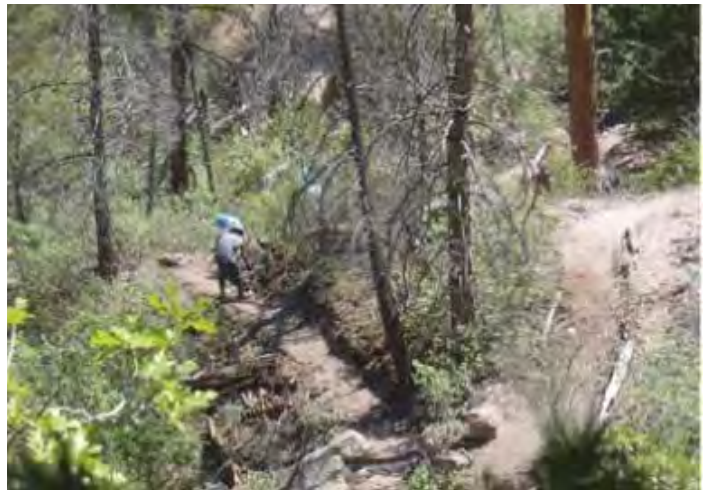
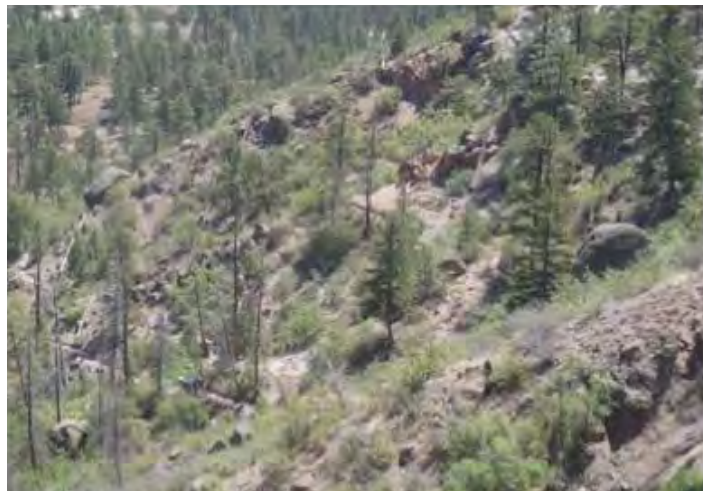
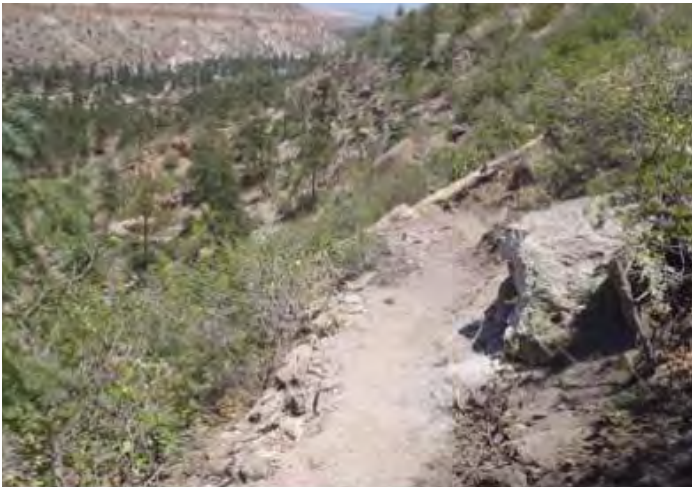
*Monitor condition of switchbacks throughout the trail.*

1. Monitor condition of the switchbacks throughout the trail.
