LOS ALAMOS COUNTY DEPARTMENT OF PUBLIC UTILITIES

**FY 2024 ELECTRIC RELIABILITY AND
RESILIENCE PLAN**

(FOR INFORMATION & DISCUSSION ONLY)

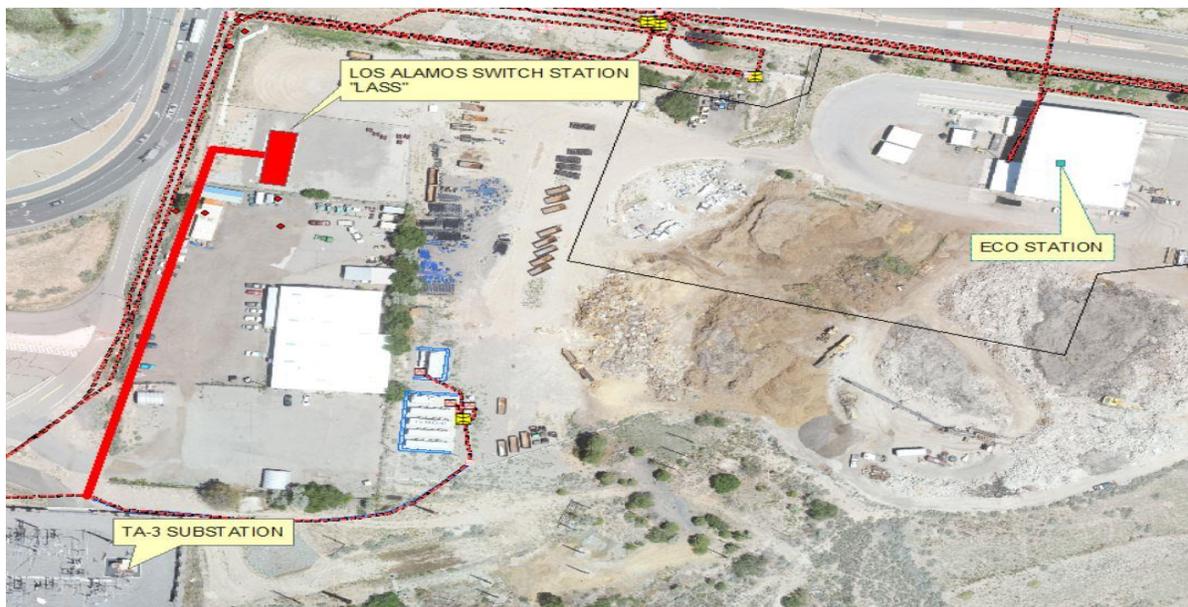
Figure 5. LASS station Location Relative to LANL

The top reliability project for LACDPU is the construction of the new LASS Substation addition near the County landfill as illustrated in Figure 17. The LASS Substation is needed to maintain the SAIDI target into the future. LASS is also critical to the supply of steady and reliable electric power to the residents of the Los Alamos Townsite; more so if the Townsite area is expected to grow electrically.

The LASS substation will relieve load from the existing Townsite Substation. The station will tie to TA-3 on breakers LC1 and LC2. Under existing conditions and for a TC1 feeder outage, the Townsite peak demand exceeds the TC2 feeder ampacity rating as illustrated in Table 3. below. The loading condition may worsen as Los

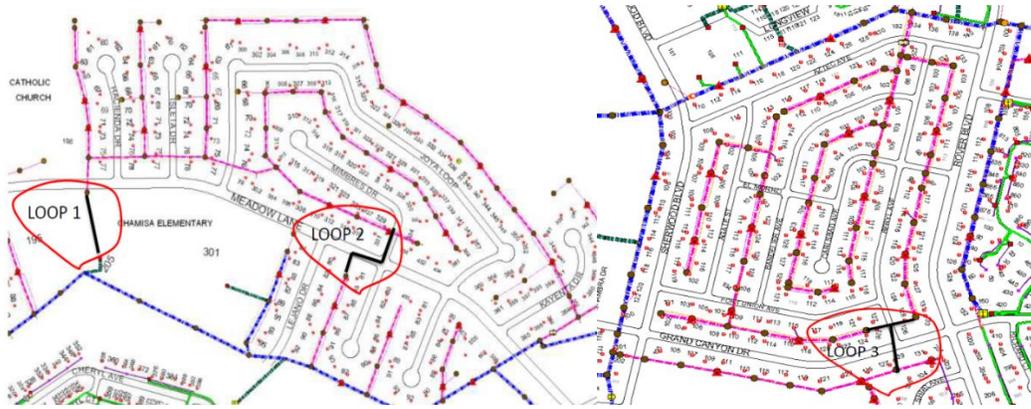
Figure 7. Single Phase Loop Addition Targets in White Rock

Other long term UG projects which will provide long-term reliability improvement is the addition of new UG or OH Loops. LACDPU has many radial lines which power anywhere from 30 to 100 customers; a failure on the radial line leaves few alternatives to restore power in a timely fashion. By identifying these long radial power lines, LACDPU can install new Loops within reasonable costs. Figure 7. illustrates priority areas for Loop additions in White Rock.

The LACDPU has many underground subdivisions with single phase primary laterals with 10+ transformers configured in a daisy-chain. When LACDPU experiences a faulted line section, it must identify the fault, isolate it, then back feed the outage area from a new power source. Back feed is done by manually transferring electrical load with a 200-amp elbow; at least two times during the restoration process. With continual line section failures, the manual back feeding process is resulting in secondary and residual failures, i.e. elbows or other weakened points. Therefore, LACDPU must look at other engineering solutions in identifying and isolating failed line sections so that no secondary or residual failures occur.
