**INCORPORATED COUNTY OF LOS ALAMOS RESOLUTION NO. 21-30**

**A RESOLUTION DECLARING THE HOTEL STRUCTURE, COMMONLY REFERRED TO AS “THE HILLTOP HOUSE,” LOCATED AT 400 TRINITY DRIVE, LOS ALAMOS, NEW MEXICO, A MENACE TO THE PUBLIC COMFORT, HEALTH, PEACE, AND SAFETY AND ORDERING REMOVAL OF THE HILLTOP HOUSE, AND ASSOCIATED RUINS, RUBBISH, WRECKAGE, AND DEBRIS FROM LOS ALAMOS COUNTY.**

## NOTICE and ORDER OF THE FIRE MARSHAL OF THE INCORPORATED COUNTY OF LOS ALAMOS, NM

400 TRINITY DRIVE

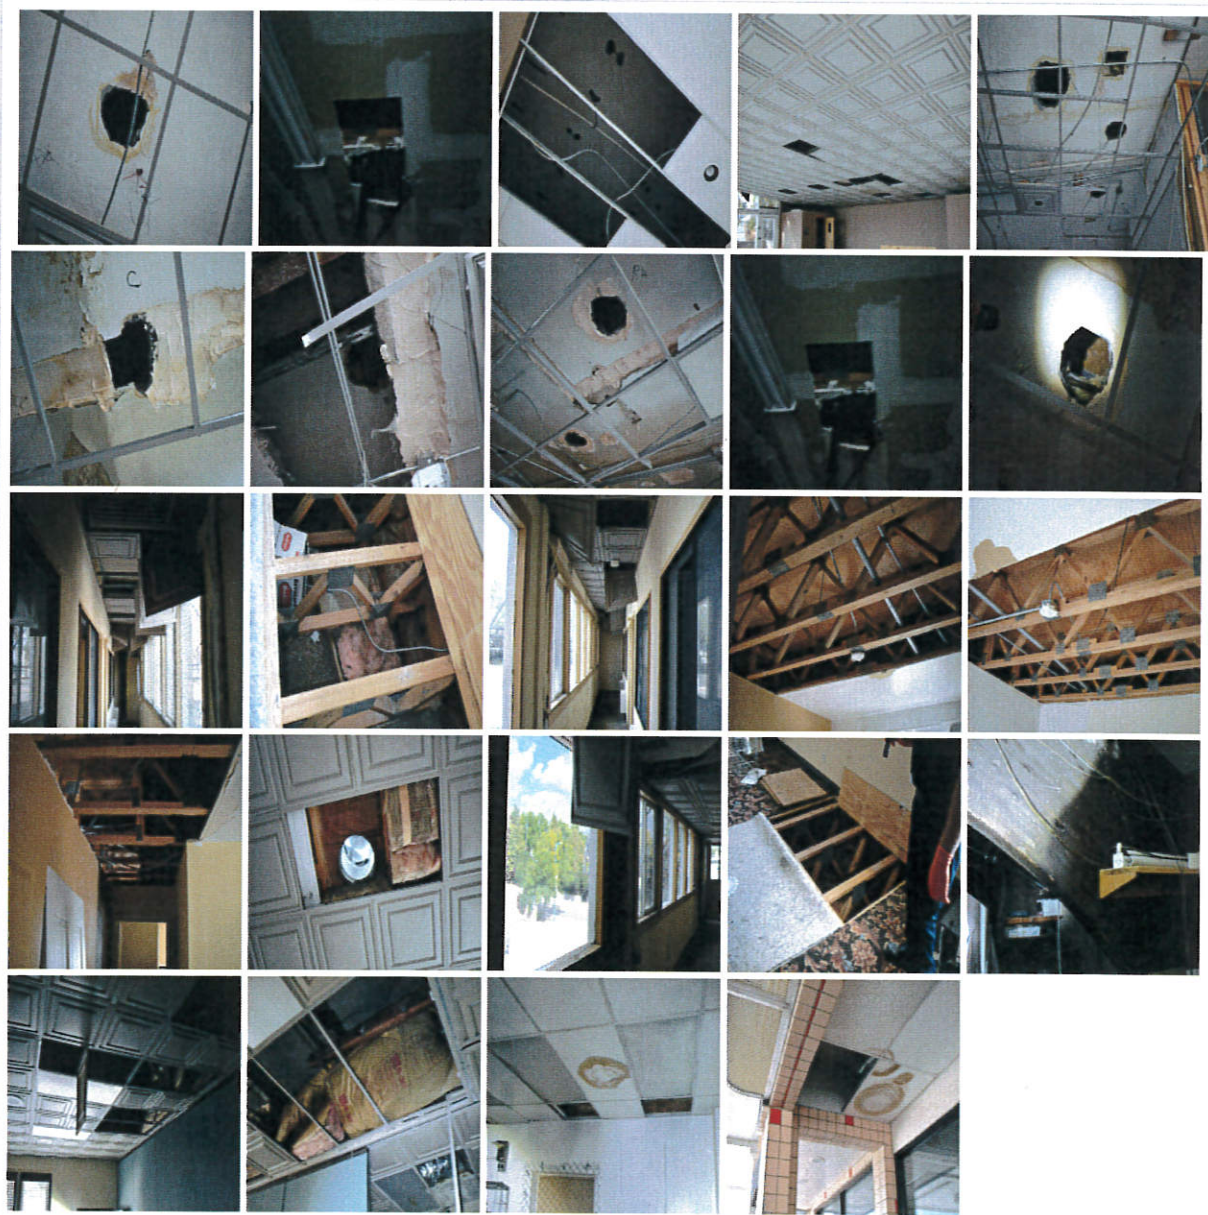
Item	Result	Remarks
Repair holes in required fire resistive construction	Fail	VERTICAL OPENINGS are exhibited throughout the structure on all floors compromising the fire resistive construction of the vacant structure. As a result fire and or superheated smoke has easy access to spread quickly via the ceiling/floor levels as fire desires to travel upwards. Voids spaces can allow fire to hide before becoming visible and ceiling fires are difficult to extinguish. The pictures are a sampling of vertical openings found during inspection and are not be representative of all vertical opening violations.

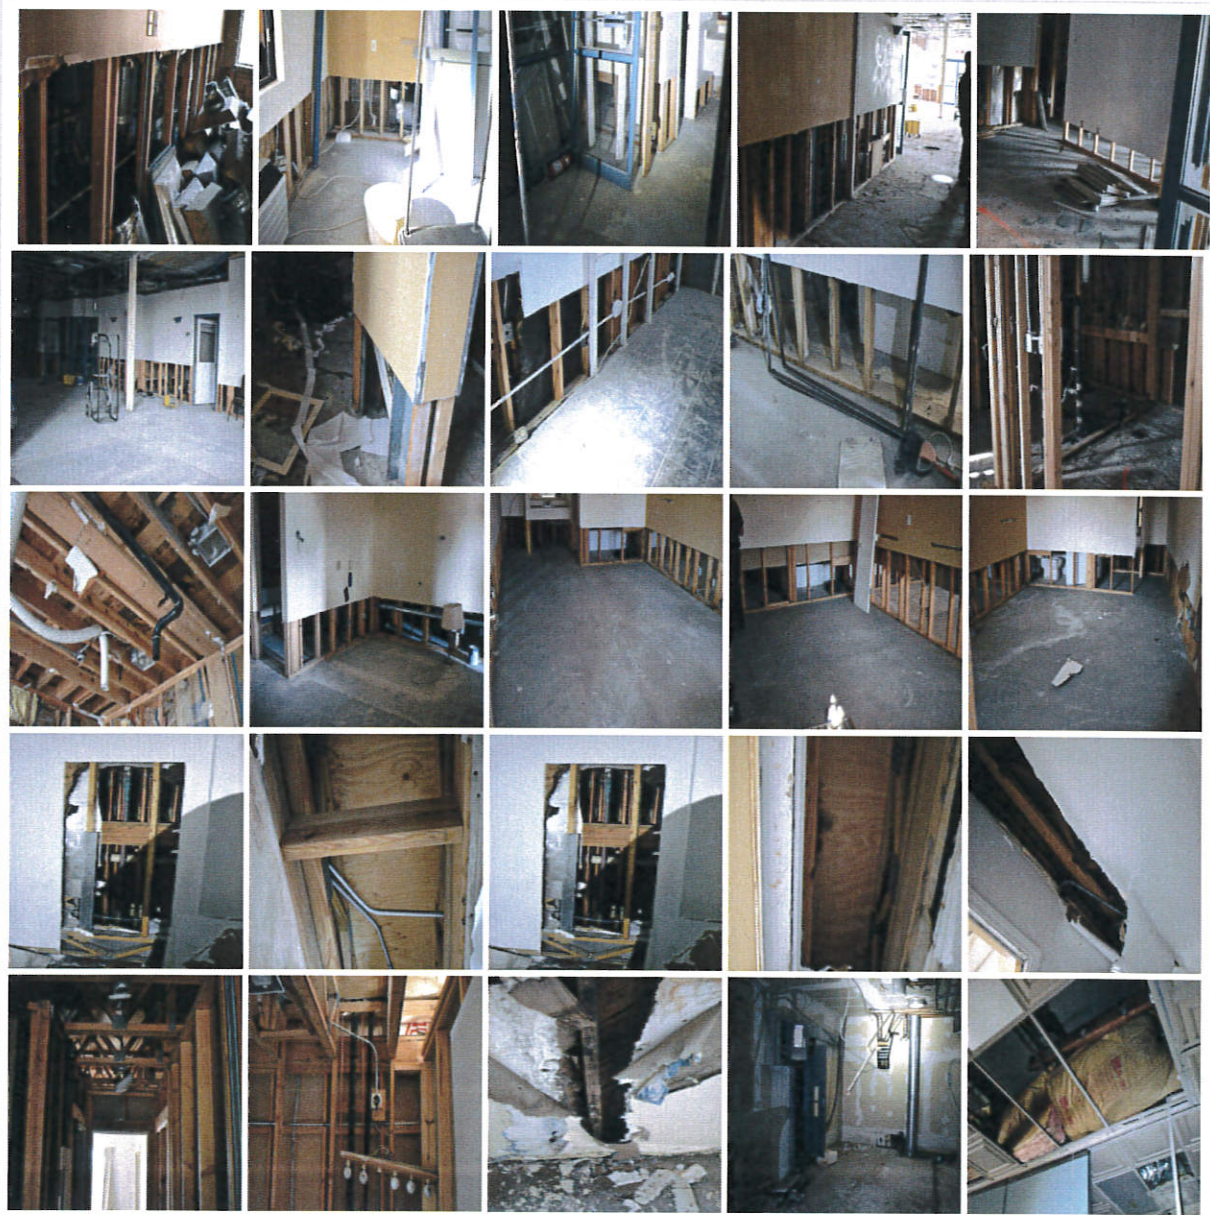
Item	Result	Remarks
Repair holes in required fire resistive construction <b>2nd Instance</b>	Fail	HORIZONTAL OPENINGS are exhibited throughout the structure on all floors compromising fire resistive construction of the vacant structure. Walls are left in various stages of construction or repair. As a result, little to no fire compartmentalization is possible allowing for rapid and extreme fire spread. The pictures are a sampling of horizontal opening found during inspection and are not be representative of all horizontal opening violations.

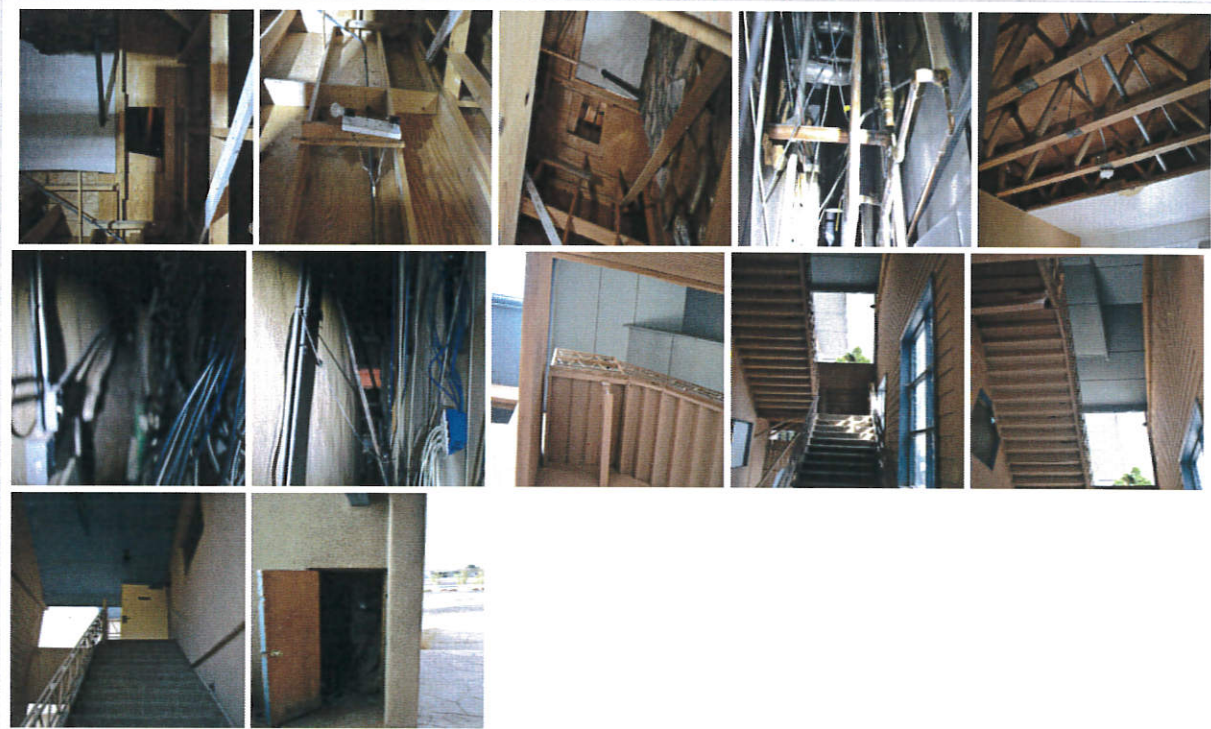
Item	Result	Remarks
Provide / repair self or automatic closing fire rated assemblies	Fail	CHASES, STAIRWAYS, ELEVATOR AND OTHER VERTICAL SHAFTS building construction that is present does not provide adequate protection and needs remediation. Non-sprinklered building requires 2-hour separation for fire rated assemblies. These areas will continue to act as a natural chimney's and aid vertical fire travel for vacant and occupied buildings. The structure has a existing utility chase that located in the middle of the building being 2 ft. wide that runs the length of the structure from floor to attic and from the Hilltop Spa to the attached gas station store area. Exterior stairways are enclosed to create an interior stairs which are "open" without the necessary fire protection provided. Additionally, two chase ways exist from the exterior main entrance carport area that extend from floor to ceiling with no protection which would easily allow for fire to spread to the main structure. Exposed steel members providing no protection from fire expediting collapse which remains a danger to life for unauthorized persons and firefighters. The elevator shaft was not able to be evaluated for level of fire protection provided during the time of inspection.

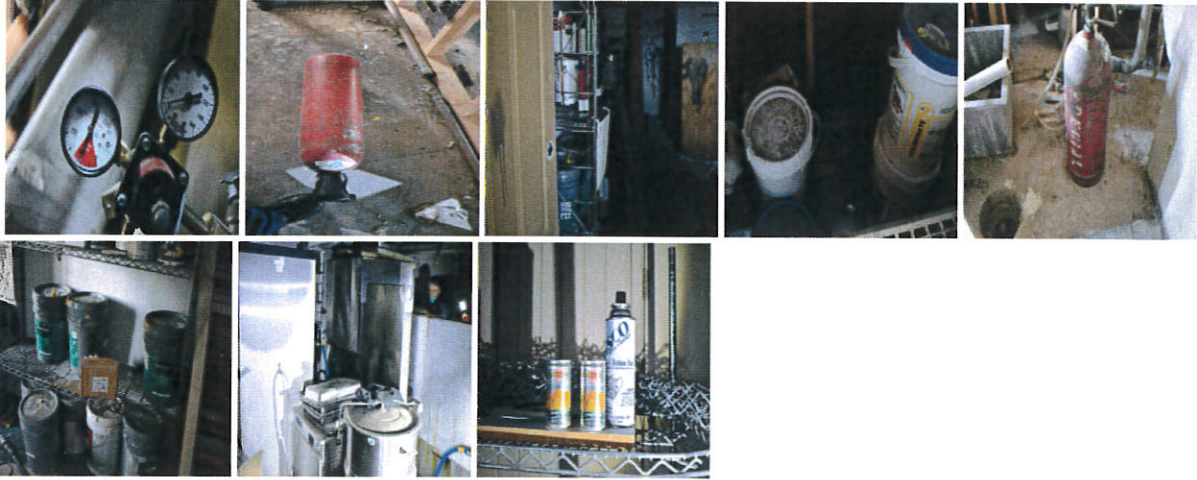
Item	Result	Remarks
Identify and remove hazardous materials, flammable or combustible liquids, or cylinders in vacant building.	Fail	Pool chemicals (chlorine) in pool atrium area and miscellaneous containers, cylinders, flammable liquids found throughout structure.
<b>Code</b>		
IFC2021P1 - 311.4 - Removal of hazardous materials. - Persons owning or having charge or control of a vacant building containing hazardous materials regulated by Chapter 50 shall comply with the facility closure requirements of Section 5001.6.

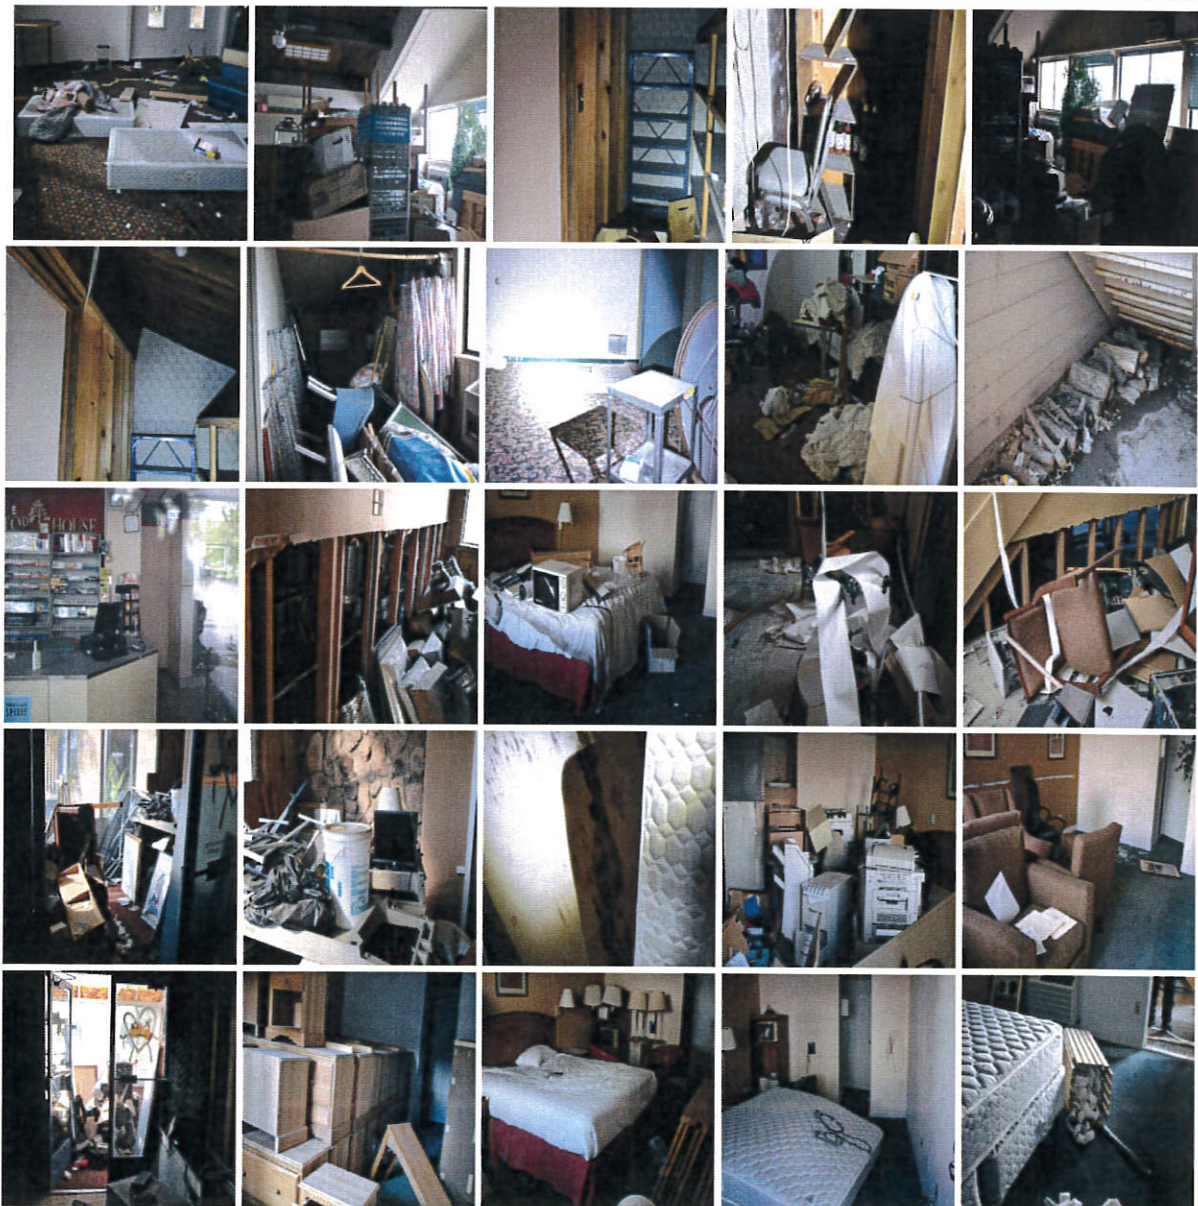
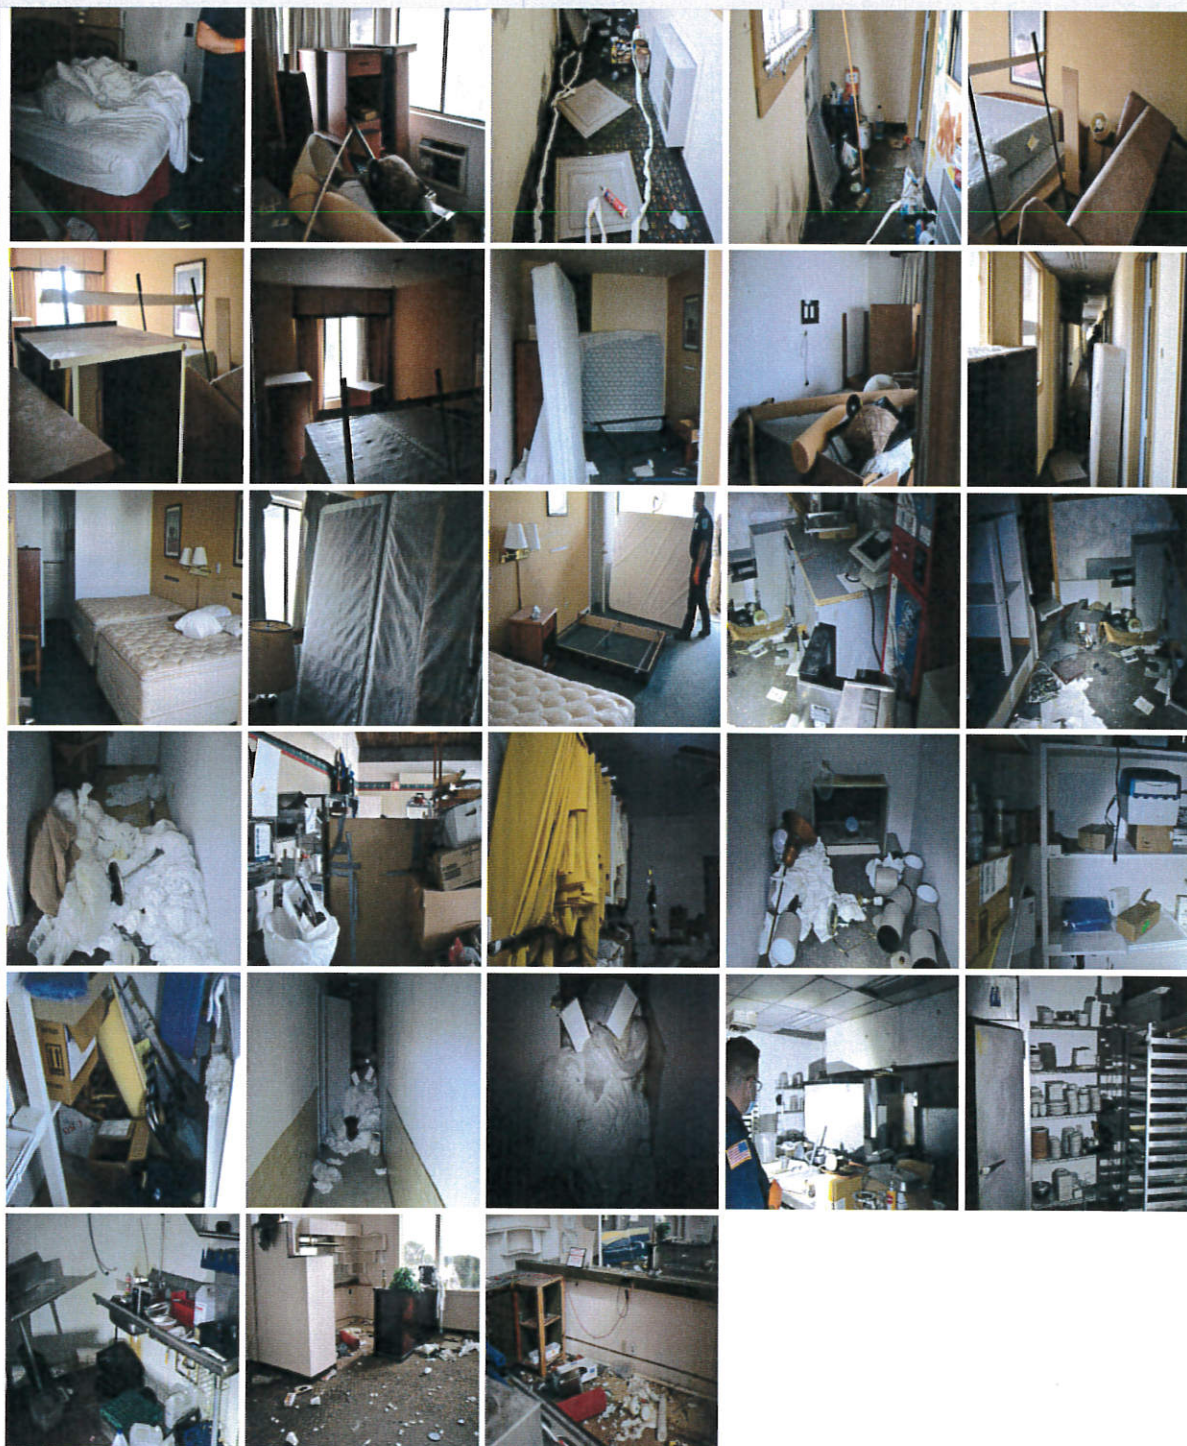
Item	Result	Remarks
Removal of all combustibles in vacant structure.	Fail	Per IFC 311.2.2 for Vacant Premises. Fire protection systems shall be maintained in an operable condition at all times. (3) Exceptions are listed to address exposed to freezing temperatures, buildings less than 12,000 sq. ft., and where premises have been cleared of all combustible materials, debris etc. All combustibles need to be cleared to bare concrete floor.

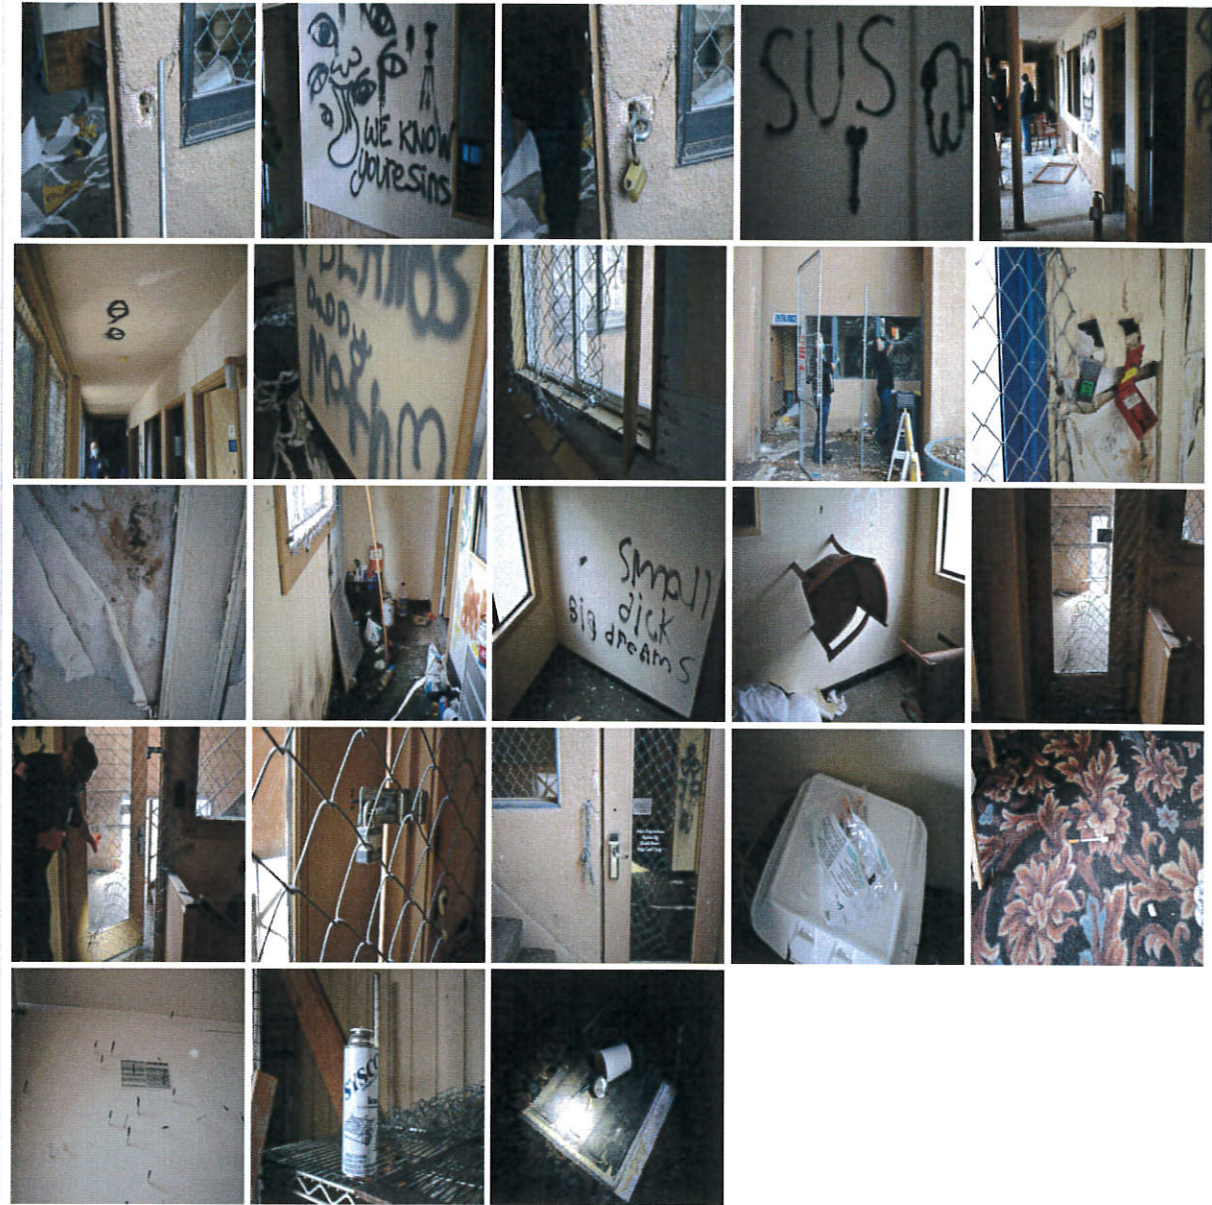
Item	Result	Remarks
Ensure unauthorized entry does not occur to protect public safety.	Fail	Strong visual evidence of unauthorized entry and or potential illegal activity. Security measures need to be reinforced immediately to fortify locks (pin to locking mechanism can slid out of stucco with no force required). Chain link is bent to allow access on entryway and exterior stairwells. Boarding of all exterior doors and windows to second floor required.

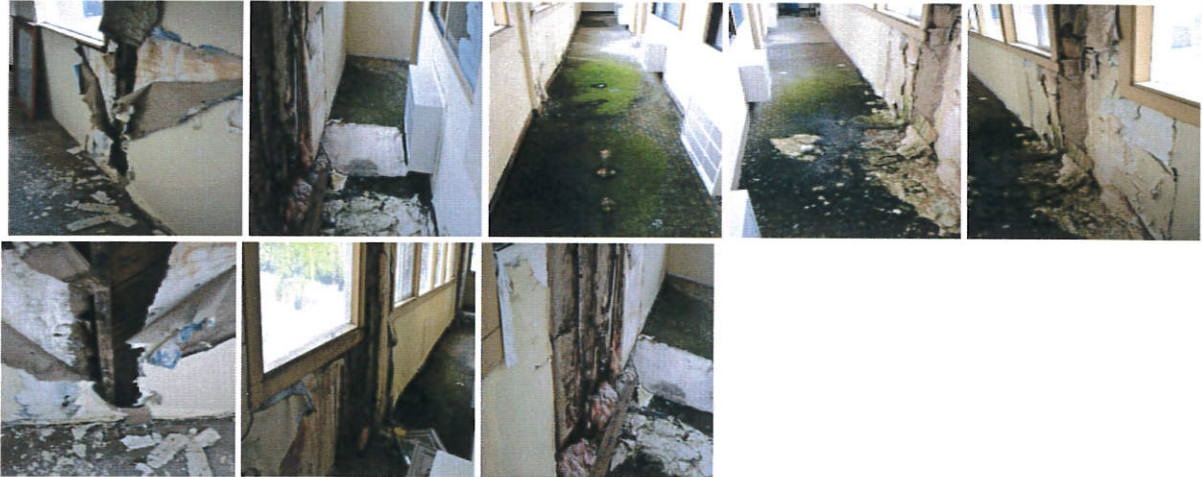
Item	Result	Remarks
Insanitary conditions found in structure. (mold, rodent droppings and human feces in toilets).	Fail	
Code		
IFC2021P1 - 114.1.1 - Unsafe conditions. - Structures or existing equipment that are or hereafter become unsafe, insanitary or deficient because of inadequate means of egress, inadequate light and ventilation, or that constitute a fire hazard, are otherwise dangerous to human life or the public welfare, or involve illegal or improper occupancy or inadequate maintenance, shall be deemed an unsafe condition. Unsafe structures shall be taken down and removed or made safe, as the fire code official deems necessary and as provided for in this section. A vacant structure that is not secured against unauthorized entry shall be deemed unsafe.

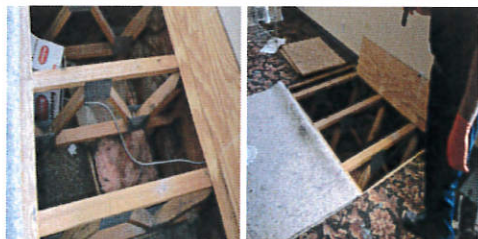
Item	Result	Remarks
Structural hazards.	Fail	During inspection of the premises on the 3rd floor (3) holes were found in the floor or floor was covered with wood planking suggestive of a hole in the floor (picture not available). The above picture was taken and this hole in the floor was from a previous structural engineer review of J. Randall who was evaluating the occupant loading capacity. (2015). In his review, he suggested to a previous owner how to add steel beams to increase occupant loading capacity safely. During the fire inspection 9/29/21 on the third floor the floor and roof in intermittent areas may have had more give or bounce upon walking. Further evaluation will be needed by a professional to ensure structural integrity. Open holes or weak floors or roofs could constitute a clear threat to human life, safety and or health of the public (unauthorized entry) or firefighters operating in a fire condition. Further orders or notice will be given by the fire code official to remove or remedy the conditions and shall be referred to the building code official for any repairs, alterations, remodeling, removing or demolition required. (IFC 114.1 General, and IFC 114.2 Structural hazards.)
